TANG FRAGMENT OF A KNIFE HR-6567 - LEADED BRONZE - LATE BRONZE AGE - SWITZERLAND

Artefact name Tang fragment of a knife HR-6567

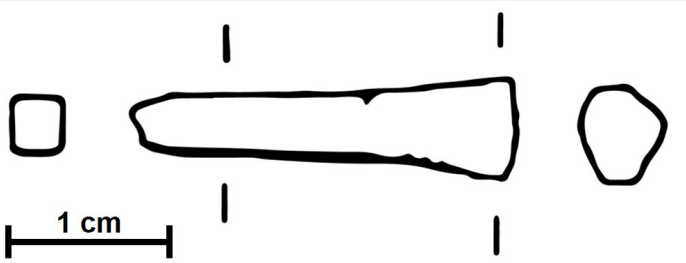
Fig. 1: Tang fragment of a knife (after Rychner-Faraggi 1983, plate 35.26),

Fig. 2: Dense and brown-yellow corrosion product (detail) of the tang fragment of a knife,

Description of the artefact	Fragment de Tang avec des produits de corrosion brun-jaune brillants encore en place localement (Fig. 2). Dimensions : L = 2,9 cm ; Ømax. = 6,8 mm ; WT = 4,9 g.
Type of artefact	Household implement
Origin	Hauterive - Champréveyres, Neuchâtel, Neuchâtel, Switzerland
Recovering date	Excavation in 1983-1985, layer 3
Chronology category	Late Bronze Age
chronology tpq	1054 B.C.
chronology taq	1000 B.C.
Chronology comment	Hallstatt B1 (1054/1037BC _ 1000BC)
Burial conditions / environment	Lake
Artefact location	Laténium, Neuchâtel, Neuchâtel
Owner	Laténium, Neuchâtel, Neuchâtel
Inv. number	HR-6567
Recorded conservation data	No conservation data available, but a coating and inventory number is visible on the surface.

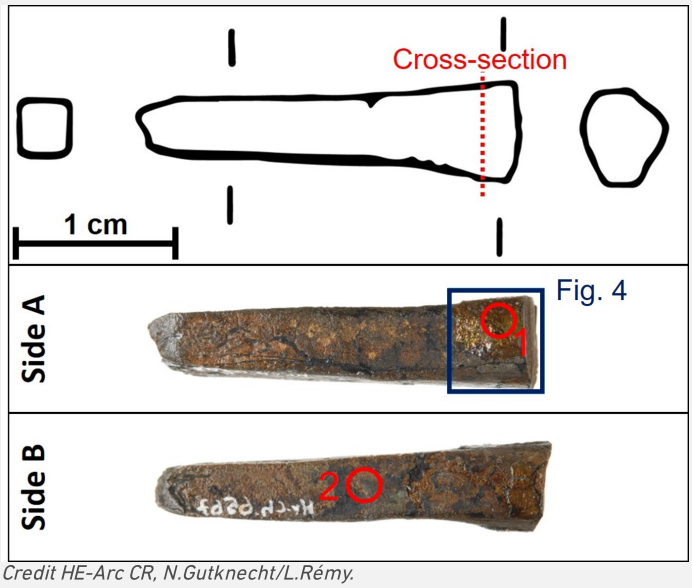
Fig. 3: Location of cross-section on drawing before sampling and both sides of fragment (after sampling) with location of the detail of Fig. 4 and XRF analysis areas (red circles),

Fig. 4: Corrosion structure (detail) from Fig. 3 showing some of the documented strata in Fig. 5,

XRF analyses of the tang fragment of a knife were carried out on two representative areas (Fig. 3). Point 1 was done on the dark yellow corrosion layer (CP2), while point 2 was performed on the remaining metal surface. For both points, soil, corrosion products and metal are analyzed at the same time.

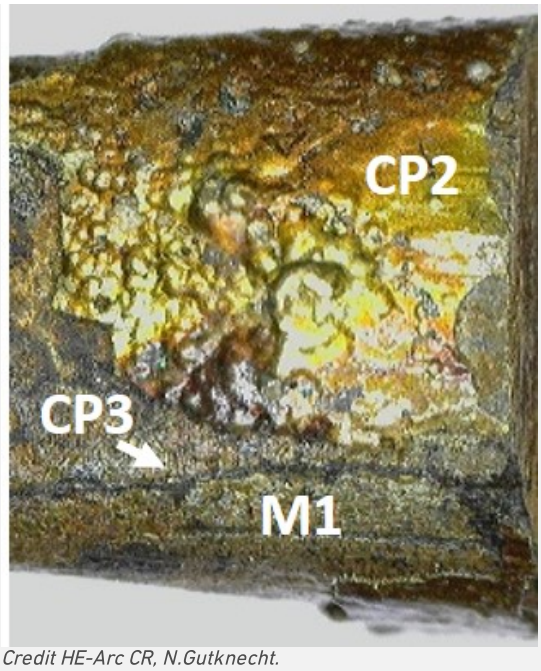
Couches	Type de strate	Principales caractéristiques
NMM1	Matériau non métallique	Film/revêtement, transparent, mince, continu
CP1	Produit corrosif	Brun, nacré, fin, discontinu, compact
CP2	Produit corrosif	Jaune foncé, épais, discontinu, compact, dur
CP3	Produit corrosif	Layer, dark grey, thin, scattered, non-compact, soft
M1	Metal	Olive, thick, metallic, soft

The NMM1 seems to be a polymer coating added after excavation of the object.

Fig. 5: Stratigraphic representation of the corrosion structure of the tang of knife by macroscopic and binocular observation with reference to Fig. 4,

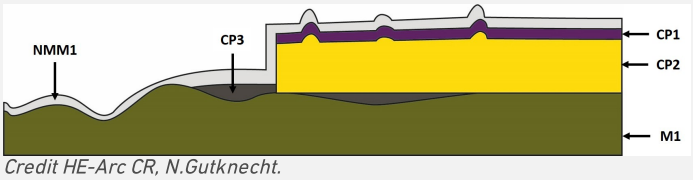
Fig. 6: Stratigraphic representation of the corrosion structure of the tang of a knife observed macroscopically under binocular microscope using the MiCorr application with reference to the whole Fig. 5. The characteristics of the strata, such as discontinuity, are accessible by clicking on the drawing that redirects you to the search tool by stratigraphy representation, Credit HE-Arc CR, N.Gutknecht.

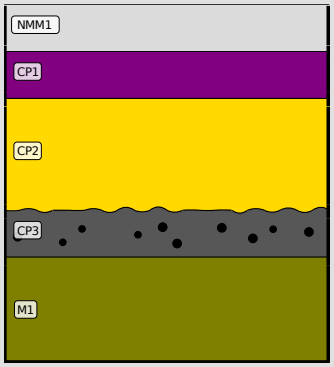
La représentation schématique ci-dessous donne un aperçu de la structure de corrosion rencontrée sur le fragment à partir d'une première observation macroscopique visuelle.

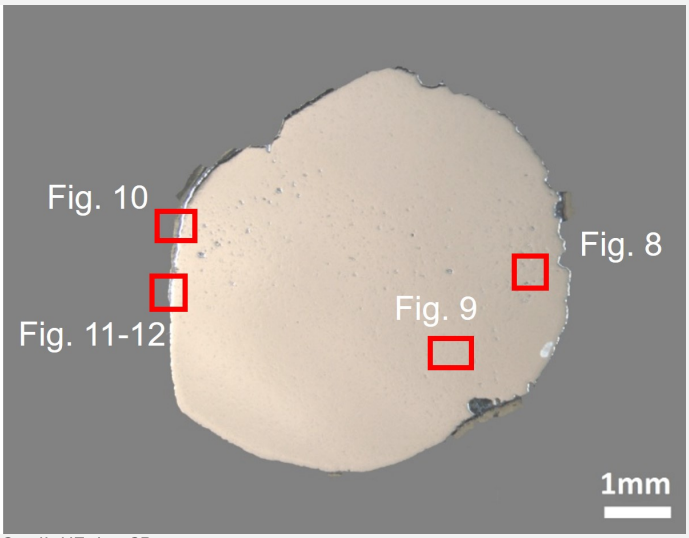
Fig. 7: Micrograph of the cross-section of the sample taken from the tang fragment of a knife showing the location of Figs. 8 to 12,

Description of sample	This cross-section shows a lateral cut through the tang (Fig. 3). Most of the corrosion structure is absent (Fig. 7).
Alloy	Leaded Bronze
Technology	Cold worked with partial annealing
Lab number of sample	MAH 87-196
Sample location	Musées d'art et d'histoire, Genève, Geneva
Responsible institution	Musées d'art et d'histoire, Genève, Geneva
Date and aim of sampling	1987, metallography and corrosion characterisation

The remaining metal is a leaded bronze (Table 2) containing numerous copper sulphide and tiny Pb inclusions (Figs. 8-10, 12 and Table 4). The porosity within the metal is high, particularly along a band through the middle of the sample (Figs. 7 and 8). The etched structure of the leaded bronze shows small, regular polygonal grains, some with twinning (Fig. 9). Slip lines appear in grains close to the metal surface (Fig. 9). The average hardness of the metal is HV1 120.

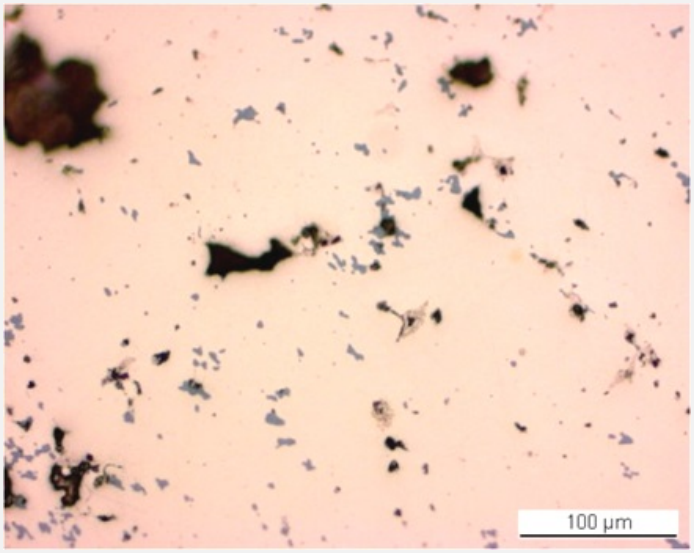
Fig. 8: Micrograph of the metal sample from Fig. 7 (detail), unetched, bright field. In pink the metal, in black the porosity and in dark-grey copper sulphide inclusions,

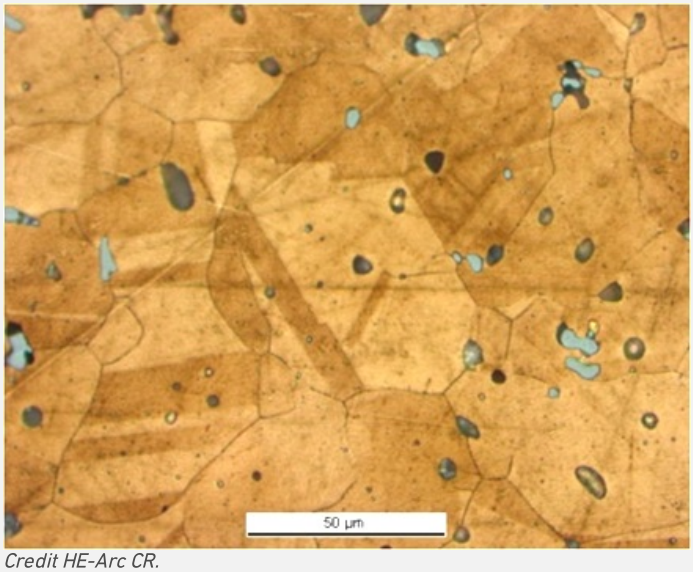
Fig. 9: Micrograph of the metal sample from Fig. 7 (detail), etched, bright field. Angular and twinned grains are revealed as well as copper sulphide inclusions in grey,

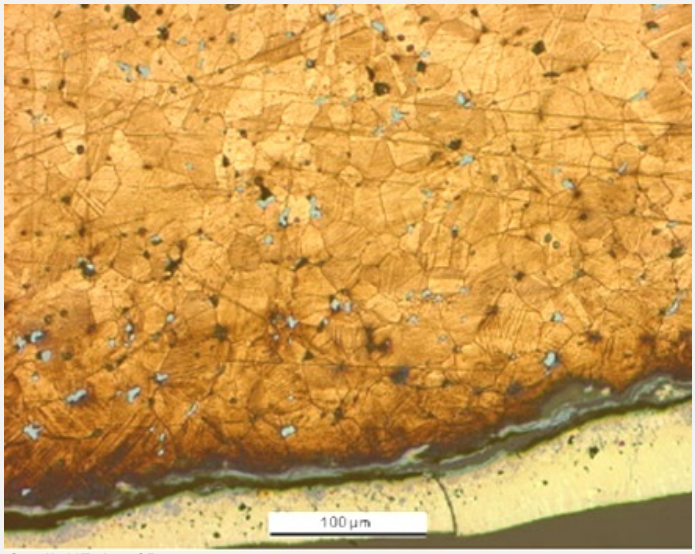
Fig. 10: Micrograph of the metal sample from Fig. 7, etched, bright field (rotated by 270°, detail). Angular grains with slip lines can be seen as well as copper sulphide inclusions in grey,

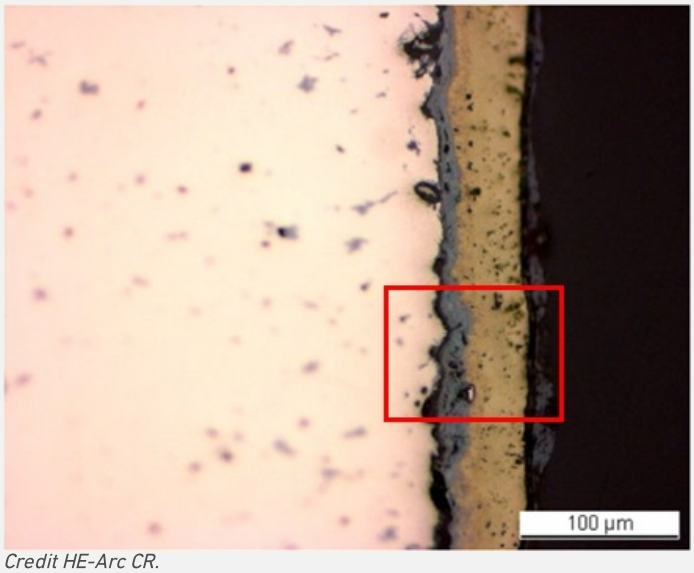
The metal has lost most of its original corrosion layer, the remainder having an average thickness between 60 and 190µm (Fig. 6). In some areas up to three corrosion strata are visible (Fig. 11). In polarised light (Fig. 12), the corrosion stratigraphy appears more clearly: it is composed of a dense black inner layer, an intermediate thick brown layer with bright spots (indicating porosity) and an outer red layer with white particles. The elemental chemical distribution of the SEM image reveals that the black inner layer (CP3) is Sn-rich, but contains Cu, O, Fe, Si, P, Pb, Ni, As, Ca and S (Table 5, Figs. 12-13). The brown layer (CP2) contains S, Fe and Cu and has a composition similar to chalcopyrite/$CuFeS_2$ (Table 5, Figs. 12-13). This was confirmed by past XRD analyses carried out by Schweizer (1994, museum report (1987)). The red layer (CP1) is an iron oxide (main elements Fe and O) and is contaminated with calcite/$CaCO_3$ particles (S1) (Table 5, Figs. 12-13).

Fig. 11: Micrograph of the metal sample from Fig. 7 (reversed picture, detail), unetched, bright field. From left to right: metal (in pink), inner light-grey layer, intermediate brown layer and top dark-grey layer. The area selected for elemental chemical distribution (Fig. 13) is marked by a red rectangle,

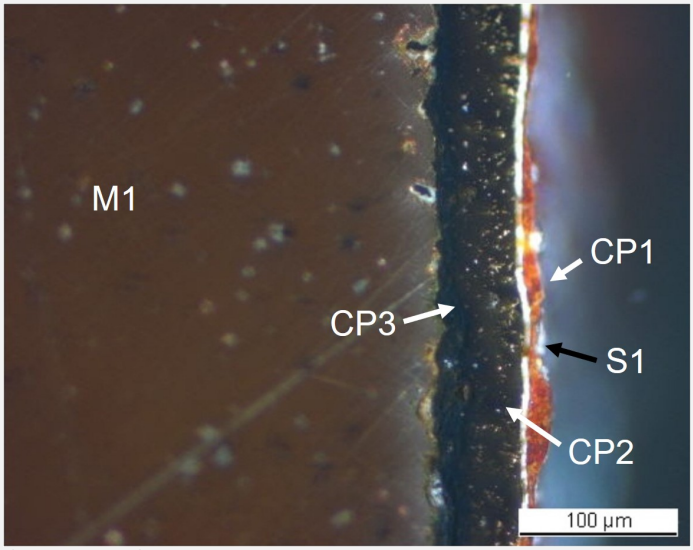
Fig. 12: Micrograph of the same area as Fig. 11 and corresponding to the stratigraphy of Fig. 14, polarized light. From left to right: metal (in brown) covered with a corrosion layer consisting of a black layer, an intermediate brown layer with bright spots, a crack (white line) and a red layer with white particles,

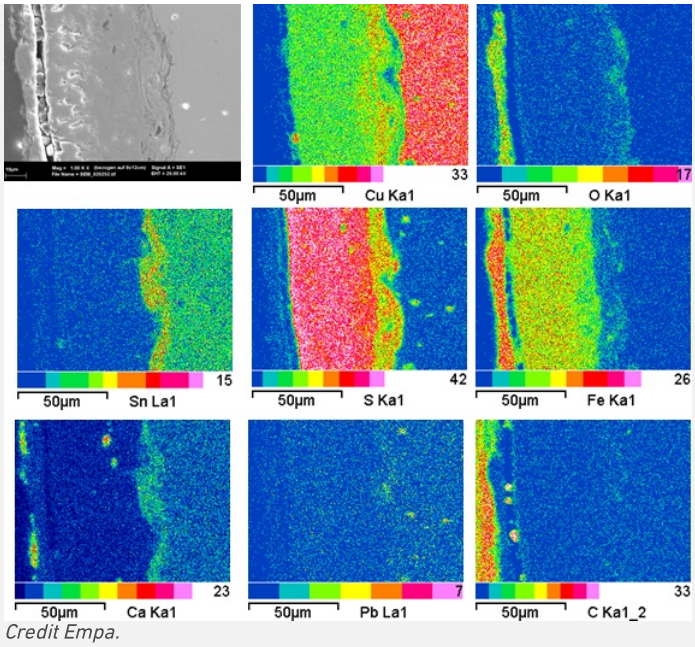
Fig. 13: SEM image, SE-mode, and elemental chemical distribution of the selected area of Fig. 11 (reversed picture). Method of examination: SEM/EDS, Laboratory of Analytical Chemistry, Empa,

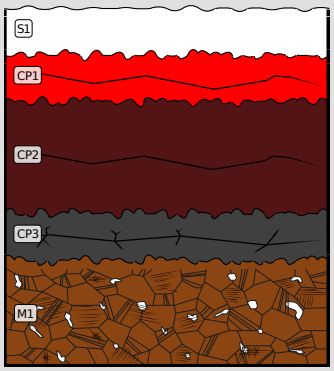
Fig. 14: Stratigraphic representation of the sample taken from the tang fragment of a knife in cross-section (dark field) using the MiCorr application. The characteristics of the strata are accessible by clicking on the drawing that redirects you to the search tool by stratigraphy representation. This representation can be compared to Fig. 12, Credit HE-Arc CR.

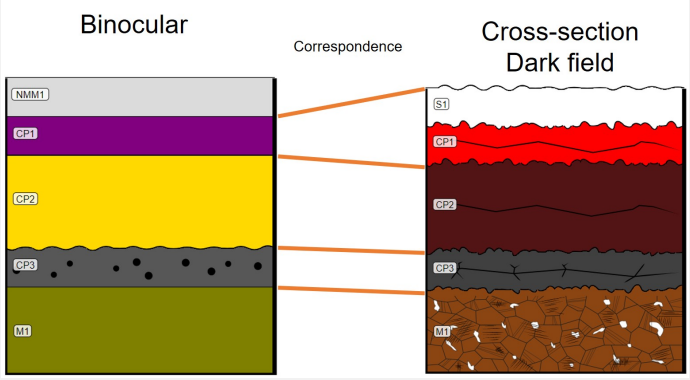
NMM1 in binocular mode is not observed in cross-section mode, as the cross-section does not show any coating.

CP1 in binocular mode is documented as sediment (S1) and CP1 in cross-section mode. But it is not clear if it matches the CP1 from cross-section, which is a Fe-rich layer, or if CP1 from binocular mode developed as an atmospheric corrosion after the excavation and is therefore not present on the embedded sample.

CP2 and CP3 in binocular mode match CP2 and CP3 in cross-section mode.

Fig. 15: Stratigraphic representation side by side of binocular view and cross-section (dark field),
