PIN HR-3071 – TIN BRONZE – LATE BRONZE AGE – SWITZERLAND

Artefact name	Pin HR-3071
Authors	Naima. Gutknecht (HE-Arc CR, Neuchâtel, Neuchâtel, Switzerland) & Rémy. Léopold (HE-Arc CR, Neuchâtel, Neuchâtel, Switzerland) & Domon Beuret. Emmanuelle (Laténium, Neuchâtel, Neuchâtel, Switzerland)
Url	/artefacts/1366/

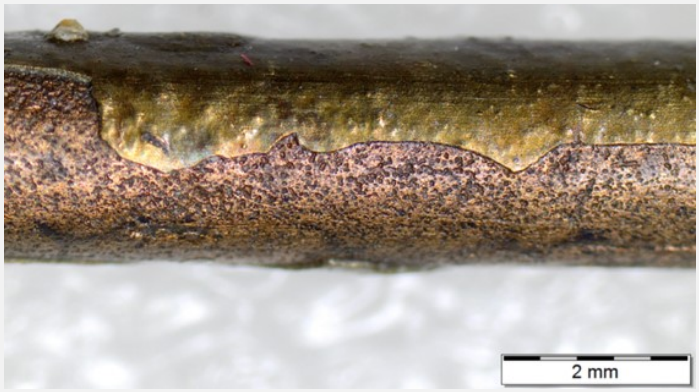
Fig. 2: Green corrosion products (detail) around the head of the pin,

Fig. 3: Dense and smooth olive green corrosion products (detail) on the middle of the pin with lacunas showing the underlying metal,

CP4 (dense, smooth olive green stratum) is enriched with Fe and S and depleted in Cu. It seems to correspond to chalcopyrite (CuFeS2).

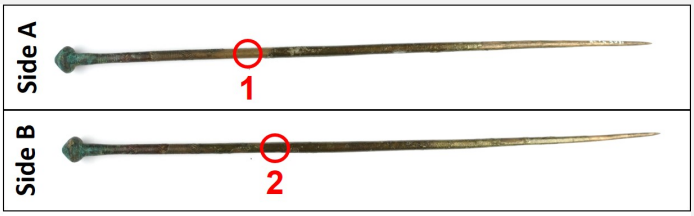
Fig. 4: Sides A and B (opposite sides) of the pin showing the XRF analysis areas (red circles),

XRF analysis was carried out on two representative areas of the surface (Fig. 4). Point 1 was performed on a lacuna of the olive green corrosion layer and point 2 on the olive green corrosion layer (CP4 of Fig. 5).

Results of point 2 are very different from those of point 1, they indicate the enrichment in Fe and in S and depletion in Cu.

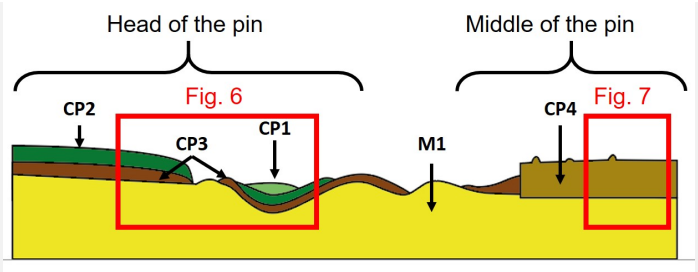
Fig. 5: Stratigraphic representation of the corrosion structure of the pin by macroscopic and binocular observation using the Micorr application with reference to Figs. 6 and 7,

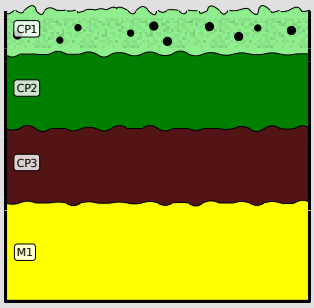
Fig. 6: Stratigraphic representation of the corrosion structure of the head of the pin (Fig. 2) observed macroscopically under binocular microscope using the MiCorr application with reference to Fig. 5. The characteristics of the strata, such as the discontinuity, are accessible by clicking on the drawing that redirects you to the search tool by stratigraphy representation, Credit HE-Arc CR, N.Gutknecht.

Fig. 7: Stratigraphic representation of the corrosion structure of the middle of the pin (Fig. 3) observed macroscopically under binocular microscope using the MiCorr application with reference to Fig. 5 where CP1 stands for CP4. The characteristics of the strata, such as the discontinuity, are accessible by clicking on the drawing that redirects you to the search tool by stratigraphy representation, Credit HE-Arc CR, N.Gutknecht.
