PIN HR-3389 - TIN BRONZE - LATE BRONZE AGE - SWITZERLAND

Artefact name Pin HR-3389

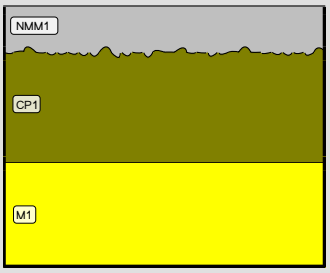
Fig. 7: Stratigraphic representation of the corrosion structure of the pin observed macroscopically under binocular microscope using the MiCorr application with reference to Fig. 6. The characteristics of the strata, such as the discontinuity, are accessible by clicking on the drawing that redirects you to the search tool by stratigraphy representation, Credit HE-Arc CR, N.Gutknecht.
