PIN HR-3389 – TIN BRONZE – LATE BRONZE AGE – SWITZERLAND

Artefact name Pin HR-3389

Authors Naima. Gutknecht (HE-Arc CR, Neuchâtel, Neuchâtel, Switzerland) & Rémy. Léopold (HE-Arc CR, Neuchâtel, Neuchâtel, Switzerland) & Domon Beuret. Emmanuelle (Laténium, Neuchâtel, Neuchâtel, Switzerland)

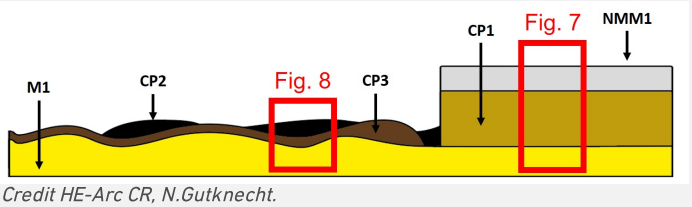
Strata	Type of stratum	Principal characteristics
NMM1	Non-metallic material	Transparent, thin, compact, only present in CP1
CP1	Corrosion product	Olive green, thick, discontinuous, compact, hard
CP2	Corrosion product	Black, veins shape, thin, discontinuous, compact, hard
CP3	Corrosion product	Dark brown, thin, continuous, compact, hard
M1	Metal	Dark yellow, thick, metallic, hard

Fig. 6: Stratigraphic representation of the corrosion structure of the pin by macroscopic and binocular observation with reference to Figs. 7 and 8,

Based on Schweizer analyses and results from table 2 CP1 of Fig. 6 should be chalcopyrite.
