PIN HR-3389 – TIN BRONZE – LATE BRONZE AGE – SWITZERLAND

Artefact name Pin HR-3389

Authors Naima. Gutknecht (HE-Arc CR, Neuchâtel, Neuchâtel, Switzerland) & Rémy. Léopold (HE-Arc CR, Neuchâtel, Neuchâtel, Switzerland) & Domon Beuret. Emmanuelle (Laténium, Neuchâtel, Neuchâtel, Switzerland)

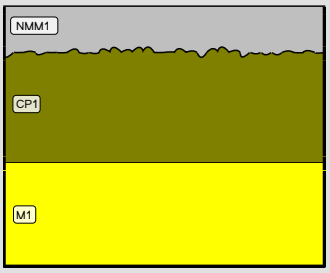
Fig. 7: Stratigraphic representation of the corrosion structure of the pin observed macroscopically under binocular microscope using the MiCorr application with reference to Fig. 6. The characteristics of the strata, such as the discontinuity, are accessible by clicking on the drawing that redirects you to the search tool by stratigraphy representation, Credit HE-Arc CR, N.Gutknecht.
