# COIN CDN 2012-1-55 - CU ALLOY - LATE ROMAN TIMES - SWITZERLAND

| **Artefact name** | Coin CdN 2012-1-55 |
| **Authors** | Naima. Gutknecht (HE-Arc CR, Neuchâtel, Neuchâtel, Switzerland) & Valentina. Valbi (Laboratoire Métallurgie et Culture (LMC), Belfort, Franche-Comté, France) & Rey-Bellet. Bernadette (Musée d'art et d'histoire, Genève, Genève, Geneva, Switzerland) |

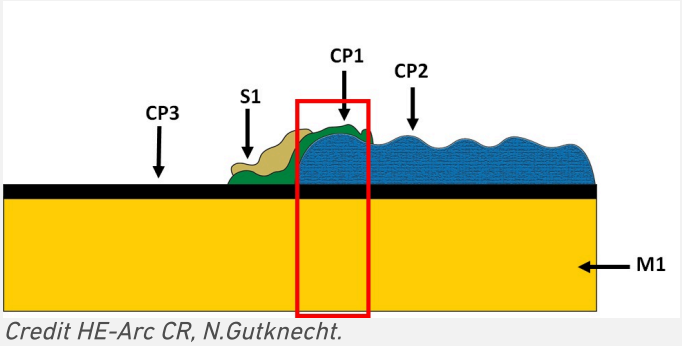
Fig. 4: Stratigraphic representation of the corrosion structure of the coin by macroscopic and binocular observation with indication of the corrosion structure used to build the MiCorr stratigraphy of Fig. 5 (red square),

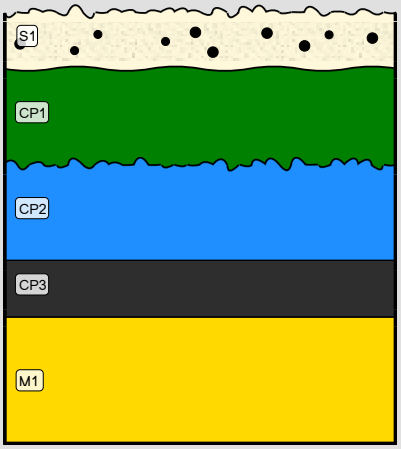
Fig. 5: Stratigraphic representation of the corrosion structure of the coin observed macroscopically under binocular microscope using the MiCorr application. The characteristics of the strata are only accessible by clicking on the drawing that redirects you to the search tool by stratigraphy representation, Credit MAHG, B.Rey-Bellet/HE-Arc CR, N.Gutknecht.

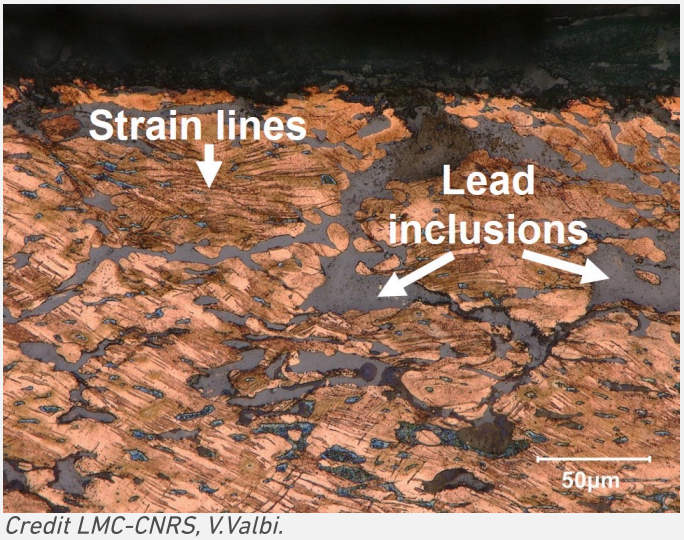
The sample presents on its whole thickness big Pb inclusions (50-100 µm, Figs. 7 and 8) homogeneously distributed. The metal has a polygonal grain structure (Figs. 8-9) with locally elongated grains and slip lines revealing that the object underwent cold working. Several longitudinal cracks are observed and are filled with corrosion products (Fig. 9).

Fig. 7: Micrograph of the cross-section of the sample taken from the coin (Fig. 2) in bright field after chemical etching,

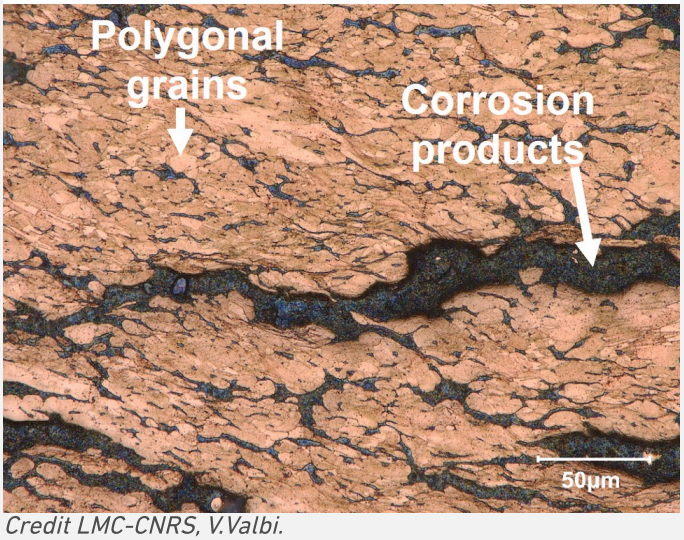
Fig. 9: Micrograph of the metal sample from Fig. 6 (detail), etched, bright field. with polygonal microstructure and presence of longitudinal crack filled with corrosion products,

The coin is composed of a Cu-Pb-Sn ternary bronze alloy with high Pb percentages (29 wt%). Pb is not soluble in the metallic structure and large lead inclusions are observed throughout the whole metal thickness. The metallic microstructure reveals that the object underwent cold working. The whole object is fragilised by the presence of longitudinal cracks filled with corrosion products.

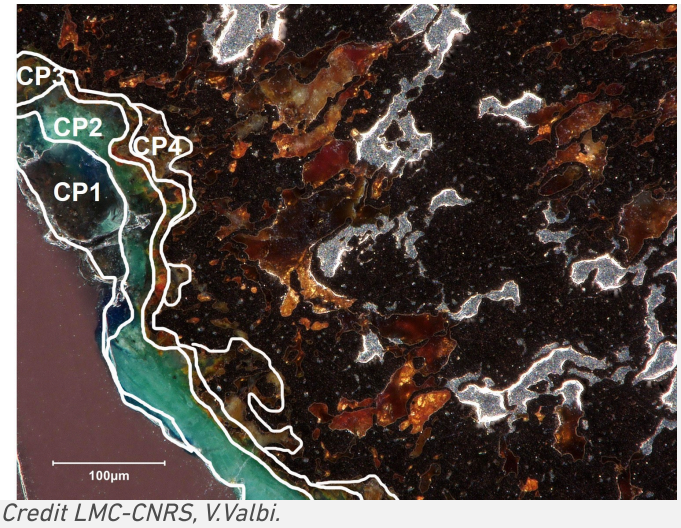
The observation of the sample in cross-section in dark field mode shows the presence of an external blue CP1 layer with sand inclusions, on top of a turquoise CP2 layer, then a red thin internal CP3 layer and an orange CP4 also present in the inclusions inside the corroded metal (Fig. 10).

Fig. 10: Micrograph of the corrosion structure from Fig. 6 (detail) with the subdivision of the different strata, unetched, dark field,

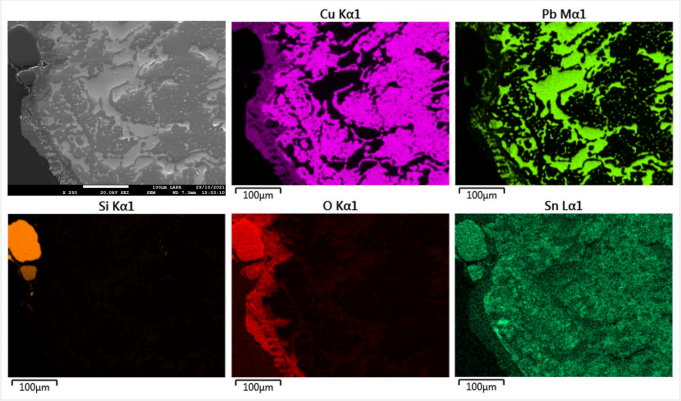
The EDX elemental analysis (Table 4, Fig.11) of the visually identified CPs by cross-sectional observation shows that the external CP1 and CP2 are Cu-based products with only few amounts of lead (3 wt %), while the orange CP4 is a lead-based compound.

Fig. 11: SEM image, BSE-mode, and elemental chemical distribution of Fig. 10,

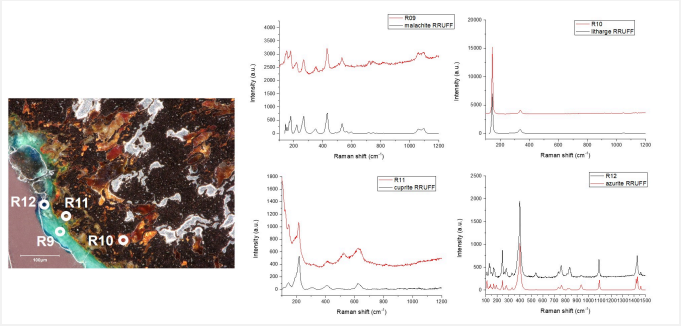
µ-Raman analyses were performed on the identified strata when possible (Fig. 12). The R12 point of analysis was performed on the blue CP1 layer and the corresponding spectrum presented the typical main peaks of azurite ($Cu_3(CO_3)_2(OH)_2$), The R9 point of analysis in the green CP2 layer shows the typical peaks of malachite ($Cu_2(CO_3)(OH)_2$). The R11 point of analysis was performed on the red thin CP3 layer and shows the main peaks of cuprite ($Cu_2O$), while the R10 point of analysis was performed on the internal orange corrosion products and showed the typical peaks of litharge (PbO).

Fig. 12: Raman points of analysis and corresponding spectra overlapped with reference spectra for malachite RRUFFID=R050508, litharge RRUFFID=R060959, cuprite RRUFFID=R140763, azurite RRUFFID=R050497,

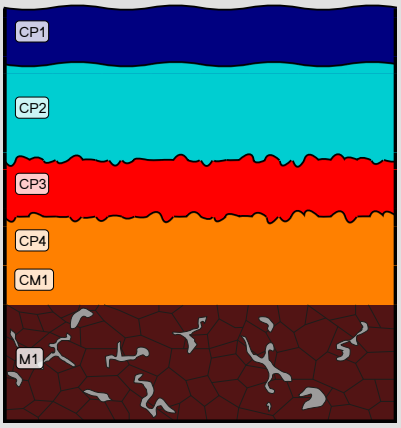
Fig. 13: Stratigraphic representation of the sample of the coin CDN 2012-1-55 observed in cross-section under dark field using the MiCorr application. The characteristics of the strata are only accessible by clicking on the drawing that redirects you to the search tool by stratigraphy representation. This representation was build according to Fig. 10, Credit LMC-CNRS, V.Valbi

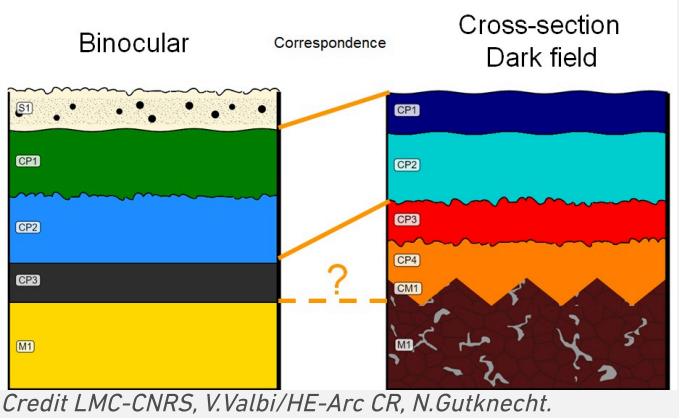
The stratigraphies obtained by binocular and cross-section observation show a few differences that can be attributed to the different scales of observation. Under binocular microscope, it is possible to differentiate strata according to texture and light colour changes that do not always correspond to changes in chemical composition, thus leading to a regrouping of several strata into one according to the cross-section observation and physicochemical characterization.

Strata S1 observed in binocular mode is lacking in cross-section observation, probably due to a different observation location. The CP1 and CP2 layers observed under binocular microscope probably correspond to the CP1 and CP2 observed in cross-section, but with the green and the blue layer inversed. The blue CP2 layer observed in binocular mode could correspond to the blue CP1 observed in cross-section and the green CP1 in binocular to the green CP2 in CS. This could be explained as well by the different locations of the observations carried out. Finally, the red cuprite CP3 and the orange litharge CP4 observed in cross-section as well as the corroded metal strata CM1 observed in cross-section were not clearly identified by binocular observation. Still, they could be linked to the black CP3 layers that can not be linked with certainty to any stratum in cross-section, but probably a regrouping of CP3, CP4 and CM1. The binocular view rarely allows documenting CM stratum, as the transition between layers is difficult to assess.

Fig. 14: Stratigraphic representation side by side of binocular view and cross-section (dark field),
