SWORD M-SCH-B2735 - P-RICH IRON - IRON AGE - SWITZERLAND

Artefact name	Sword M-Sch-B2735
Authors	Marianne. Senn (Empa, Dübendorf, Zurich, Switzerland) & Christian. Degrigny (HE-Arc CR, Neuchâtel, Neuchâtel, Switzerland)
Url	/artefacts/1441/

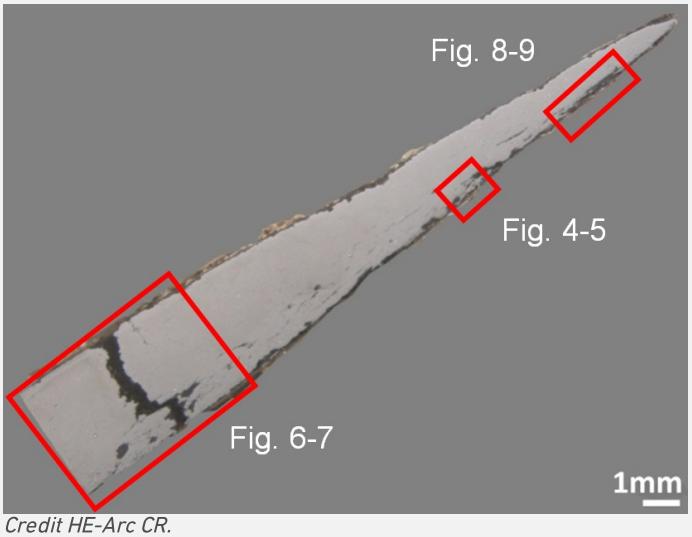
Fig. 3: Micrograph of the cross-section of the sample taken from the sword showing the location of Figs. 4 to 9,

Description of sample	The sample includes half of the sword blade (Figs. 2 and 3). The corrosion layer is thin (Fig. 3).
Alloy	P-rich iron
Technology	Forged, annealed and cold worked
Lab number of sample	M-SCH-B2735
Sample location	HE-Arc CR, Neuchâtel, Neuchâtel
Responsible institution	Schweizerisches Landesmuseum, Zürich, Zurich
Date and aim of sampling	1969, metallography

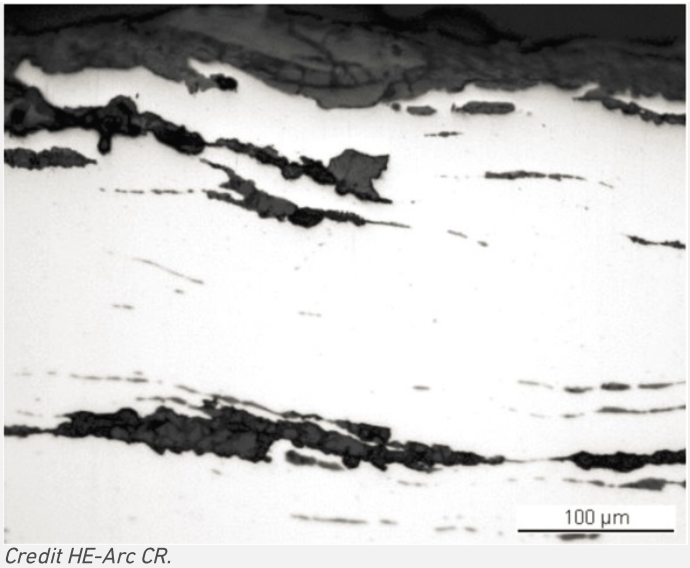
The remaining metal is a P-rich (0.2 mass%) iron (Table 1) with long parallel slag inclusions (Fig. 4) concentrated on one side of the blade. The slag inclusions are composed of wüstite/FeO dendrites and fayalite/Fe_2SiO_4 in a glassy matrix (Fig. 5 and Table 2). Their chemical composition is typical for iron produced by the bloomery process (dominated by iron oxides and silica). It is difficult to identify the ore type from the slag composition. Interestingly in one case the slag composition is very specific (alumina and P-rich material). After etching, the metal shows a ferritic structure (Fig. 6). The grain size is variable (between ASTM grain sizes of 4 to 7) and some grains include Neuman bands (Fig. 7). A large crack has developed through the metal section (Figs. 3 and 6). The average hardness of the metal (HV1 185) is quite high for a wrought iron. The level of hardness and Neuman bands are typical for a P-rich iron. Neuman bands are said to develop by cold working and shock deformation. According to Swiss and McDonnell 2003 they form when little cold work is carried out. Distortion (grain deformation) after cold working starts to be apparent in iron after a reduction in thickness of between 30-40%. Since no grain deformation is visible, the present reduction is probably a little less than this range.

Fig. 4: Micrograph of the metal sample from Fig. 3 (detail, rotated by 225°), unetched, bright field. In white the metal containing elongated slag inclusions (in grey); in black porosity,

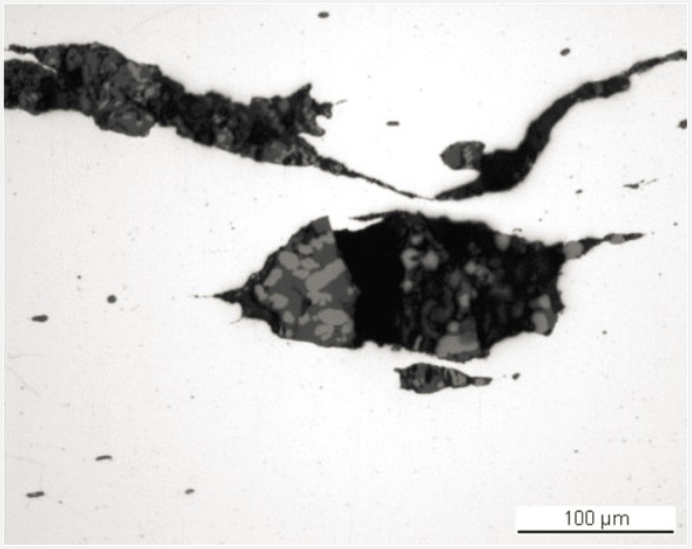
Fig. 5: Micrograph of the metal sample from Fig. 3 (detail), unetched, bright field. Detail with slag inclusions showing a structure with wüstite dendrite (light-grey) and fayalite (dark-grey),

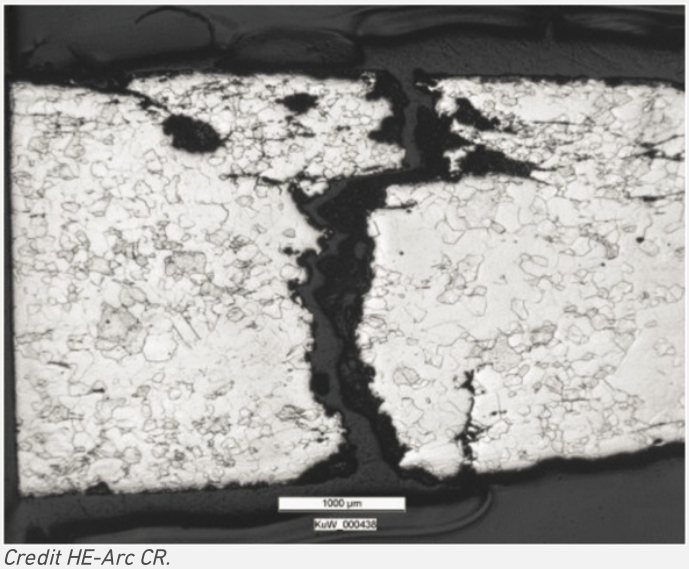
Fig. 6: Micrograph of the metal sample from Fig. 3 (reversed picture, rotated by 225°, detail), etched, bright field. Metal with a large pre-existing crack and ferritic, recrystallized structure. Grains have different sizes,

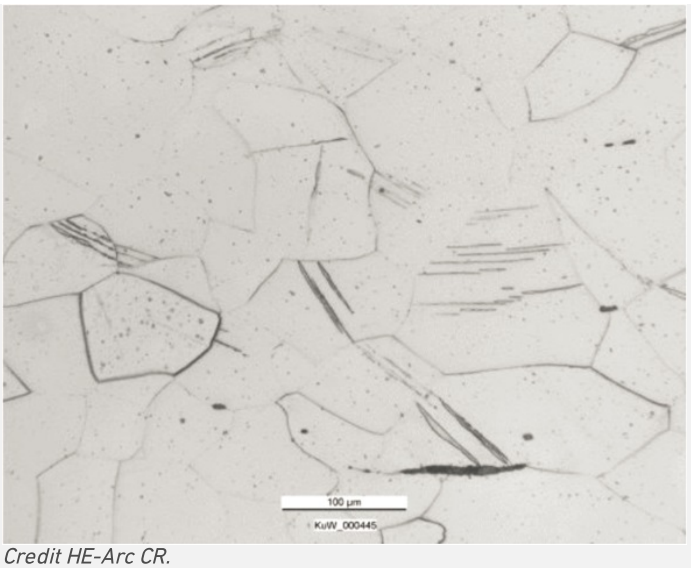
Fig. 7: Micrograph of the metal sample (detail of Fig. 6), etched, bright field. Ferrite grains including Neuman bands formed after cold working in a P-rich iron,

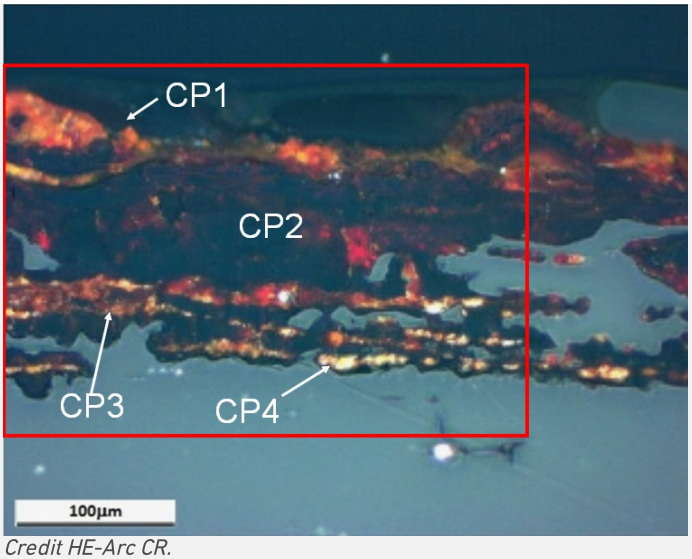
The remaining metal, including the large crack, is covered by a thin, fissured corrosion crust (Figs. 3, 4, 6 and 8). The corrosion crust is thicker on the side containing the long slag inclusions (Fig. 3). In bright field and in the BSE-mode of the SEM image only light and dark-grey areas can be distinguished (Figs. 4 and 9). Under polarised light the corrosion products appear yellow-orange near the metal surface and then become successively dark-red and black. The outer layer (CP1) is orange-yellow, as is the inner one (CP4, Fig. 8). There is a correlation between the level of grey in SEM/BSE-mode, the colours under polarised light, and the chemical composition of the corrosion layer (Table 3, Figs. 8 and 9). The lighter the grey of the SEM/BSE-mode, or the colours (light-brown and red) under polarised light, the richer the area is in Fe and the more depleted it is in O. Surprisingly the inner corrosion layers (CP3 and CP4) are contaminated with Si, Al and O.

Fig. 8: Micrograph showing the metal - corrosion crust interface from Fig. 3 (inverted picture, rotated by 135°, detail) and corresponding to the stratigraphy of Fig. 10, unetched, polarised light. The metal appears in blue and the corrosion changes from yellow-orange (CP4) to dark-red (CP3), black (CP2) and orange (CP1). The area selected for elemental chemical distribution (Fig. 9) is marked by a red rectangle,

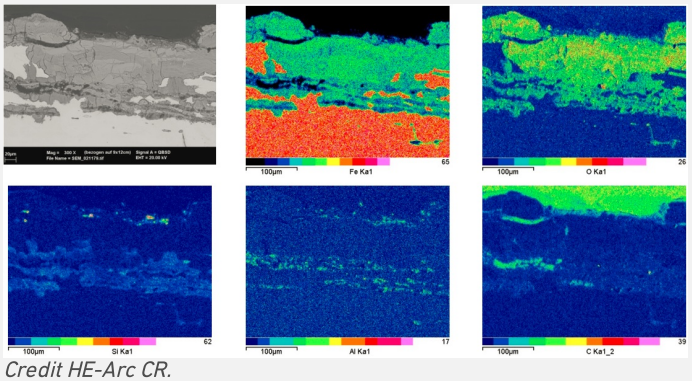
Fig. 9: SEM image, BSE-mode, and elemental chemical distribution of the selected area from Fig. 8. Method of examination: SEM/EDS, Laboratory of Analytical Chemistry, Empa.,

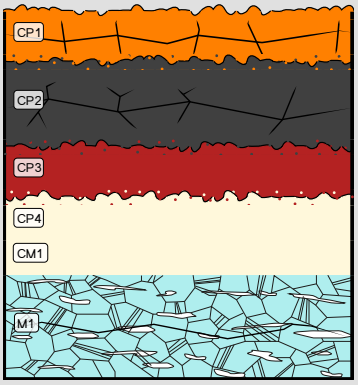
Fig. 10: Stratigraphic representation of the sample taken from the sword in cross-section (dark field) using the MiCorr application. The characteristics of the strata are only accessible by clicking on the drawing that redirects you to the search tool by stratigraphy representation. This representation can be compared to Fig. 8, Credit HE-Arc CR.
