SWORD M-SCH-B2735 - P-RICH IRON - IRON AGE - SWITZERLAND

Artefact name	Sword M-Sch-B2735
Authors	Marianne. Senn (Empa, Dübendorf, Zurich, Switzerland) & Christian. Degrigny (HE-Arc CR, Neuchâtel, Neuchâtel, Switzerland)
Url	/artefacts/1441/

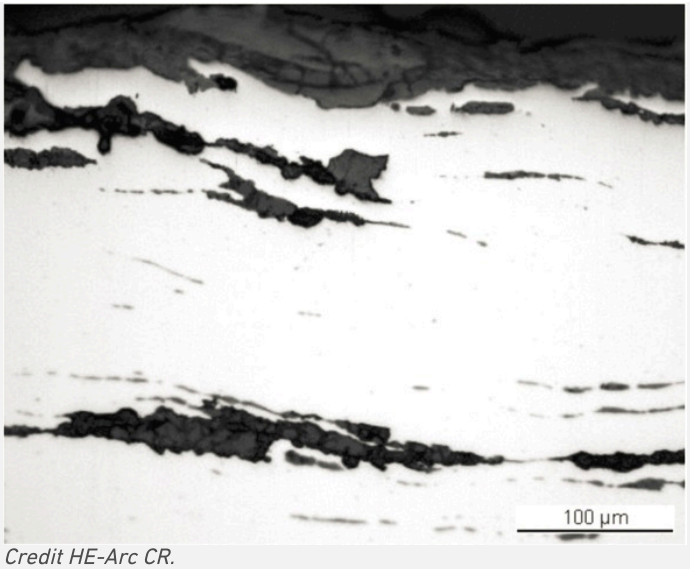
The remaining metal is a P-rich (0.2 mass%) iron (Table 1) with long parallel slag inclusions (Fig. 4) concentrated on one side of the blade. The slag inclusions are composed of wüstite/FeO dendrites and fayalite/Fe_2SiO_4 in a glassy matrix (Fig. 5 and Table 2). Their chemical composition is typical for iron produced by the bloomery process (dominated by iron oxides and silica). It is difficult to identify the ore type from the slag composition. Interestingly in one case the slag composition is very specific (alumina and P-rich material). After etching, the metal shows a ferritic structure (Fig. 6). The grain size is variable (between ASTM grain sizes of 4 to 7) and some grains include Neuman bands (Fig. 7). A large crack has developed through the metal section (Figs. 3 and 6). The average hardness of the metal (HV1 185) is quite high for a wrought iron. The level of hardness and Neuman bands are typical for a P-rich iron. Neuman bands are said to develop by cold working and shock deformation. According to Swiss and McDonnell 2003 they form when little cold work is carried out. Distortion (grain deformation) after cold working starts to be apparent in iron after a reduction in thickness of between 30-40%. Since no grain deformation is visible, the present reduction is probably a little less than this range.

Fig. 4: Micrograph of the metal sample from Fig. 3 (detail, rotated by 225°), unetched, bright field. In white the metal containing elongated slag inclusions (in grey); in black porosity,

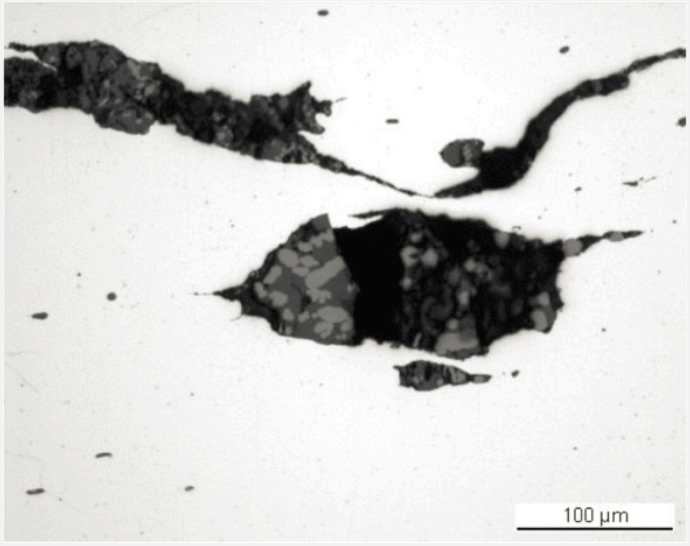
Fig. 5: Micrograph of the metal sample from Fig. 3 (detail), unetched, bright field. Detail with slag inclusions showing a structure with wüstite dendrite (light-grey) and fayalite (dark-grey),

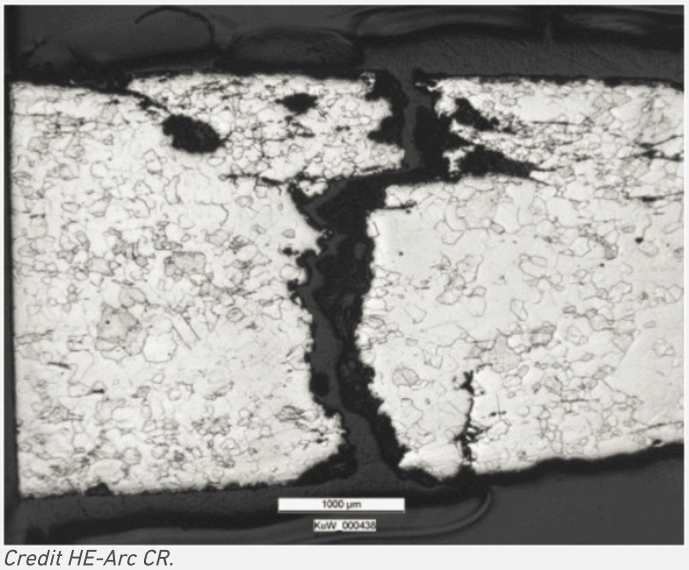
Fig. 6: Micrograph of the metal sample from Fig. 3 (reversed picture, rotated by 225°, detail), etched, bright field. Metal with a large pre-existing crack and ferritic, recrystallized structure. Grains have different sizes,

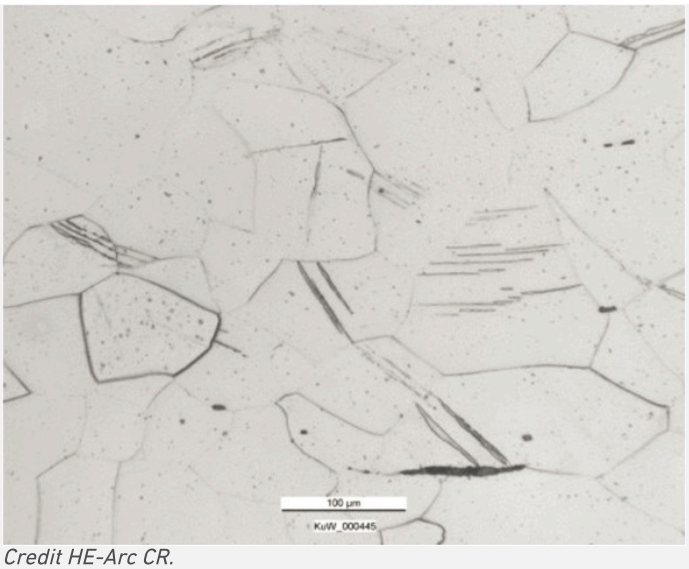
Fig. 7: Micrograph of the metal sample (detail of Fig. 6), etched, bright field. Ferrite grains including Neuman bands formed after cold working in a P-rich iron,

Microstructure	Recrystallized grains, Newman bands, ghost structure
First metal element	Fe
Other metal elements	P

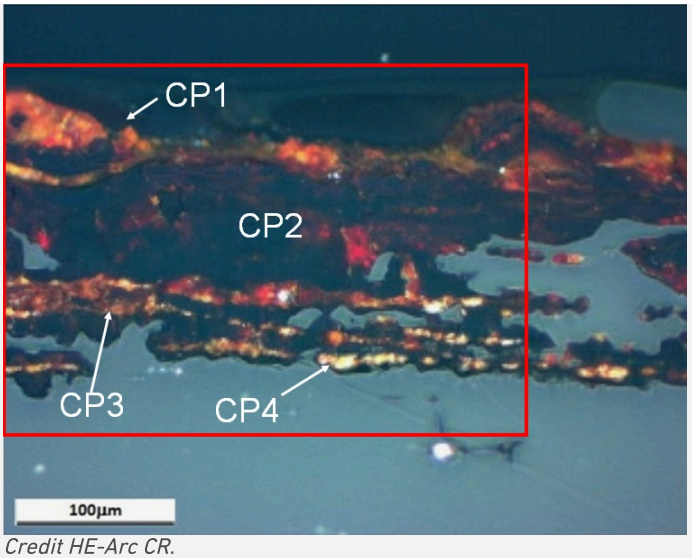
The remaining metal, including the large crack, is covered by a thin, fissured corrosion crust (Figs. 3, 4, 6 and 8). The corrosion crust is thicker on the side containing the long slag inclusions (Fig. 3). In bright field and in the BSE-mode of the SEM image only light and dark-grey areas can be distinguished (Figs. 4 and 9). Under polarised light the corrosion products appear yellow-orange near the metal surface and then become successively dark-red and black. The outer layer (CP1) is orange-yellow, as is the inner one (CP4, Fig. 8). There is a correlation between the level of grey in SEM/BSE-mode, the colours under polarised light, and the chemical composition of the corrosion layer (Table 3, Figs. 8 and 9). The lighter the grey of the SEM/BSE-mode, or the colours (light-brown and red) under polarised light, the richer the area is in Fe and the more depleted it is in O. Surprisingly the inner corrosion layers (CP3 and CP4) are contaminated with Si, Al and O.

Fig. 8: Micrograph showing the metal - corrosion crust interface from Fig. 3 (inverted picture, rotated by 135°, detail) and corresponding to the stratigraphy of Fig. 10, unetched, polarised light. The metal appears in blue and the corrosion changes from yellow-orange (CP4) to dark-red (CP3), black (CP2) and orange (CP1). The area selected for elemental chemical distribution (Fig. 9) is marked by a red rectangle,

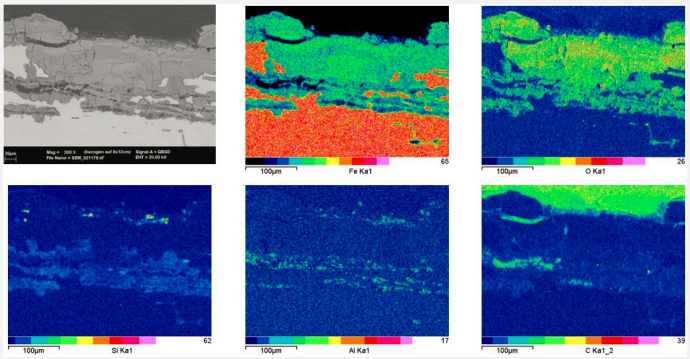
Elements	O	Si	Fe	Total
Light or dark-red corrosion products (CP3)	25	2	67	94
Light or dark-red corrosion products (CP3)	32	<	74	108
Dark or dark-red corrosion products (CP2)	41	<	67	109

Fig. 9: SEM image, BSE-mode, and elemental chemical distribution of the selected area from Fig. 8. Method of examination: SEM/EDS, Laboratory of Analytical Chemistry, Empa.,

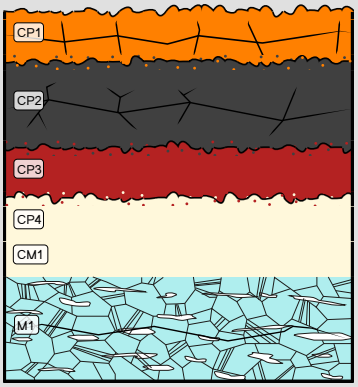
Fig. 10: Stratigraphic representation of the sample taken from the sword in cross-section (dark field) using the MiCorr application. The characteristics of the strata are only accessible by clicking on the drawing that redirects you to the search tool by stratigraphy representation. This representation can be compared to Fig. 8, Credit HE-Arc CR.
