SWORD M-SCH-B2735 - P-RICH IRON - IRON AGE - SWITZERLAND

Artefact name	Sword M-Sch-B2735
Authors	Marianne. Senn (Empa, Dübendorf, Zurich, Switzerland) & Christian. Degrigny (HE-Arc CR, Neuchâtel, Neuchâtel, Switzerland)
Url	/artefacts/1441/

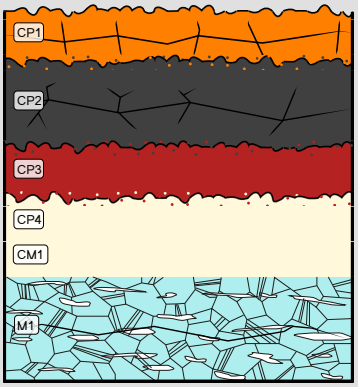
Fig. 10: Stratigraphic representation of the sample taken from the sword in cross-section (dark field) using the MiCorr application. The characteristics of the strata are only accessible by clicking on the drawing that redirects you to the search tool by stratigraphy representation. This representation can be compared to Fig. 8, Credit HE-Arc CR.
