BELT BUCKLE – MEDIEVAL TIMES – FRANCE

Artefact name Belt buckle

Authors TOUZEAU. Julie (Laboratoire MATERIA VIVA, Toulouse, Midi-Pyrénées, France)

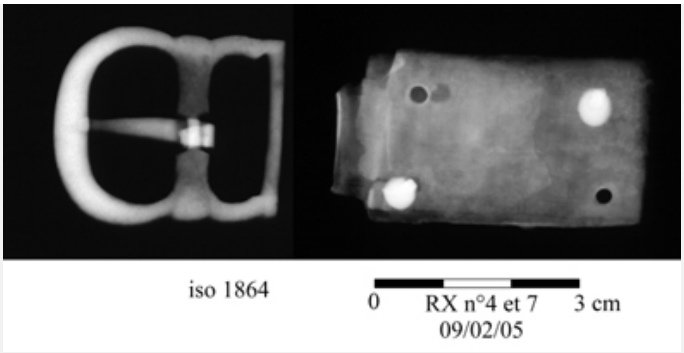
Fig. 1: Belt buckle before restoration with brown and green corrosion products, from Saint-Jean cemetery, Toulouse, Midi-Pyrénées, France,

Fig. 2: Part of the belt buckle after restoration, from Saint-Jean cemetery, Toulouse, Midi-Pyrénées, France,

Description of the artefact	Complete belt buckle covered with green and brown/reddish corrosion products.
Type of artefact	clothing element
Origin	Saint-Jean cemetery, Toulouse, Midi-Pyrénées, France
Recovering date	Excavation 2003
Chronology category	Medieval times
chronology tpq	1100 A.D.
chronology taq	1300 A.D.
Chronology comment	
Burial conditions / environment	Soil
Artefact location	Musée Saint-Raymond, Toulouse
Owner	Musée Saint-Raymond, Toulouse
Inv. number	ISO 1864, SEP 1243
Recorded conservation data	Mechanical removal of the corrosion products and protection with resin paraloid B72 in acetone.

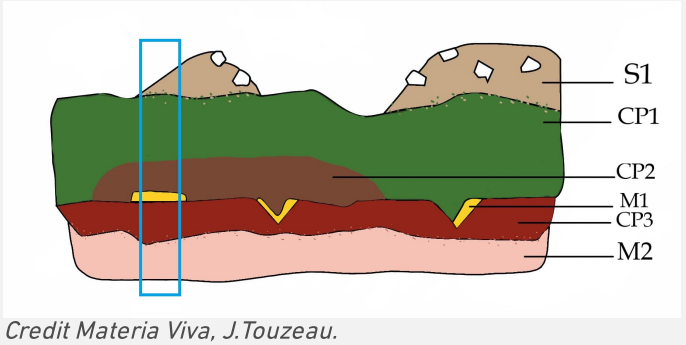
Strata	Type of stratum	Principal characteristics
S1	Sediment	light brown sediment with inclusions of silica grains
CP1	Corrosion product	powdery, porous medium green corrosion product
CP2	Corrosion product	discontinuous, cohesive, brown corrosion product
M1	Metal	discontinuous fine layer of gold
CP3	Corrosion product	continuous layer of compact red corrosion product
M2	Metal	compact metal

Table 1: Description of the principal characteristics of the strata as observed under binocular and described according to Bertholon's method. Gilded incisions are between CP2 and CP3.

Fig. 5: Stratigraphic representation of the corrosion structure of the belt buckle by macroscopic and binocular observation with indication of the corrosion structure used to buils the MiCorr stratigraphy of Fig. 6 (blue rectangle),

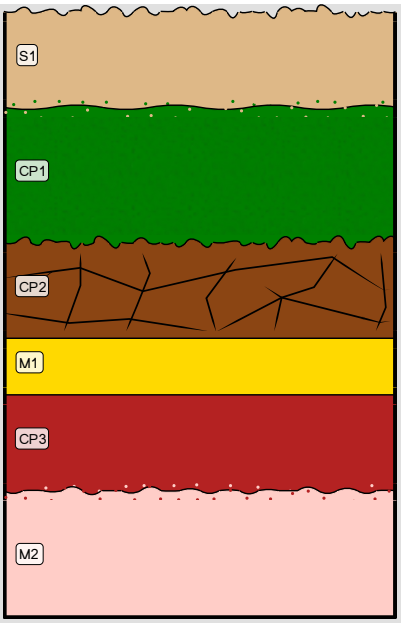
Fig. 6: Stratigraphic representation of the corrosion structure of the belt buckle observed macroscopically under binocular microscope using the MiCorr application with reference to Fig. 5. The characteristics of the strata are only accessible by clicking on the drawing that redirects you to the search tool by stratigraphy representation, credit Materia Viva J.Touzeau.

Usually, belt buckles were made of a copper-based alloy whose surface was entirely covered with gold, but wear due to burial and the development of corrosion led to partial preservation of the gold, only in the incised areas and under the rivet (as it was protected from abrasion). Binocular observation therefore shows these areas where the gold has been preserved and demonstrates that the original surface must have been between CP2 and M1 or between CP3 and CP2 when the gold disappeared.
