BELT BUCKLE - MEDIEVAL TIMES - FRANCE

Artefact name Belt buckle

Authors TOUZEAU. Julie (Laboratoire MATERIA VIVA, Toulouse, Midi-Pyrénées, France)

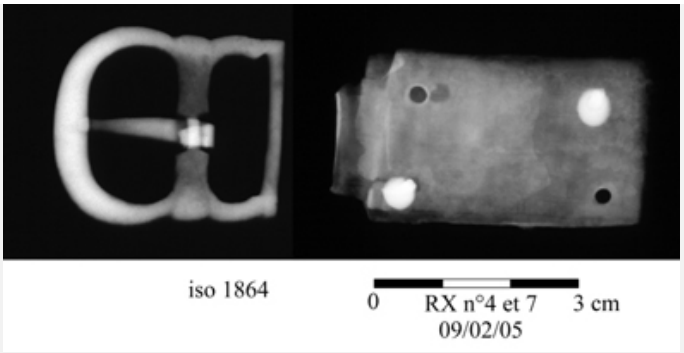
Fig. 1: Belt buckle before restoration with brown and green corrosion products, from Saint-Jean cemetery, Toulouse, Midi-Pyrénées, France,

Fig. 2: Part of the belt buckle after restoration, from Saint-Jean cemetery, Toulouse, Midi-Pyrénées, France,

Description of the artefact	Complete belt buckle covered with green and brown/reddish corrosion products.
Type of artefact	clothing element
Origin	Saint-Jean cemetery, Toulouse, Midi-Pyrénées, France
Recovering date	Excavation 2003
Chronology category	Medieval times
chronology tpq	1100 A.D.
chronology taq	1300 A.D.
Chronology comment	
Burial conditions / environment	Soil
Artefact location	Musée Saint-Raymond, Toulouse
Owner	Musée Saint-Raymond, Toulouse
Inv. number	ISO 1864, SEP 1243
Recorded conservation data	Mechanical removal of the corrosion products and protection with resin paraloid B72 in acetone.

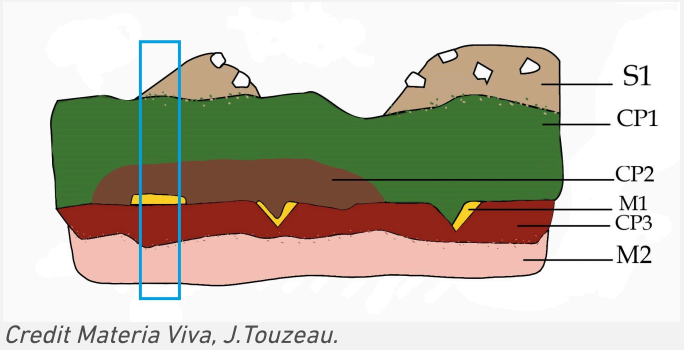
Strata	Type of stratum	Principal characteristics
S1	Sediment	light brown sediment with inclusions of silica grains
CP1	Corrosion product	powdery, porous medium green corrosion product
CP2	Corrosion product	discontinuous, cohesive, brown corrosion product
M1	Metal	discontinuous fine layer of gold
CP3	Corrosion product	continuous layer of compact red corrosion product
M2	Metal	compact metal

Table 1: Description of the principal characteristics of the strata as observed under binocular and described according to Bertholon's method. Gilded incisions are between CP2 and CP3.

Fig. 5: Stratigraphic representation of the corrosion structure of the belt buckle by macroscopic and binocular observation with indication of the corrosion structure used to buils the MiCorr stratigraphy of Fig. 6 (blue rectangle),

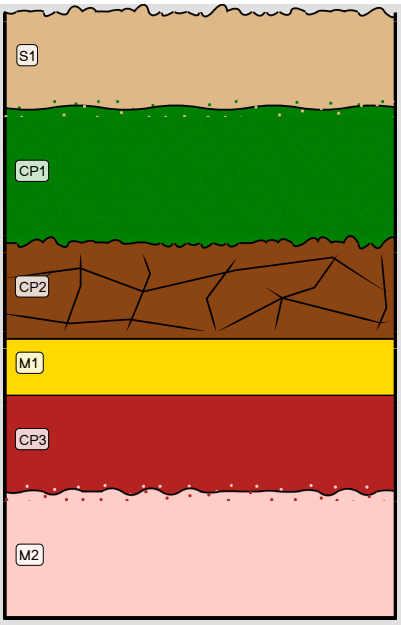
Fig. 6: Stratigraphic representation of the corrosion structure of the belt buckle observed macroscopically under binocular microscope using the MiCorr application with reference to Fig. 5. The characteristics of the strata are only accessible by clicking on the drawing that redirects you to the search tool by stratigraphy representation, credit Materia Viva J.Touzeau.

Usually, belt buckles were made of a copper-based alloy whose surface was entirely covered with gold, but wear due to burial and the development of corrosion led to partial preservation of the gold, only in the incised areas and under the rivet (as it was protected from abrasion). Binocular observation therefore shows these areas where the gold has been preserved and demonstrates that the original surface must have been between CP2 and M1 or between CP3 and CP2 when the gold disappeared.
