UNDETERMINED - FE ALLOY - EARLY MEDIEVAL TIMES

Artefact name Undetermined

Authors Moreau. Caroline (Laboratoire MATERIA VIVA, Toulouse, Midi-Pyrénées, France) & TOUZEAU. Julie (Laboratoire MATERIA VIVA, Toulouse, Midi-Pyrénées, France)

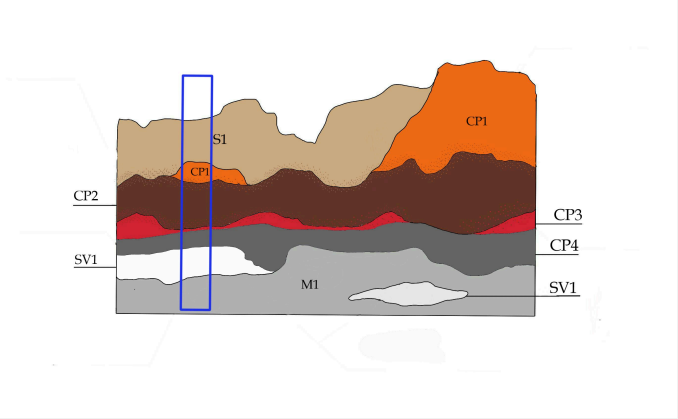
S1	Sediment	powdery and non adherent
CP1	Corrosion product	bright orange corrosion product or soil orange-coloured by corrosion products
CP2	Corrosion product	brown layer of corrosion products with silica grains
CP3	Corrosion product	very thin discontinuous layer of a red corrosion product without silica grains
CP4	Corrosion product	grey/blue continuous layer
SV1	Structural void	
M1	Metal	compact metal. Observation of stretched metal around the structural voids

Fig. 6: Stratigraphic representation of the corrosion structure of the object by macroscopic and binocular observation with indication of the corrosion structure used to build the MiCorr stratigraphy of Fig. 7 (blue rectangle),

This ferrous alloy object that may have belonged to a wooden box was found near a forge area. Among the observed corrosion strata and characteristic of the corrosion process of ferrous metals, two corrosion layers CP3 and CP4 appear atypical compared to other corrosion profiles of similar metals (cf MiCorr | Knife with a groove on both sides DEV 995/814 PR - Fe Alloy - Early medieval times - Switzerland). They could be related to high temperature exposure due to the proximity of a forging zone.

The limit of the original surface is probably between CP2/CP3 and CP3/CP4. Layer CP3 (in red) shows no more silica grain coming from the burial environnement. CP3 can be removed, but this will eliminate certain elements relating to the history of the artefact.

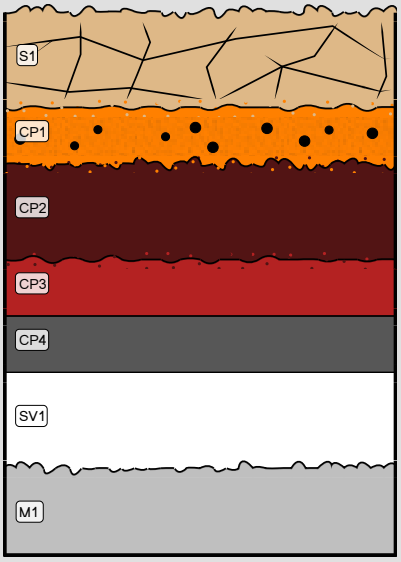
Fig. 7: Stratigraphic representation of the corrosion structure of the object observed macroscopically under binocular microscope using the MiCorr application with reference to Fig. 6. The characteristics of the strata are only accessible by clicking on the drawing that redirects you to the search tool by stratigraphy representation, credit Materia Viva, C.Moreau.
