BELT BUCKLE - CU ALLOY - MEDIEVAL TIMES - FRANCE

Artefact name Belt buckle

Authors TOUZEAU. Julie (Laboratoire MATERIA VIVA, Toulouse, Midi-Pyrénées, France)

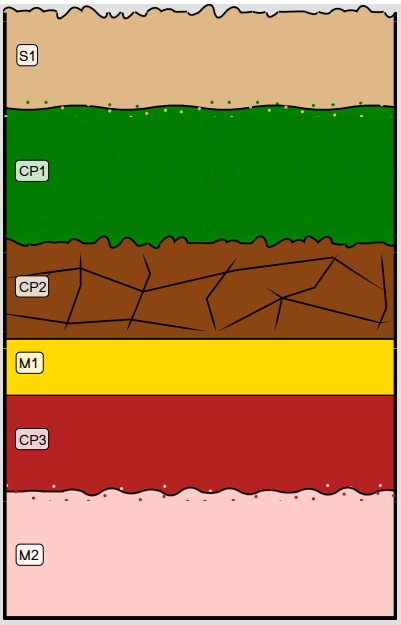
Fig. 6: Stratigraphic representation of the corrosion structure of the belt buckle observed macroscopically under binocular microscope using the MiCorr application with reference to Fig. 5. The characteristics of the strata are only accessible by clicking on the drawing that redirects you to the search tool by stratigraphy representation, credit Materia Viva J.Touzeau.

Usually, belt buckles were made of a copper-based alloy whose surface was entirely covered with gold, but wear due to burial and the development of corrosion led to partial preservation of the gold, only in the incised areas and under the rivet (as it was protected from abrasion). Binocular observation therefore shows these areas where the gold has been preserved and demonstrates that the original surface must have been between CP2 and M1 or between CP3 and CP2 when the gold disappeared.
