# FRAGMENTS OF OENOCHOE GV132-01 US26-OBJ.10 - TIN BRONZE - ROMAN TIMES - SWITZERLAND

| **Artefact name** | Fragments of oenochoe GV132-01 US26-obj.10 |
| **Authors** | Christian. Degrigny (HE-Arc CR, Neuchâtel, Neuchâtel, Switzerland) & Sandra. Gillioz (HE-Arc CR, Neuchâtel, Neuchâtel, Switzerland) & Valentin. Boissonnas (HE-Arc CR, Neuchâtel, Neuchâtel, Switzerland) |

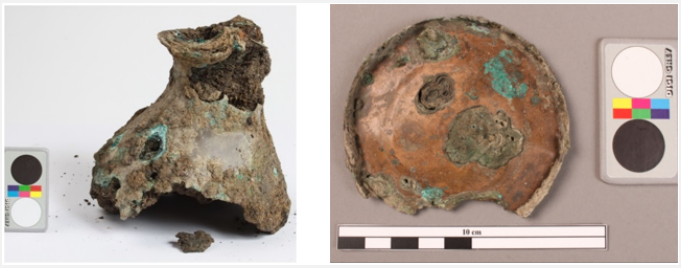
Fig. 1: Oenochoe, belly / neck of the vessel with its base. Only the base is considered in the present sheet,

| **Description of the artefact** | Base of an oenochoe (Fig. 1) developing locally green corrosion products covered or not with sediments. Dimensions: L = 82 mm; W = 74 (after degradation) ; T =6,5 mm; WT = 30,9 g. |

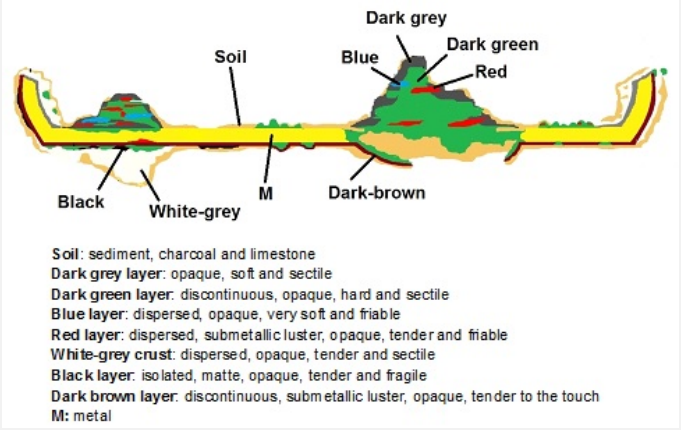
Fig. 3: Stratigraphic representation of the oenochoe base by macroscopic observation,

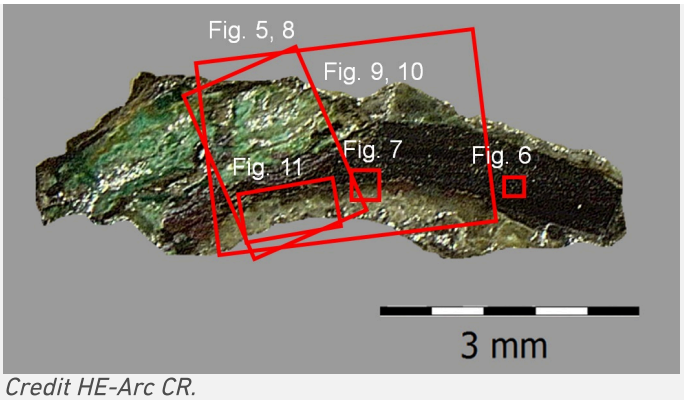
Fig. 4: Micrograph of the cross-section of the sample taken from the oenochoe base showing the location of Figs. 5 to 11,

| **Description of sample** | The sample was cut from the edge shown in Fig. 2. Its dimensions are L = 6.5 mm, W = 1.5 mm. The sample contains some remaining metal covered with a crust and a voluminous pustule corrosion (Fig. 4). |

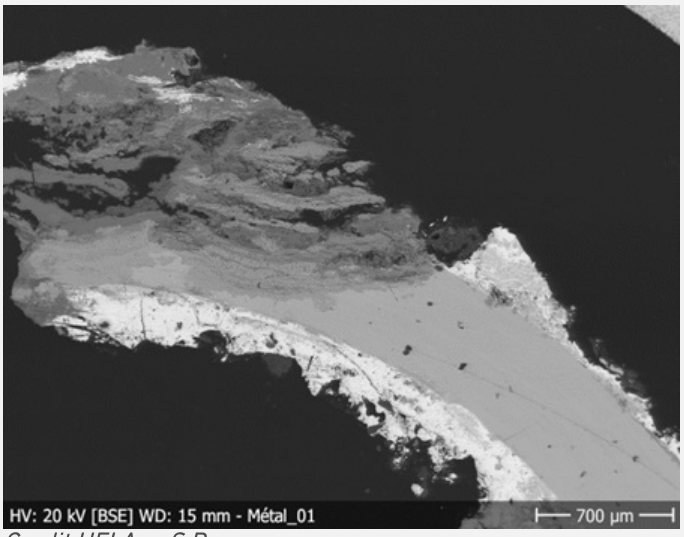
The remaining metal is a tin bronze (Table 1). The etched metal shows a structure of polygonal grains with twinned and strain lines (Fig. 8).

Table 1: Chemical composition of the metal. Method of analysis: SEM-EDS, Lab of Electronic Microscopy and Microanalysis, IMA (Néode), HEI Arc.

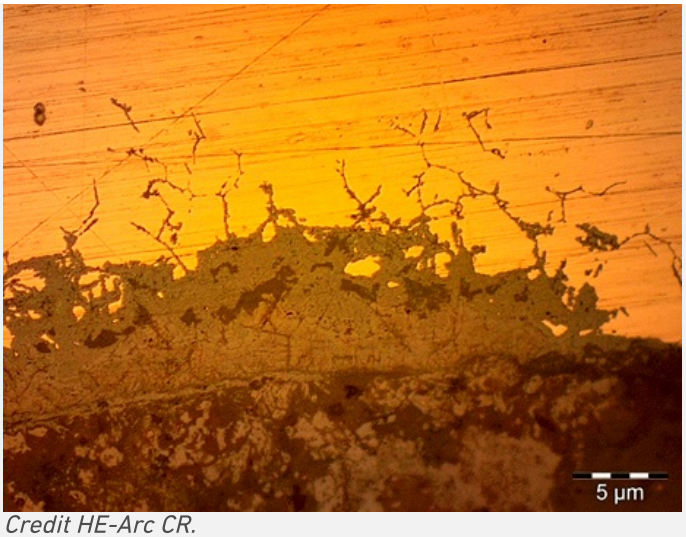
Table 2: Chemical composition of the multi-layered pustule corrosion from Figs. 8, 9 and 10 in dark field. SEM-EDS, Lab of Electronic Microscopy and Microanalysis, IMA (Néode) (+++: high concentration, ++ medium concentration, + low concentration, nd: not-detected).

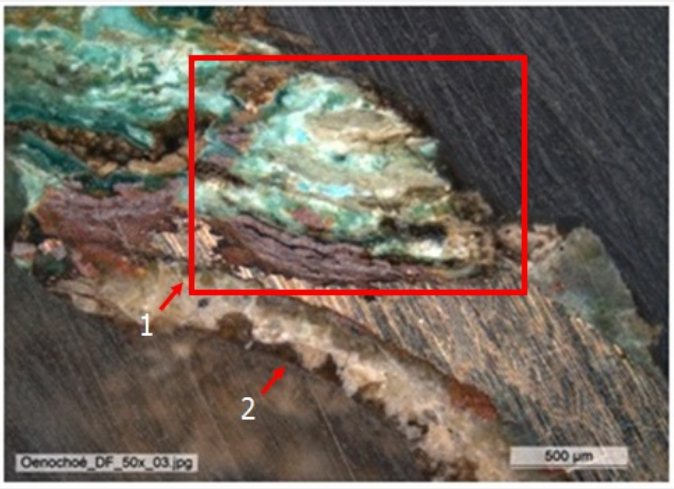
Intergranular corrosion is observed on the edges of the remaining metal (Fig. 7).The sample shows two forms of corrosion: multi-layered pustule corrosion at the left extremity of the sample (Fig. 8, area 1) and a corrosion crust covering the metal (Fig. 8, area 2). The multi-layered pustule corrosion has an average thickness of about 1.1 mm (L) and 0.79 mm (W) (Fig. 9). It is composed of a sandwich of 7 corrosion products, mainly green, grey, red and blue in dark field. Microscopic observation allows us to highlight new corrosion products that were not detected during the first visual examination (Fig. 9):

The corrosion crust on the metal has an average thickness of about 70 µm (Fig. 11). It consists of two sub-layers. The inner corrosion layer (CP2) is thin and dark brown in dark field or light grey in bright field. It has penetrated into the metal structure in some areas (Fig. 7). In dark field, the outer corrosion layer (CP1) is constituted of a heterogeneous light brown corrosion crust (Fig.11). The inner brown corrosion layer is enriched in Sn and O but also contains P, while the outer light brown corrosion layer is mainly composed of Pb and O but also contains P and Fe (Fig. 12). The outer light brown layer is probably due to the presence of a soft solder used to assemble the base to the body.

Fig. 7: Micrograph of the metal sample from Fig. 4, unetched, bright field, 50x. The grain boundaries are revealed by the intergranular corrosion,

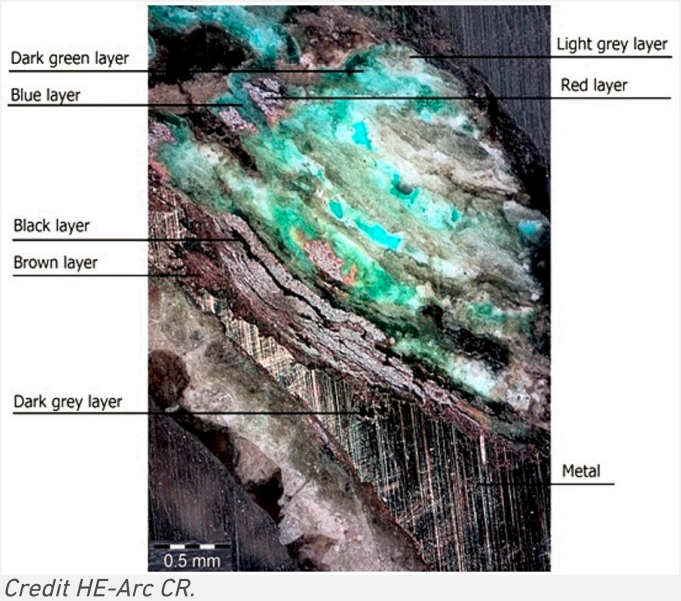
Fig. 8: Micrograph of the metal sample (same as Fig. 7, 30° rotated), unetched, dark field, showing the location of the multi-layered pustule corrosion (area 1 to compare to Fig. 12) and the corrosion crust (area 2 to compare to Fig. 13). The area selected for elemental chemical distribution (Fig. 10) is marked by a red rectangle,

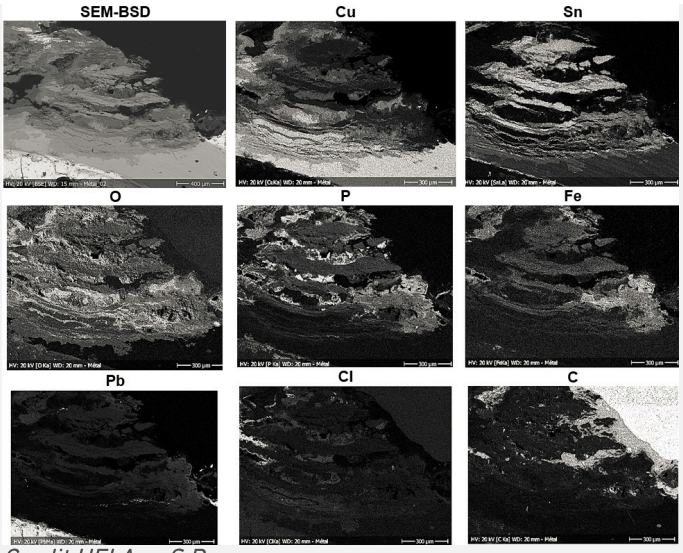
CP1. Light grey layer, containing mainly Sn, O, some Fe, P and a small amount of Pb combined with dark green layer, containing mainly Cu, O and P (Fig. 10, Fig. 12 and table 2)

CP2. Blue layer, containing mainly Cu, Cl, O (Fig. 10, Fig. 12 and table 2)

CP3. Red layer, containing mainly Cu and O combined with black layer containing mainly Sn and O (Fig. 10, Fig. 12 and table 2)

CP4. Brown layer containing mainly Cu, Sn and O (Fig. 10, Fig. 12 and table 2)

CP5. Dark grey layer containing mainly Cu, Sn and O (Fig. 10, Fig. 12 and table 2)

Fig. 10: SEM image, SE-mode, and elemental chemical distribution of the selected area of Fig. 8. Method of examination: SEM-EDS, Lab of Electronic Microscopy and Microanalysis, IMA (Néode), HEI Arc,

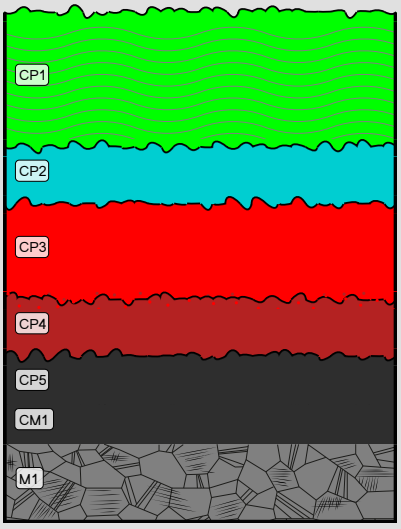
Fig. 12: Stratigraphic representation of the sample taken from the oenochoe base in cross-section (dark field) using the MiCorr application. The characteristics of the strata are only accessible by clicking on the drawing that redirects you to the search tool by stratigraphy representation. This representation can be compared to Fig. 9, Credit HE-Arc CR, C.Degrigny.

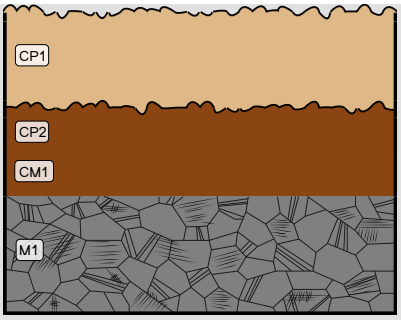
Fig. 13: Stratigraphic representation of the sample taken from the oenochoe base in cross-section (dark field) using the MiCorr application. The characteristics of the strata are only accessible by clicking on the drawing that redirects you to the search tool by stratigraphy representation. This presentation can be compared to Fig. 11, Credit HE-Arc CR, C.Degrigny.

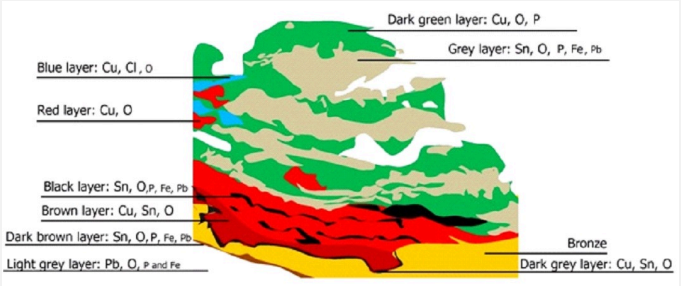
The schematic representation of corrosion layers of Fig. 3 integrating additional information based on the analyses carried out is given in Fig. 14. The addition of "e" and "i" within the coding refers to the location of the strata which are either internal ("i") or in contact with the atmosphere ("e").

Fig. 14: Improved stratigraphic representation of the multi-layered pustule form of the oenochoe from visual observations and analyses,
