FRAGMENTS OF OENOCHOE GV132-01 US26-OBJ.10 - TIN BRONZE - ROMAN TIMES - SWITZERLAND

Artefact name	Fragments of oenochoe GV132-01 US26-obj.10
Authors	Christian. Degrigny (HE-Arc CR, Neuchâtel, Neuchâtel, Switzerland) & Sandra. Gillioz (HE-Arc CR, Neuchâtel, Neuchâtel, Switzerland) & Valentin. Boissonnas (HE-Arc CR, Neuchâtel, Neuchâtel, Switzerland)
Url	/artefacts/1483/

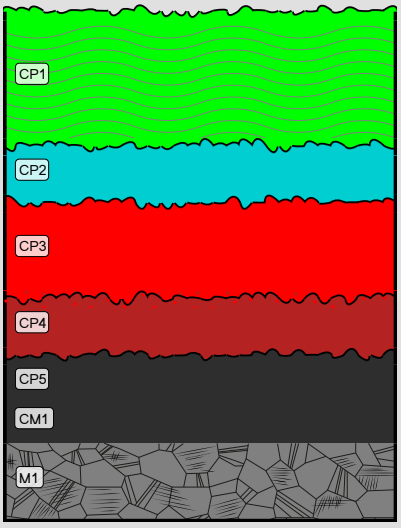
Superior markers such as contextual Fe and P are present in several layers. Their penetration illustrates the cracking of the primary corrosion layer during the formation of the pustule. The P-enrichment in some corrosion layers may be due to an environment rich in organic material (for example bones). The multi-layered pustule corrosion type has developed similarly to the process presented by Formigli (1975) and Scott (2002).

Fig. 12: Stratigraphic representation of the sample taken from the oenochoe base in cross-section (dark field) using the MiCorr application. The characteristics of the strata are only accessible by clicking on the drawing that redirects you to the search tool by stratigraphy representation. This representation can be compared to Fig. 9, Credit HE-Arc CR, C.Degrigny.

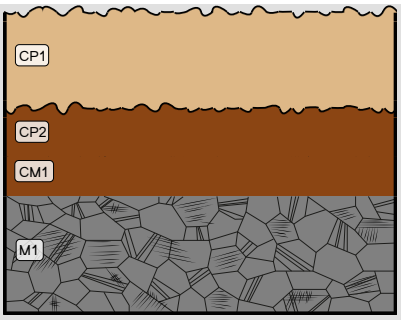
The corrosion crust on the metal has an average thickness of about 70 µm (Fig. 11). It consists of two sub-layers. The inner corrosion layer (CP2) is thin and dark brown in dark field or light grey in bright field. It has penetrated into the metal structure in some areas (Fig. 7). In dark field, the outer corrosion layer (CP1) is constituted of a heterogeneous light brown corrosion crust (Fig.11). The inner brown corrosion layer is enriched in Sn and O but also contains P, while the outer light brown corrosion layer is mainly composed of Pb and O but also contains P and Fe (Fig. 12). The outer light brown layer is probably due to the presence of a soft solder used to assemble the base to the body.

Fig. 13: Stratigraphic representation of the sample taken from the oenochoe base in cross-section (dark field) using the MiCorr application. The characteristics of the strata are only accessible by clicking on the drawing that redirects you to the search tool by stratigraphy representation. This presentation can be compared to Fig. 11, Credit HE-Arc CR, C.Degrigny.
