MOIL CHISEL DEV 995 762 PR - STEEL - EARLY MEDIEVAL TIMES - SWITZERLAND

Artefact name	Moil chisel DEV 995 762 PR
Authors	Marianne. Senn (Empa, Dübendorf, Zurich, Switzerland) & Christian. Degrigny (HE-Arc CR, Neuchâtel, Neuchâtel, Switzerland)
Url	/artefacts/1485/

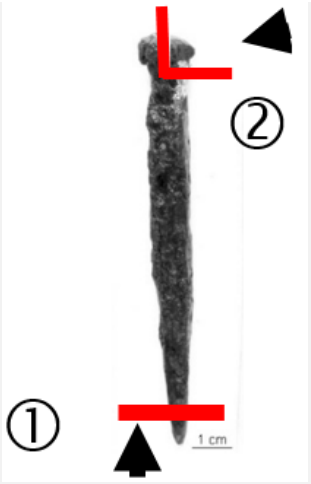
Fig. 2: Location of sampling areas,

Description of sample	Two samples were taken on both extremities of the chisel (Fig. 2). They show the remaining metal covered by thick and cracked corrosion crusts (Fig. 3).
Alloy	Steel
Technology	Welded
Lab number of sample	DEV 762
Sample location	HE-Arc CR, Neuchâtel, Neuchâtel
Responsible institution	Office de la Culture, Porrentruy, Jura
Date and aim of sampling	2000, metallography and chemical composition of the metal

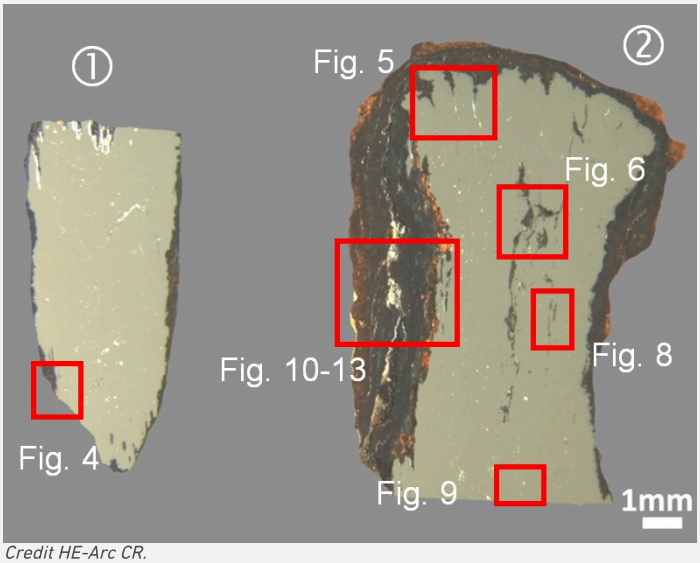
Fig. 3: Micrograph of the cross-sections of samples 1 and 2 taken from the moil chisen showing the location of Figs. 4 to 6 and 8 to 13,

The metal - corrosion products interface is irregular (Fig. 3) and the average thickness of the corrosion crust is about 0.6mm. However, on the left side of the sample taken from the head of the chisel (Fig. 3) the corrosion crust is thicker with an average thickness of about 2mm. This area is further detailed below (Figs. 10 and 11). The corrosion crust can be divided into several layers (CP1-CP4). In bright field, and in the BSE-mode of the SEM image, darker and lighter regions are visible (Figs. 10, 12 and 13). In this area the corrosion layer contains typical trace elements of the metal (As and P, Table 3). In polarised light we see a dark-red zone in which different grey zones are included (Fig. 12). The element mapping and the analyses show that at the metal - corrosion crust interface iron chlorides occur (Figs. 12 and Table 3, CP4 in Fig. 14). Only the outer zone, which has reacted with the soil, has a different colour (orange) and incorporates many rock inclusions (Si, Al and Ca) (Fig. 13 and Table 3, CP1 in Fig. 14).

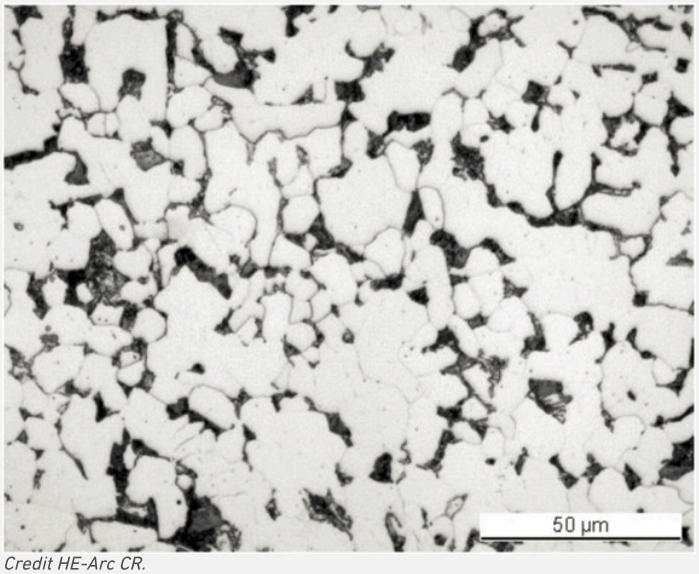
Fig. 8: Micrograph of metal sample 2 from Fig. 3 (detail), nital etched, bright field. We observe a hypoeutectoid steel including a ferritic zone surrounded by slag inclusions,

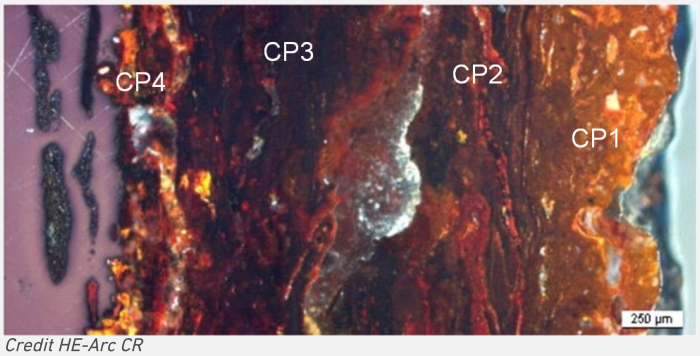
Fig. 10: Micrograph showing the metal - corrosion crust interface from Fig. 3 (reversed picture, detail), unetched, bright field. The areas selected for elemental chemical distributions (Fig. 12 (left) and Fig. 13 (right)) are marked by red rectangles,

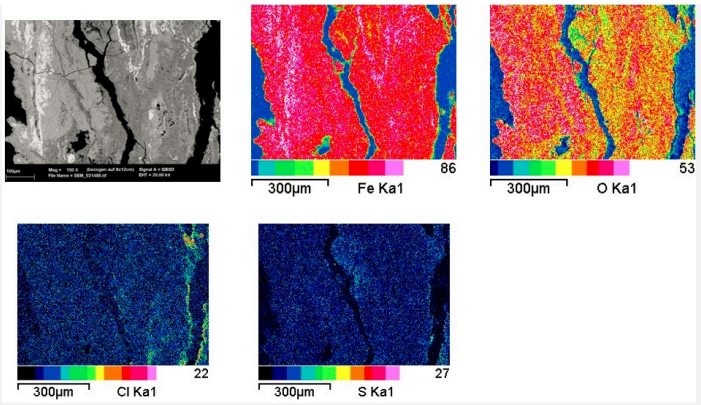
Fig. 12: SEM image, BSE-mode, and elemental chemical distribution of the selected area from Fig. 10 (reversed picture). Method of examination: SEM/EDS, Laboratory of Analytical Chemistry, Empa,

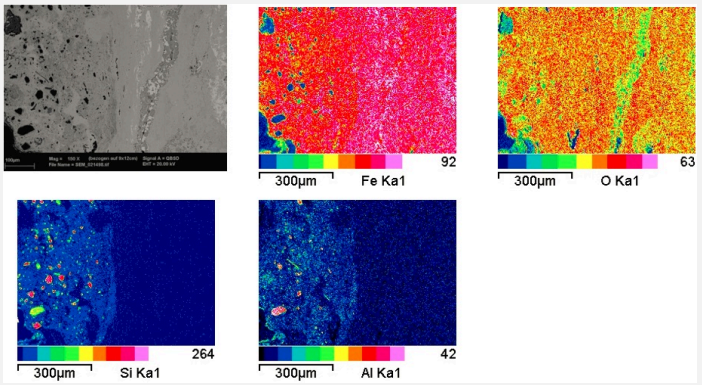
Fig. 13: SEM image, BSE-mode, and elemental chemical distribution of the selected area from Fig. 10 (reversed picture). Method of examination: SEM/EDS, Laboratory of Analytical Chemistry, Empa,

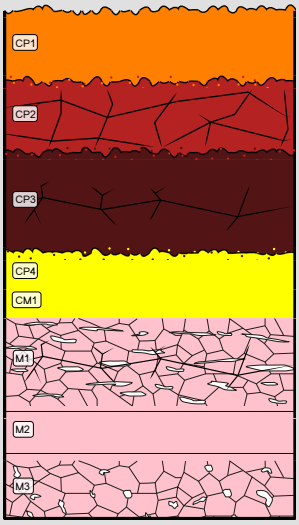
Fig. 14: Stratigraphic representation of sample 2 from the moil chisel in cross-section (dark field) using the MiCorr application. The characteristics of the strata are only accessible by clicking on the drawing that redirects you to the search tool by stratigraphy representation. This representation can be compared to Fig. 11, Credit HE-Arc CR.
