FIGURINE OF EGYPTIAN GOD BES 1 - ÆIN 223 - LEADED BRONZE - 3RD INTERMEDIATE PERIOD TO LATE PERIOD

Artefact name Figurine of Egyptian God Bes 1 - ÆIN 223

Authors Ida. Langemark (The Royal Danish Academy, Copenhagen, Capital Region, Denmark)

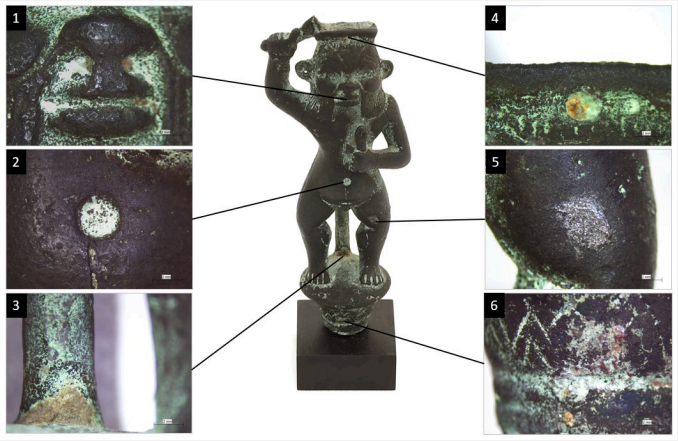
Fig. 1: Face, back and side views of the figurine,

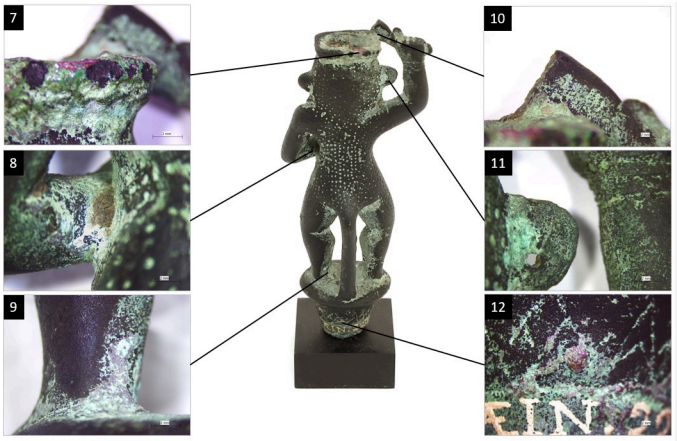
Fig. 2: Dark patina with light green powdery corrosion products on the surface of the front side (details),

The heterogenous corrosion crust covers the whole object with various types of corrosion products, mostly Robbiola type I. Most of the bronze surface is covered with a dark grey patina, with powdery light green corrosion products

located in and around engravings, edges, and curves, as well as horizontal surfaces and the insides of both legs and tail.

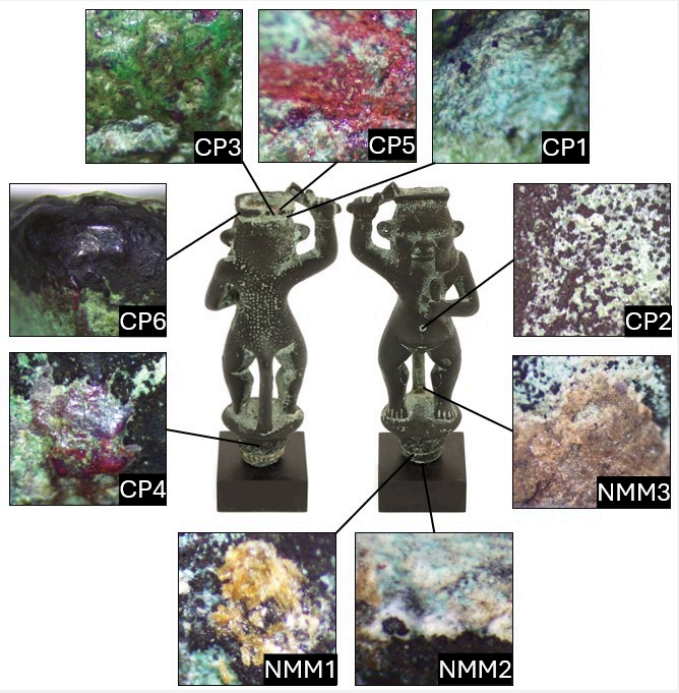
Fig. 3: Dark patina with light green powdery corrosion products on the surface of the back side (details),

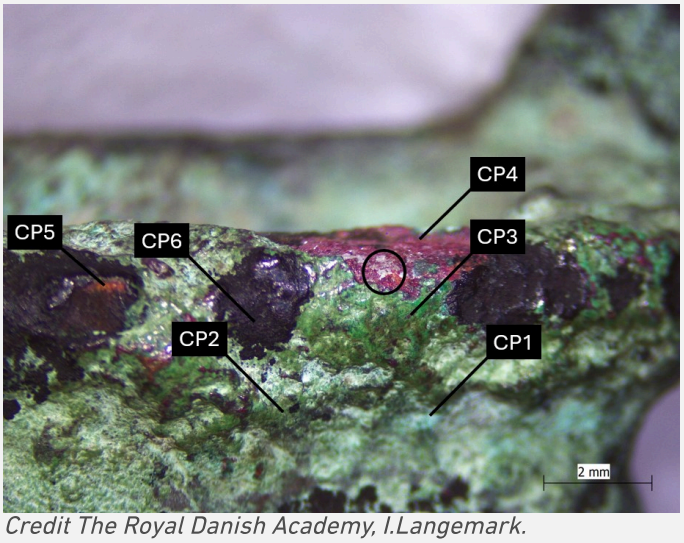
Fig. 5: Distribution of corrosion forms on the crown (detail) observed under binocular microscopy,

Small amounts of white and waxy corrosion product have been observed (encircled in Fig. 5). Based on the presence of high amounts of copper tri-hydroxychloride (paratacamite) in the sample obtained from CP1 and CP2, this substance could very well be nantokite (CuCl).

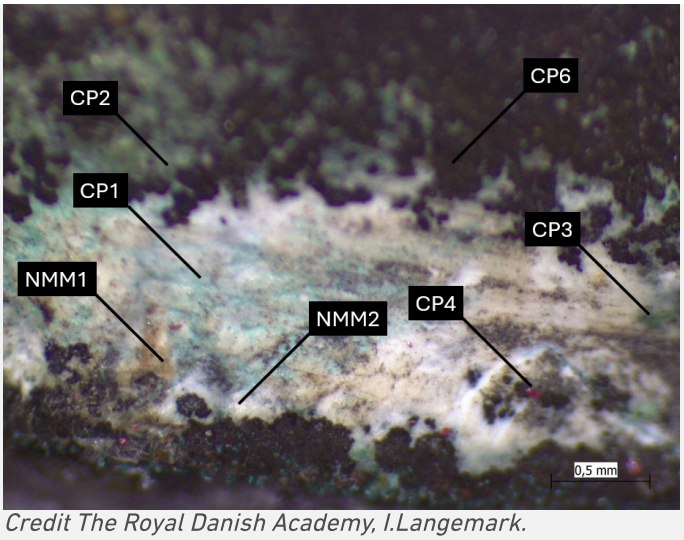
Fig. 6: Distribution of corrosion forms on the standing base (detail) observed under binocular microscopy,

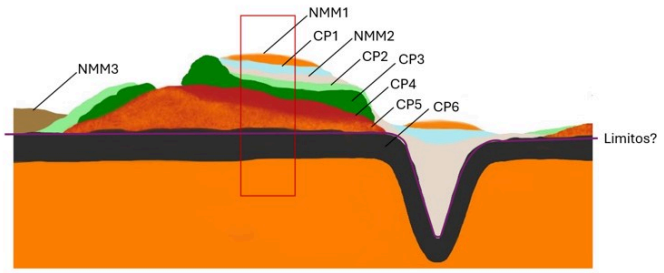
Captions	Colour, aspect, hardness and cohesion
NMM1	Orange non-metallic substance. Waxy, semi-translucent, loosely adhered with sharp transition to underlying layer. Can be removed in malleable flakes.
NMM2	White, matte, non-compact substance. Very loosely adhered to underlaying layer. Removes as powder under action of a scalpel blade. Presumed to be precipitation of calcium (alternatively lead or tin corrosion products).
NMM3	Remains of sediment.
CP1	Light blue corrosion products. Matte and powdery. Very loosely adhered to underlaying surface.
CP2	Light bluish-green corrosion products. Matte and powdery. Distributed in a very thin, loosely adhered layer. Mainly located in engravings, craters, or edges across the figure's surface. Sharp transition to underlaying layers.
CP3	Bright green corrosion products. Opaque and slightly reflective. Apparent as small compact and cohesive lumps. Removes in brittle flakes when shaved with a scalpel blade.

CP4	Dark red corrosion products. Semi-translucent and reflective. Found in lumps that are compact and very cohesive, with sharp transition to other corrosion layers. Powdery under action of a scalpel blade.
CP5	Orange powdery corrosion products. Located beneath CP4, directly on top of CP6.
CP6	Black dense corrosion layer. Very small homogenous crusts strongly adhered to underlaying surface (probably M1 – surface not observed). Opaque, matte or slightly reflective surface. Traces of engravings.
M1	Bronze.

Fig. 8: Stratigraphic representation of the corrosion structure of the figurine by macroscopic and binocular observation, with indication of the corrosion structure used to build the MiCorr stratigraphy of Fig. 9 (red rectangular),

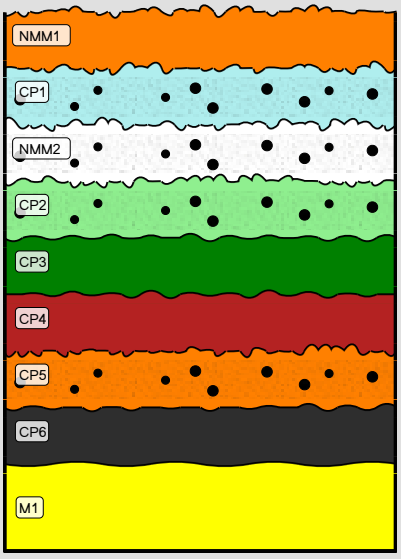
Fig. 9: Stratigraphic representation of the corrosion structure of the figurine observed macroscopically under binocular microscope using the MiCorr application. Credit The Royal Danish Academy, I.Langemark.

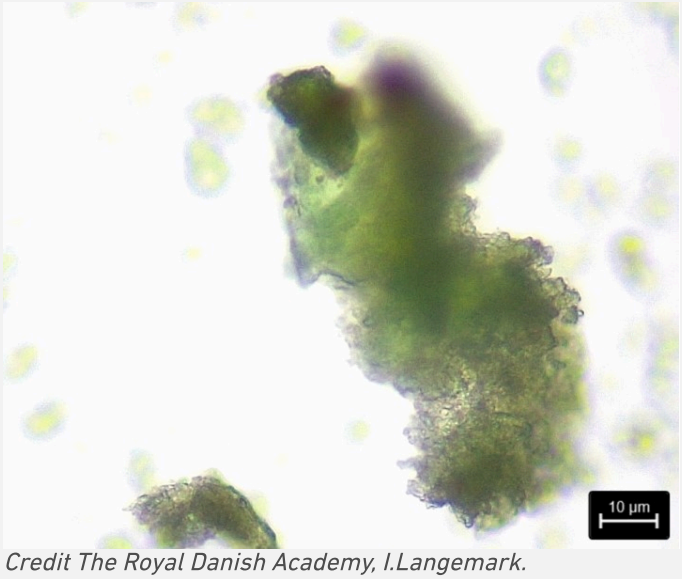
Fig. 11: Microscopic examination of sample obtained from CP2,

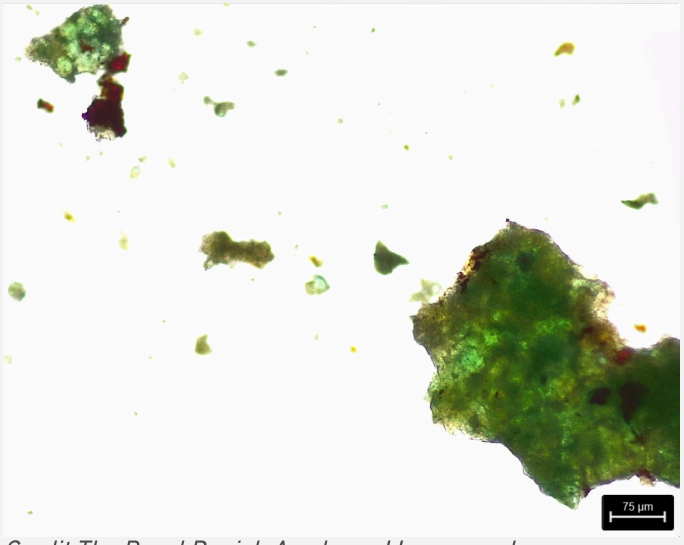
Fig. 12: Microscopic examination of sample obtained from CP3,

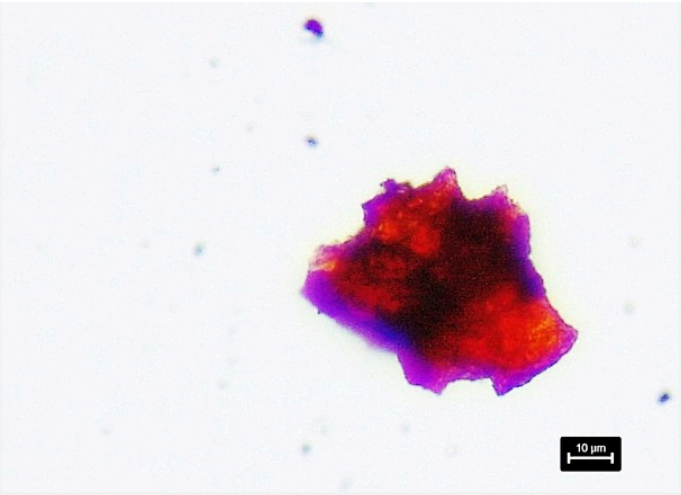
Fig. 13: Microscopic examination of sample obtained from CP4,

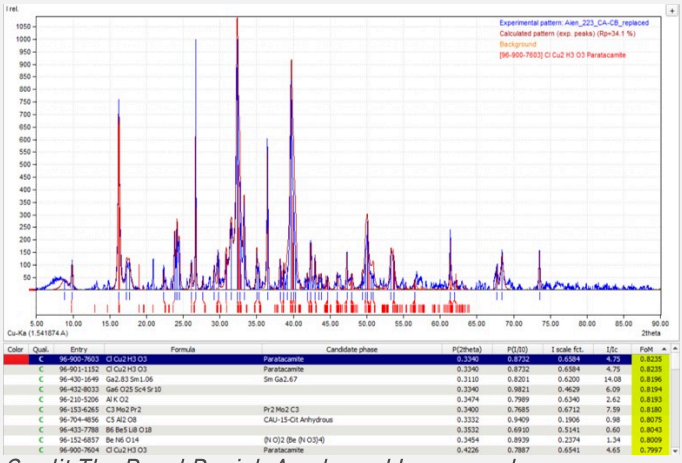
PXRD-analysis of corrosion powder obtained from CP1 and CP2 show the presence of the copper tri-hydroxychloride paratacamite (Fig. 14), and traces of spertiniite (full data-sheet available on request).

Fig. 14: XRD spectrum obtained from PXRD-analysis of CP1 and CP2,

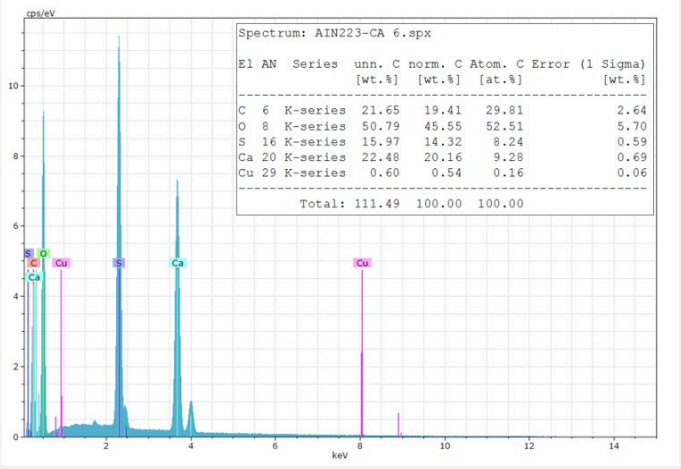
SEM-EDS-analysis of the white substance found on the standing base (NMM2) shows a high content of calcium (Fig. 15). In some areas, the white layers have an almost waxy appearance, a feature that often reveals the presence of nantokite (copper oxychloride). Distinguishing between areas of calcium precipitation and nantokite would require more samples to be analysed.

Fig. 15: SEM-EDS data from analysis of NMM2, showing a high amount of calcium,
