FIGURINE OF EGYPTIAN GOD BES 1 - ÆIN 223 - LEADED BRONZE - 3RD INTERMEDIATE PERIOD TO LATE PERIOD

Artefact name Figurine of Egyptian God Bes 1 - ÆIN 223

Authors Ida. Langemark (The Royal Danish Academy, Copenhagen, Capital Region, Denmark)

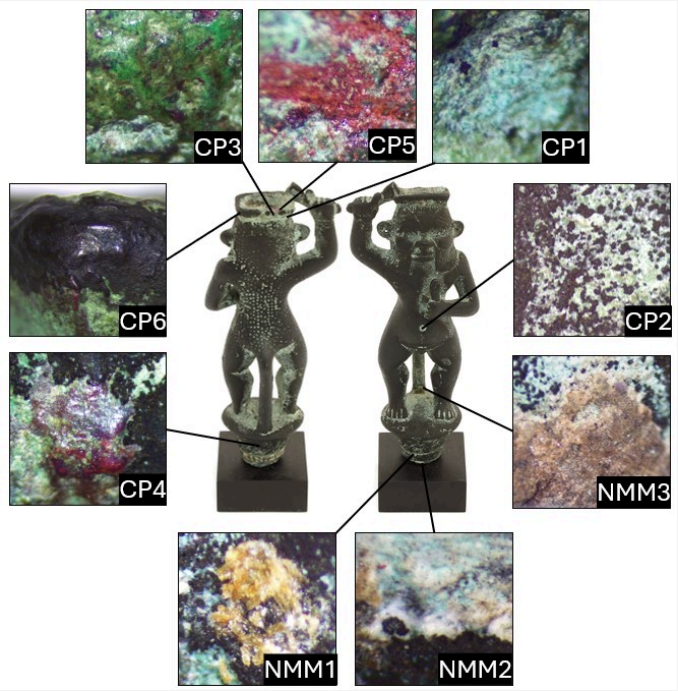
Fig. 3: Dark patina with light green powdery corrosion products on the surface of the back side (details),

Description of the artefact	Bes appears in his typical form with grotesque face, naked male body, short and hooked legs, lion's mane, mouth, and tail. The god was perceived as a protector who defeated evil forces with force of arms or magical music and is here depicted as a snake slayer with a sword raised in his right hand and a cobra in his left hand. Dimensions: Height=11.6cm; Width=4.8cm; Thickness=3.3cm. The figure has lost its crown, which was shaped like a feather tassel, but its original existence is revealed by an empty mounting hole at the top of the head. The figure originally stood on vertical stands that illustrated the flowering papyrus stalks, symbols of health and freshness, wadj, but only sparse remains are preserved under the figure's feet. The wadj-symbol with the god on top may have been mounted at the top of a ceremonial staff or had a place on a base, possibly together with other figures (Jørgensen 2009 23.1.). The figure is covered by a dark corrosion layer which could be an original artificial patina, with light green powdery corrosion products located in and around engravings, edges, and curves, as well as horizontal surfaces and the insides of legs and tale (Fig. 2 and 3).

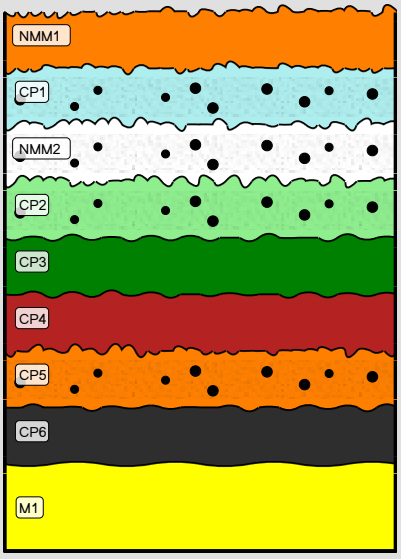
Fig. 9: Stratigraphic representation of the corrosion structure of the figurine observed macroscopically under binocular microscope using the MiCorr application. Credit The Royal Danish Academy, I.Langemark.

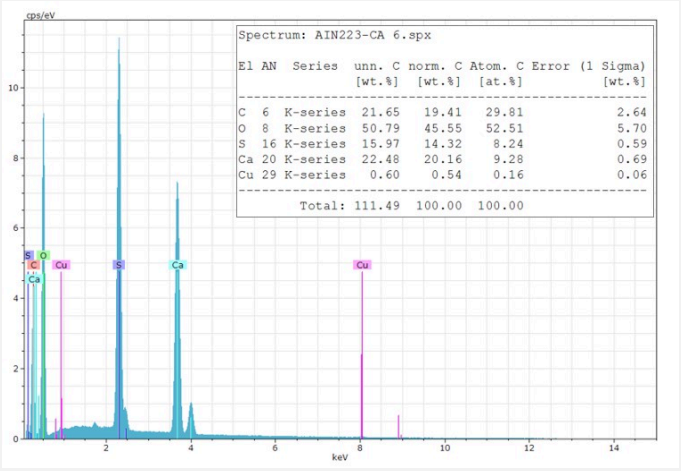
SEM-EDS-analysis of the white substance found on the standing base (NMM2) shows a high content of calcium (Fig. 15). In some areas, the white layers have an almost waxy appearance, a feature that often reveals the presence of nantokite (copper oxychloride). Distinguishing between areas of calcium precipitation and nantokite would require more samples to be analysed.

Fig. 15: SEM-EDS data from analysis of NMM2, showing a high amount of calcium,
