SITULA EMT09-554.665 - TIN BRONZE - IRON AGE - SWITZERLAND

Artefact name	Situla EMT09-554.665
Authors	Christian. Degrigny (HE-Arc CR, Neuchâtel, Neuchâtel, Switzerland) & Marie-Jeanne. Scholl (HE-Arc CR, Neuchâtel, Neuchâtel, Switzerland) & Valentin. Boissonnas (HE-Arc CR, Neuchâtel, Neuchâtel, Switzerland)
Url	/artefacts/1506/

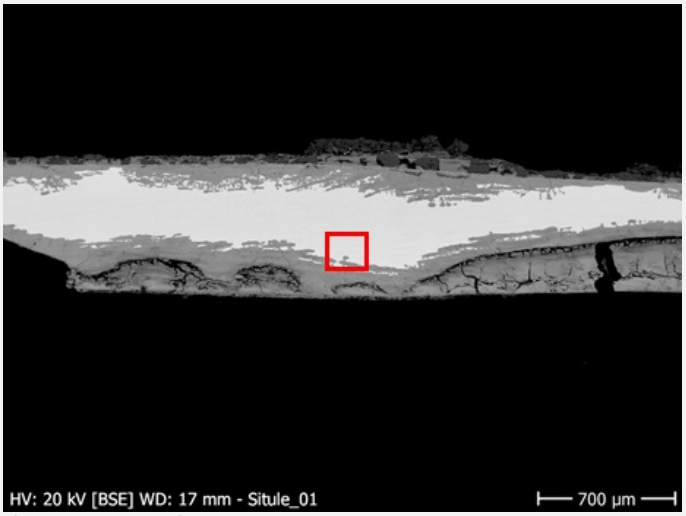
The remaining metal is a dense tin bronze (Fig. 5, Table 1), showing no inclusion. In bright field, the etched alloy shows a structure principally consisting of polygonal alpha phase grains (Fig. 6). Some of the grains include twin lines (Fig. 7). The presence of strain lines (slip lines) indicates a final cold work without annealing.

Fig. 5: SEM image, BSE-mode, of the metal sample from Fig. 4. Area of Fig. 6 is marked by a red square,

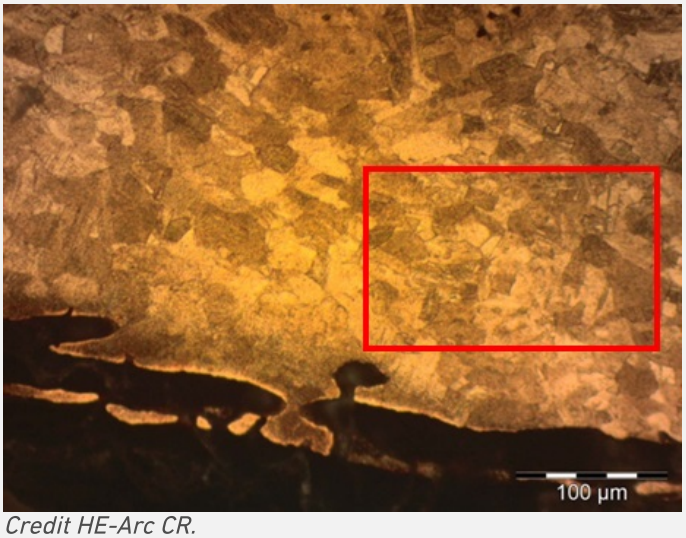
Fig. 6: Micrograph of the metal structure from Fig. 5 (detail), etched, bright field, 50x. The alpha phase of the alloy shows polygonal grains. Area of Fig. 7 is marked by a red rectangle,

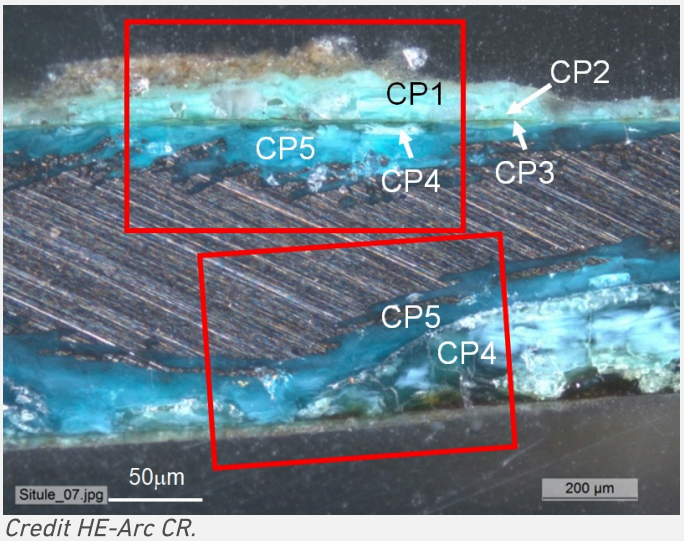
Fig. 8: Micrograph of the metal sample from Fig. 4, unetched, dark field, 50x. Areas of Fig. 9 (bottom, corresponding to the stratigraphy of Fig. 14) and Figs. 10 and 11 (top, corresponding to the stratigraphy of Fig. 15) are marked by a rectangle. Codes are those of Fig. 15,

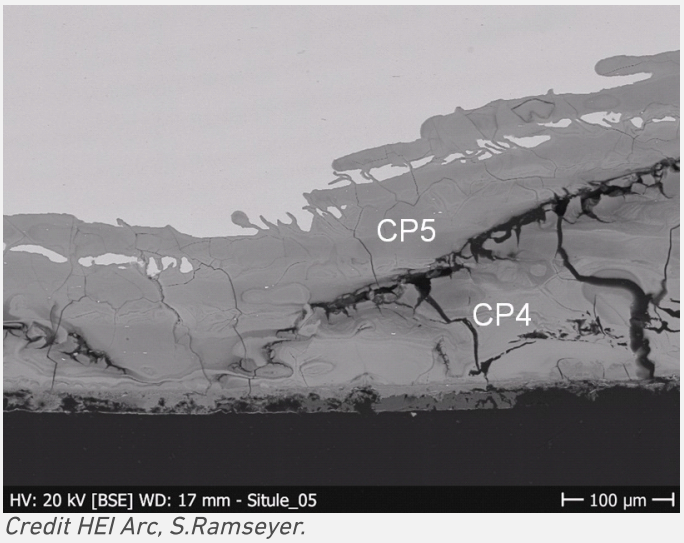
The corrosion crust is heterogeneous and has in places completely replaced the metal. The metal – corrosion products interface is irregular due to transgranular corrosion (Figs 5-6). In most cases, the corrosion crust can be divided in three main layers: first, an inner compact blue layer directly on the metal core (CP5, Figs. 8, 10 and 15 and CP3, Fig. 14). In areas of extensive corrosion this blue layer coexists with a friable light blue-green layer (CP4, Figs. 8, 10 and 15 and CP2, Fig. 14). Secondly, and depending on the area, either a very fine dark green (CP3, Figs. 8 and 15) or red corrosion layer (CP2, Figs. 10 and 15) marks the limit of the original surface. Finally, there is a fourth outer layer, consisting of friable and sometimes curly pale green corrosion products, interspersed with soil products (CP1, Figs. 8, 10 and 15). In heavily worked and fragile parts of the object a cleavage between the inner layers of blue and light blue-green corrosion is present, rendering the light blue-green corrosion vulnerable to loss (Fig. 9).

Fig. 9: SEM image, BSE-mode of the metal sample from Fig. 8 (detail) showing cleavage between the inner blue (CP5) and green (CP4) layers of Fig. 15,

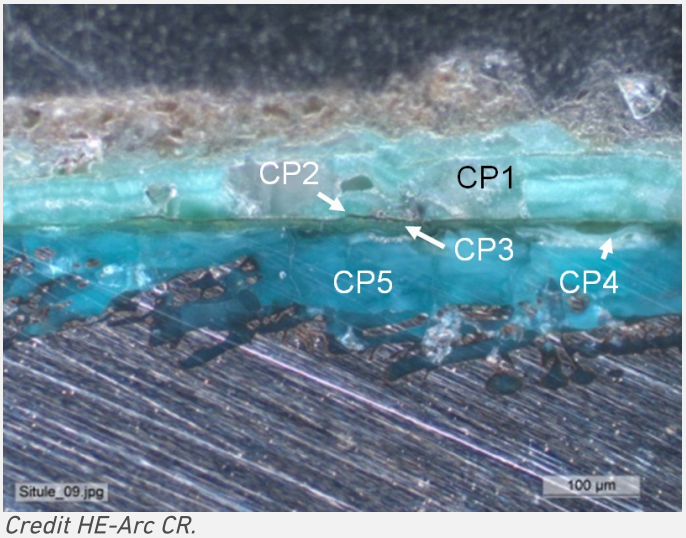
Fig. 10: Micrograph of the metal / corrosion interface (detail of Fig. 8) unetched, dark field, 100x. The outer layer (CP1 of Fig. 15) incorporates soil material and the thin dark layer (CP2 of Fig. 15) highlights the limit of the original surface,
