SITULA EMT09-554.665 - TIN BRONZE - IRON AGE - SWITZERLAND

Artefact name	Situla EMT09-554.665
Authors	Christian. Degrigny (HE-Arc CR, Neuchâtel, Neuchâtel, Switzerland) & Marie-Jeanne. Scholl (HE-Arc CR, Neuchâtel, Neuchâtel, Switzerland) & Valentin. Boissonnas (HE-Arc CR, Neuchâtel, Neuchâtel, Switzerland)
Url	/artefacts/1506/

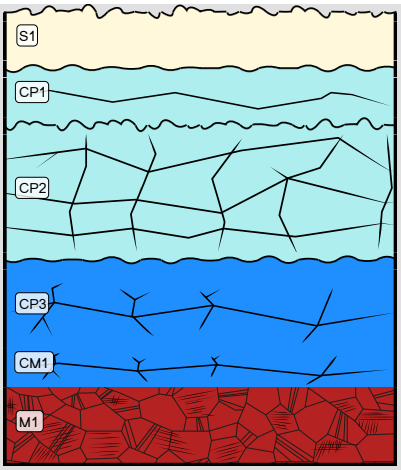
Fig. 14: Stratigraphic representation of the sample taken from the detached fragment of the situla in cross-section (dark field) using the MiCorr application. The characteristics of the strata are only accessible by clicking on the drawing that redirects you to the search tool by stratigraphy representation. This representation shows the interior face and can be compared to Fig. 8 (bottom red rectangle), Credit HE-Arc CR, M-J.Scholl.

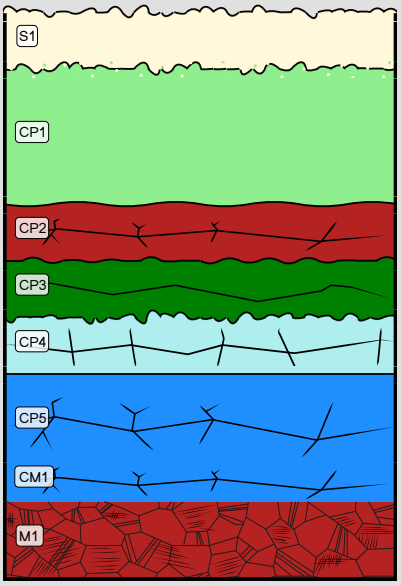
Fig. 15: Stratigraphic representation of the sample taken from the detached fragment of the situla in cross-section (dark field) using the MiCorr application. The characteristics of the strata are only accessible by clicking on the drawing that redirects you to the search tool by stratigraphy representation. This representation shows the exterior face and can be compared to Fig. 8 (top red rectangle), Credit HE-Arc CR, M-J.Scholl.
