JAR/CUP FO-NR. 71064.2.3 - BRONZE - LATE IRON AGE

Artefact name	Jar/cup FO-Nr. 71064.2.3
Authors	Ingrid González. (HE-Arc CR, Neuchâtel, Neuchâtel, Switzerland) & Valentin. Boissonnas (HE-Arc CR, Neuchâtel, Neuchâtel, Switzerland)
Url	/artefacts/1507/

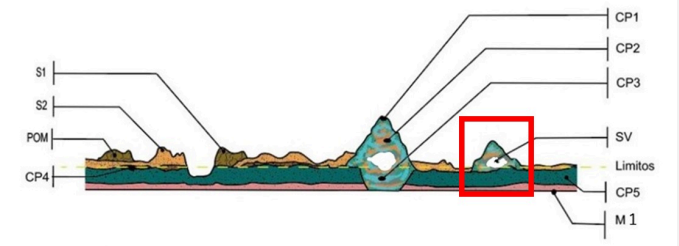
Layer	Color	Description
S1	Brown	Granular and powdery sediments
S2	Brown	Granular and powdery sediments with strong adhesion to the surface
P.O.M.	Brown	Filiform structure
CP1	Light green	Shiny, hard, dense, adherent corrosion
CP2	Orange	Powdery and loose corrosion
CP3	Light green	Powdery and loose corrosion
SV		Empty space
CP4	Dark brown	Matte and smooth corrosion
CP5	Dark green	Matte and smooth corrosion
M1		Bronze surface

Fig. 4: Stratigraphic representation of the corrosion structures of the cup (based on visual observation) with indication of the corrosion structure used to build the MiCorr stratigraphy of Fig. 5 (red rectangular),

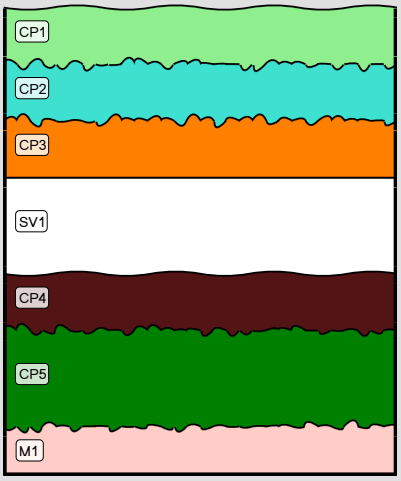
Fig. 5: Stratigraphic representation of the corrosion structure of the cup/jar observed macroscopically under binocular microscope using the MiCorr application. The characteristics of the strata are only accessible by clicking on the drawing that redirects you to the search tool by stratigraphy representation. This representation can be compared to the selected detail of Fig. 4, credit HE-Arc CR, I.González.

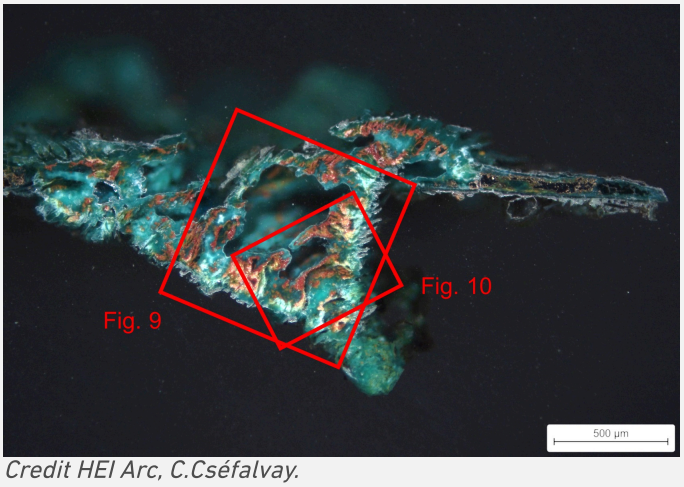
Fig. 7: Micrograph of the cross-section of a sample taken from the fragments of the base of the cup (Fig. 3 and same as Fig. 6) showing the location of Figs. 9 & 10, dark field,

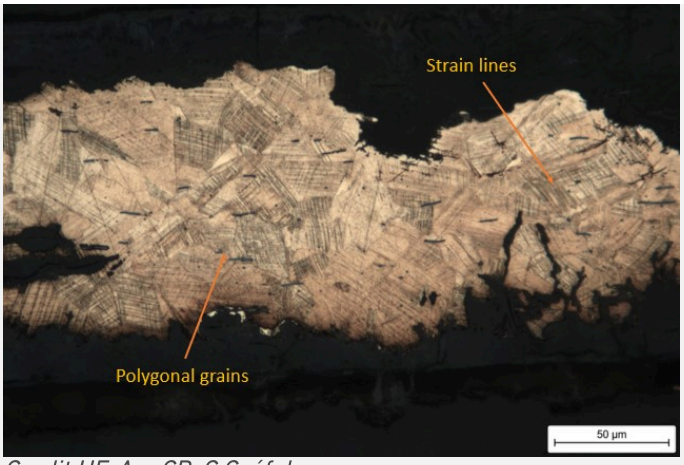
The etched metal shows a structure of polygonal grains with strain lines (Fig. 8). This indicates that either the object was submitted to a light annealing process after the intense mechanical work that can be perceived through the slip lines. Or the final mechanical work did not affect the main structure of the grains formed by the previous annealing. Small Pb inclusions are distributed through the sample.

Fig. 8: Micrograph of the etched cross-section of the sample taken from the fragment of the base of the cup (detail of Fig. 6) in bright field,

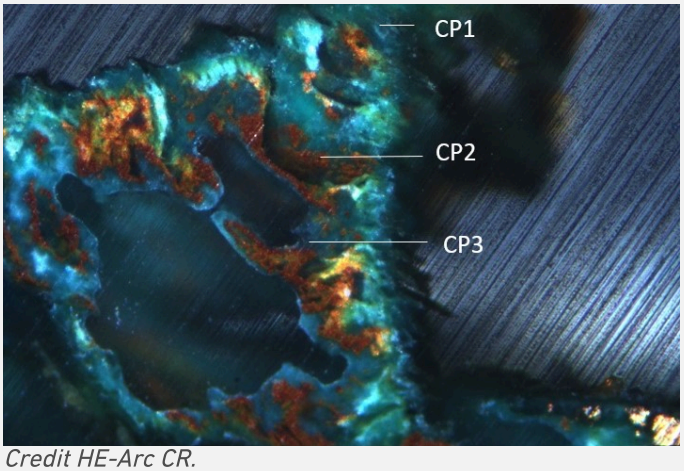
The observation of a pustule in cross-section in dark field shows three main corrosion products overlaying each other (Fig. 9). The first green corrosion layer (CP1) possibly corresponds to atacamite ($Cu_2Cl(OH)_3$) as suggested by the FTIR spectrum of Fig. 10. The second corrosion layer inside the pustule (CP2) is probably a copper oxide - cuprite (Cu_2O) and the third light green (CP3) corrosion layer could be malachite ($Cu_2CO_3(OH)_2$), as suggested again by FTIR spectrum of Fig. 12.

Fig. 9: Micrograph of the metal sample (Fig. 7, rotated by 110°), dark field, showing the location of the multi-layered pustule corrosion,

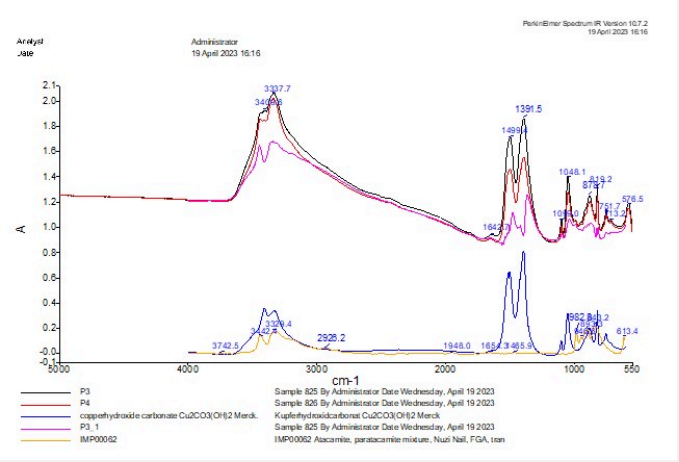
Fig. 10: FTIR spectrum of the analysis of a sample from the base of the object Fig. 3, identified as possibly atacamite,

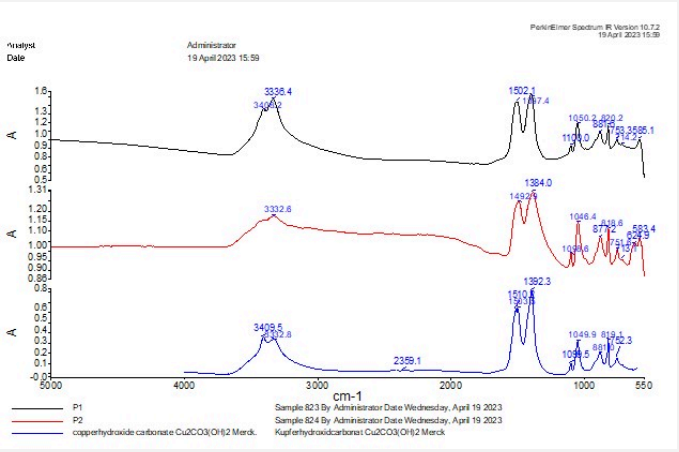
Fig. 11: FTIR spectrum of the analysis of a sample from the base of the object Fig. 3, identified as malachite,

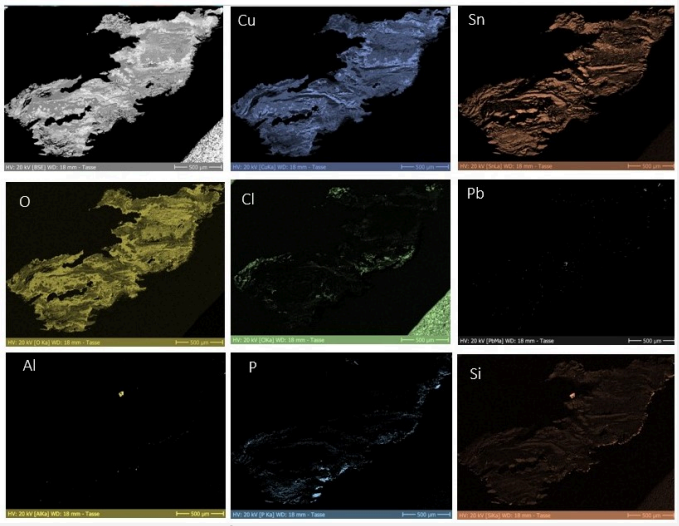
Elemental EDX analysis and mapping (Fig. 10) show phases which are richer in Sn than in Cu. Cl is located in the area closest to the outside of the pustule. Phosphorus (P) is also located in this area, possibly as a soil contaminant in the presence of human remains.

Fig. 10: SEM image, BSE-mode, and elemental chemical distribution of the selected area (Fig.7, rotated by 45°),

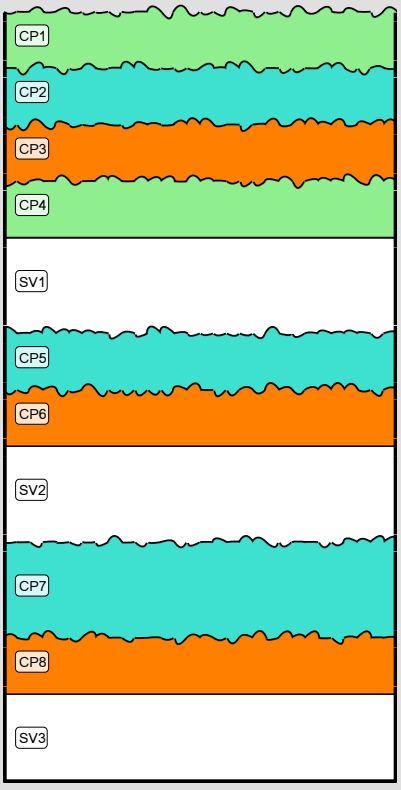
Fig. 13: Stratigraphic representation of the sample taken from the cup/jar in cross-section (dark field) using the MiCorr application. The characteristics of the strata are only accessible by clicking on the drawing that redirects you to the search tool by stratigraphy representation. This representation can be compared to fig. 9, Credit HE-Arc CR, I. González.

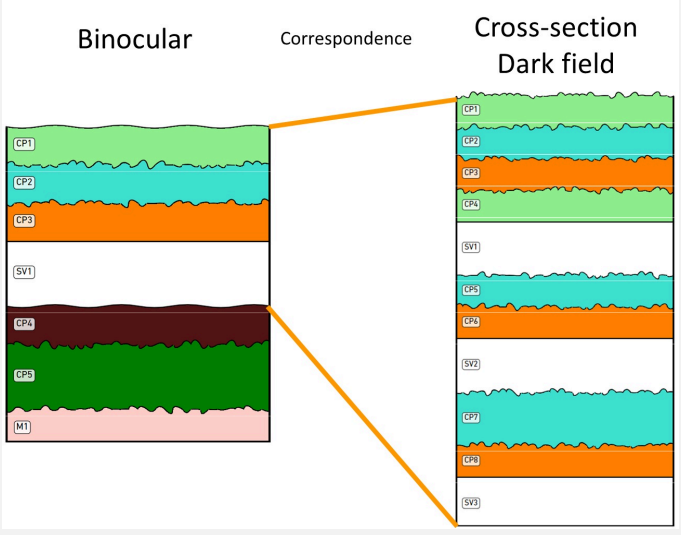
The stratigraphies obtained by binocular and cross-section observation show a few differences that can be attributed to the different scales of observation and the impossibility to visualise both a pustule and the remaining metal underneath. Under binocular microscope, it is difficult to differentiate the multiple strata of the pustule. Only the main strata are indicated.

Under cross-section, the distribution of strata appears more clearly while this distribution and succession of strata are different in the middle of the pustule versus its edges. CP4 is similar to CP1, while CP5/CP7 are similar to CP2 and CP6/CP8 are similar to CP3.

CP4 and CP5 of the Bi stratigraphy do not show up on the CS stratigraphy. Similarly the M1 stratum is not described.

Fig. 14: Stratigraphic representation side by side of binocular view and cross-section (dark field),
