FRAGMENT OF THE SUPPORT STRUCTURE OF AN ENGINE VHS-404 - GREY CAST IRON - MODERN TIMES - SWITZERLAND

Artefact name	Fragment of the support structure of an engine VHS-404
Authors	Marianne. Senn (EMPA, Dübendorf, Zurich, Switzerland) & Christian. Degrigny (HE-Arc CR, Neuchâtel, Neuchâtel, Switzerland)
Url	/artefacts/1570/

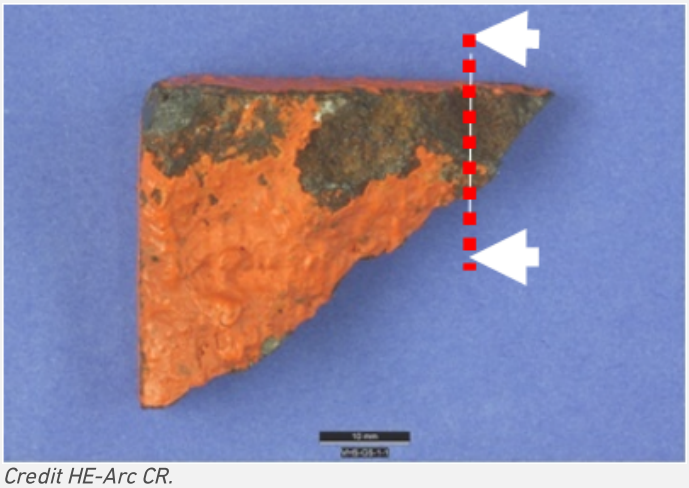
Fig. 2: Location of sampling area,

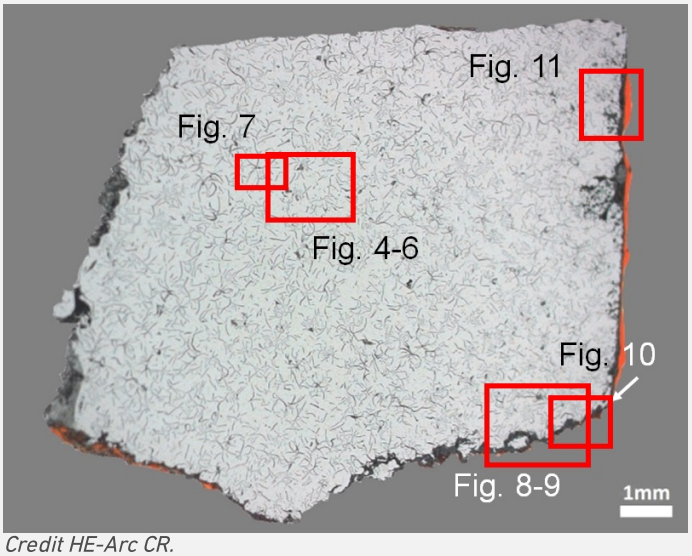
Fig. 3: Micrograph of the cross-section of the fragment showing the location of Figs. 4 to 11,

Description of sample	The sample is a cross-section through the fragment of the support structure of the engine (Fig. 3). Dimensions: Lmax = 10mm; Wmax = 10mm.
Alloy	Grey cast iron
Technology	As-cast
Lab number of sample	VHS-G-1
Sample location	HE-Arc CR, Neuchâtel, Neuchâtel
Responsible institution	Swiss Museum of Transport, Luzern, Lucerne
Date and aim of sampling	07/09/2009 metallography

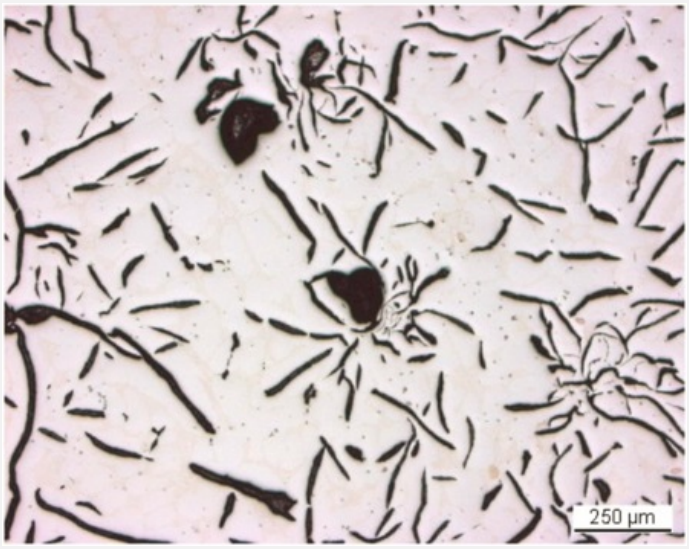
The remaining metal is a high P and Si grey cast iron with elevated Mn and V contents (Tables 1 and 2). The structure contains black graphite flakes and graphite nodules (Fig. 4) as well as angular grey manganese sulphide inclusions which can contain a dark alumina-rich centre (Fig. 4 and Table 1). The graphite flakes are irregular and vary in size. At low magnification the flakes are evenly spread over the entire surface with a tendency to form clusters. Some porosity is noticeable. Under SEM, in the BSD-mode, an additional eutectic phase is visible (Fig. 5). After etching one can see how the graphite is surrounded by alpha-iron in a pearlite matrix (Figs. 6 and 7). The lamellar pearlite includes steadite (Fe_3P) and manganese sulphide (MnS) inclusions. According to the cast iron diagram after Maurer (Bargel and Schulze 2008, 257), the structure is typical for a hypoeutectic pearlitic grey cast iron (C content <4.3 mass%, Si content ca. 2.0 mass%) including pearlite, steadite and graphite. The slow cooling rate and the higher Si level have favoured the formation of graphite. The high P content favours the growth of interconnected networks of steadite. The average hardness of the metal is HV1 160. This hardness is only approximate. Normally cast iron hardness is determined with a Brinell test, but due to the small size of the sample this could not be carried out. The calculated HB is about 150.

Fig. 4: Micrograph of the metal sample from Fig. 3 (inverted picture, detail), unetched, bright field. We observe graphite flakes and irregular nodules in black and the metal in white. The small grey spots are manganese sulphide inclusions,

Fig. 5: SEM image from Fig. 3 (detail), BSE-mode, unetched. We observe the graphite flakes in black, the manganese sulphide inclusions in grey and the eutectic mixture in light-grey,

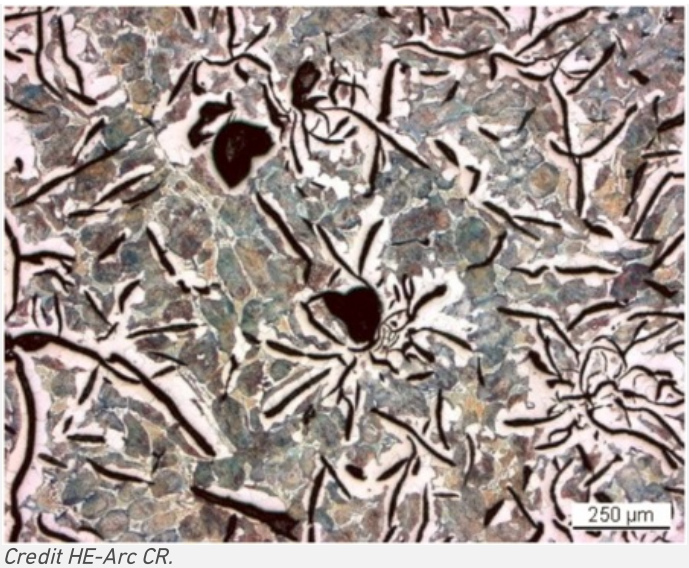
Fig. 6: Micrograph (same as Fig. 4), etched, bright field. In between the black graphite flakes we observe alpha-iron in white and pearlite / steadite in grey,

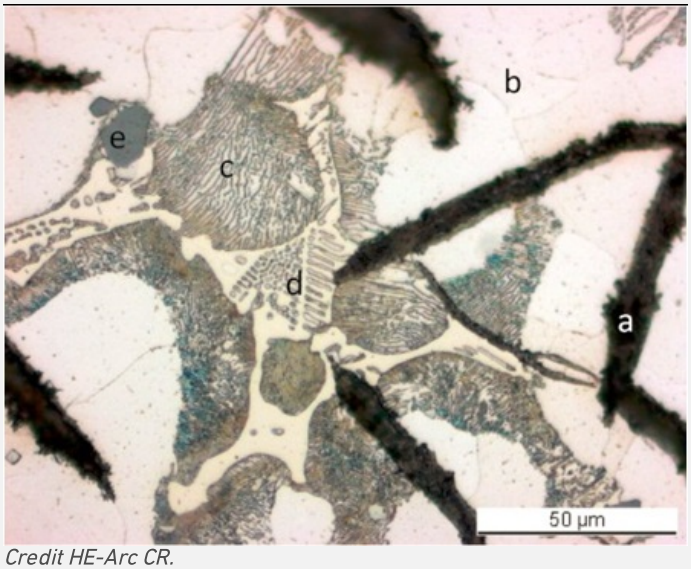
Fig. 7: Micrograph of the metal sample from Fig. 3 (detail), etched, bright field. The structure is composed of graphite (a), ferrite (b), pearlite (c), steadite (d) and MnS inclusions (e),

Microstructure	Graphite lamellars + pearlite + ferrite + steadite (Fe3P)
First metal element	Fe
Other metal elements	C, Si, P, Ti, V, Mn

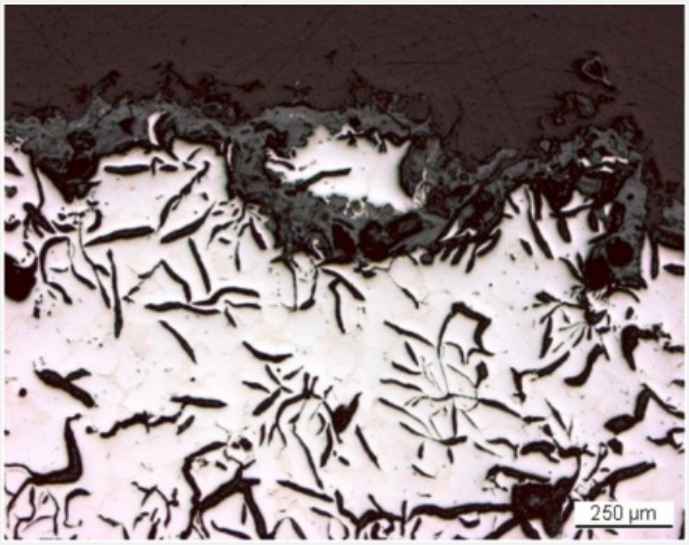
The thin corrosion crust (CP1) is limited to three sides of the sample and some remains of a paint coating (orange) are visible (Fig. 3). In bright field, the corrosion crust appears light-grey (Fig. 8), under polarised orange (Fig. 9). It is mainly composed of iron oxides (Table 3 and Fig. 10). The Pb and Ba-rich paint system has been applied directly onto the oxidized Fe, Si and Mn-rich casting skin (Fig. 11). The paint layer is probably an anodic inhibitor made from minium (red lead) with a barium sulphate filler. Because of the interference of Pb with S in the EDS spectra S is difficult to detect.

Fig. 8: Micrograph showing the metal - corrosion layer interface from Fig. 3 (inverted picture, detail), unetched, bright field. We observe in white the metal, in light-grey the corrosion layer, in black the graphite flakes,

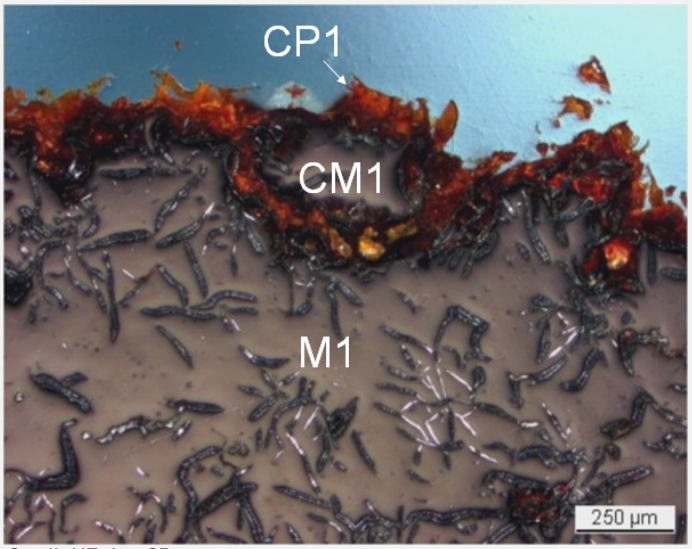
Fig. 9: Micrograph (same as Fig. 8) corresponding to the stratigraphy of Fig. 12, unetched, polarised light. We observe in violet the metal, in orange the corrosion, in blue the resin,

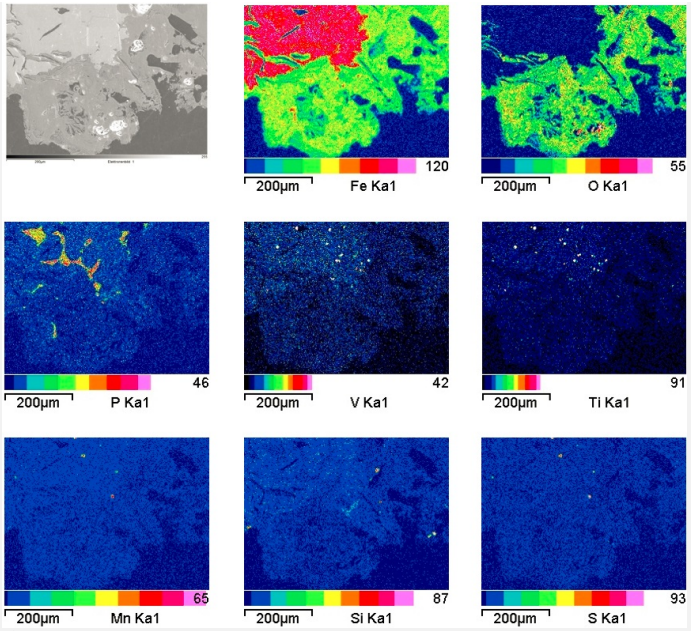
Dark-grey casting skin (Fig. 11)	27	<	14	<	<	21	33	<	<	95
Paint system (Fig. 11)	20	<	<	<	<	<	<	18	55	93
Grey corrosion layer (Fig. 10)	35	<	1	<	<1	<	59	<	<	96

Fig. 10: SEM image, SE-mode, and elemental chemical distribution of the selected area from Fig. 3 (detail). Method of examination: SEM/EDS, Laboratory of Analytical Chemistry, Empa,

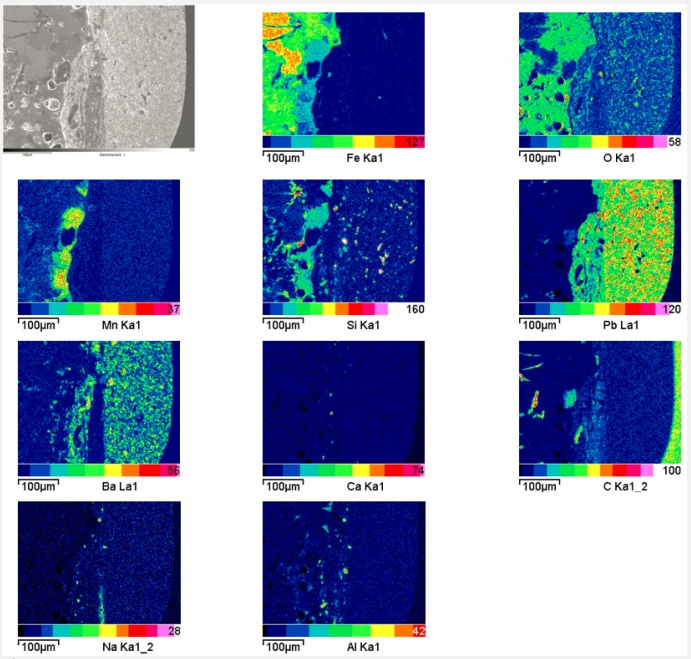
Elements	O	Mg	Si	P	S	Mn	Fe	Ba	Pb	Total
Inner light-grey corrosion layer (Fig. 11)	20	<	<	<	<	1	76	<	<	97

Fig. 11: SEM image, SE-mode, and elemental chemical distribution of the selected area from Fig. 3 (detail). Method of examination: SEM/EDS, Laboratory of Analytical Chemistry, Empa,
