FRAGMENT OF THE SUPPORT STRUCTURE OF AN ENGINE VHS-404 - GREY CAST IRON - MODERN TIMES - SWITZERLAND

Artefact name	Fragment of the support structure of an engine VHS-404
Authors	Marianne. Senn (EMPA, Dübendorf, Zurich, Switzerland) & Christian. Degrigny (HE-Arc CR, Neuchâtel, Neuchâtel, Switzerland)
Url	/artefacts/1570/

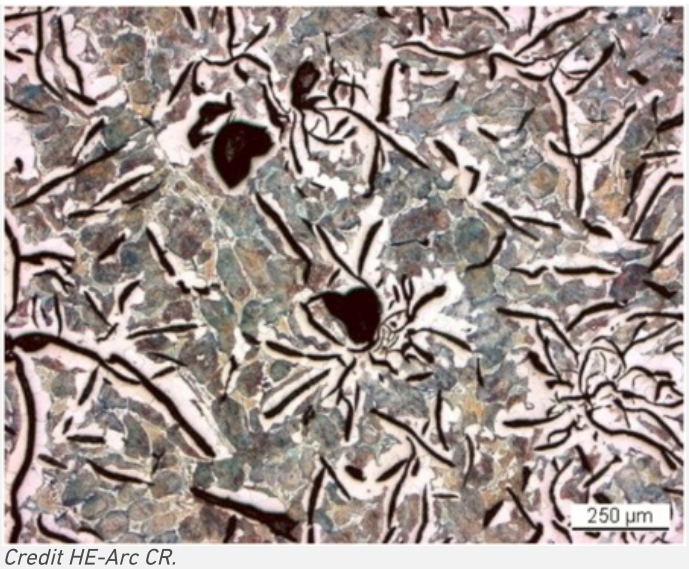
Fig. 5: SEM image from Fig. 3 (detail), BSE-mode, unetched. We observe the graphite flakes in black, the manganese sulphide inclusions in grey and the eutectic mixture in light-grey,
