FITTING ON BACK PANEL OF A MILITARY CARRIAGE – THOMAS STEEL – MODERN TIMES – SWITZERLAND

Artefact name	Fitting on back panel of a military carriage
Authors	Marianne. Senn (Empa, Dübendorf, Zurich, Switzerland) & Christian. Degrigny (HE-Arc CR, Neuchâtel, Neuchâtel, Switzerland)
Url	/artefacts/1573/

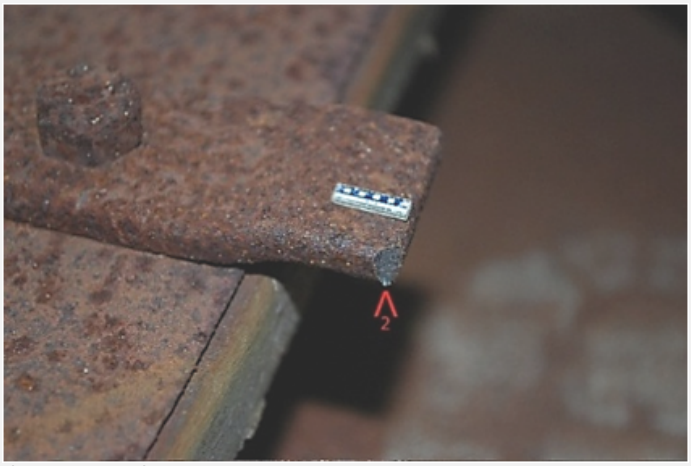
Fig. 1: Fitting on back panel of a military carriage,

Description of the artefact	Fitting on back panel, first exposed outdoors, later indoors (Fig. 1). Uniform corrosion and pitting corrosion are visible.
Type of artefact	Military carriage
Origin	Historical Swiss Army Material Foundation, Burgdorf, Bern, Switzerland
Recovering date	Built by Konstruktions-Werkstätte, 1918
Chronology category	Modern Times
chronology tpq	1918 A.D.
chronology taq	----
Chronology comment	
Burial conditions / environment	Outdoor to indoor atmosphere
Artefact location	Historical Swiss Army Material Foundation, Burgdorf, Bern
Owner	Historical Swiss Army Material Foundation, Burgdorf, Bern
Inv. number	None.
Recorded conservation data	N/A

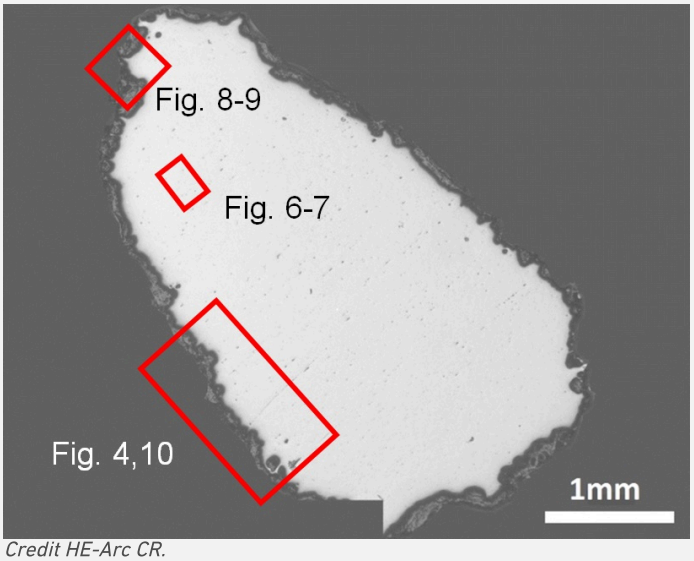
Fig. 2: Location of sampling area,

Description of sample	This sample is a cut from the corner of one of the two fittings on the back panel (Fig. 2). The metal is covered by a thin corrosion layer (Fig. 3).
Alloy	Thomas steel
Technology	Piled from several strips, hot rolled and annealed

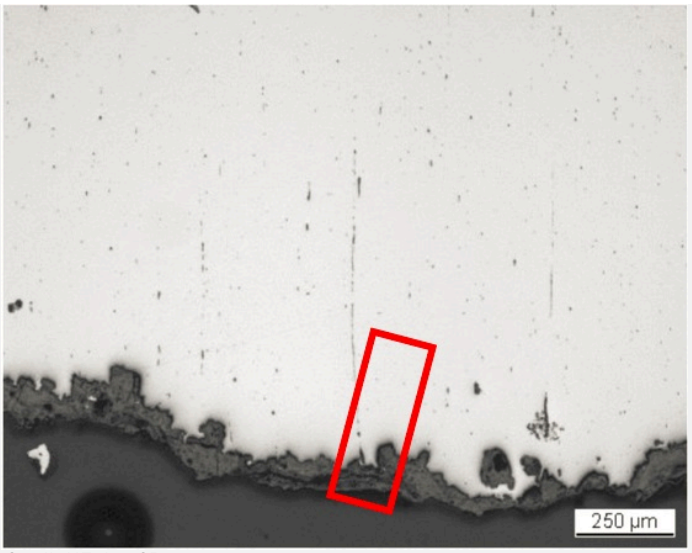
Fig. 3: Micrograph of the cross-section of the sample taken from the fitting showing the location of Figs. 4 and 6 to 10,

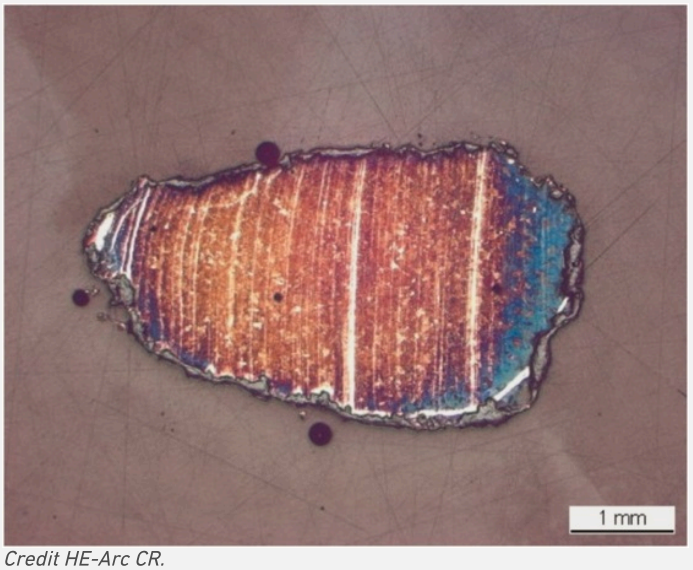
The remaining metal is a Mn-rich soft steel (C content around 0.1 mass%) containing manganese sulphide inclusions with a varying Fe content (Tables 1 and 2). The numerous inclusions form parallel rows (Fig. 4). This orientation is typical for hot rolled metal. After etching with Oberhoffer's reagent, three main welding seams (P-rich) become visible (Fig. 5). Near the surface they are also outlined by corrosion (Figs. 4 and 10). After nital etching, the metal shows a ferritic structure with tertiary cementite and lamellar pearlite at the grain boundaries (Figs. 6 and 7). The grains are small with an ASTM grain size of 10 and are recrystallized due to annealing after hot rolling. The average hardness of the metal is HV1 165. The hardness is slightly high for such a structure and this is due to the Mn content of the metal. The chemical composition, especially the Mn content and the presence of carbo-nitrides (not analysed here), is typical for Thomas steel.

Fig. 4: Micrograph of the metal sample from Fig. 3 (rotated by 270°, detail), unetched, bright field. We observe the metal including welding seams outlined by corrosion products and MnS inclusions. The area selected for elemental chemical distribution (Fig. 10) is marked by a red rectangle,

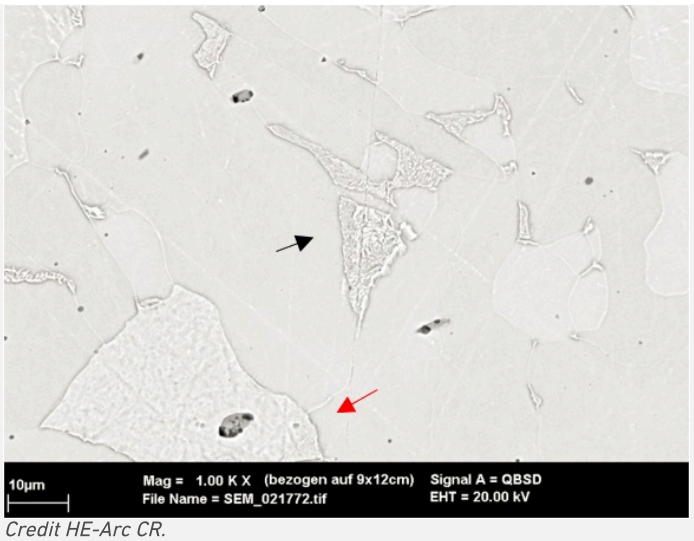
Fig. 6: Micrograph of the metal sample, nital etched, bright field. We observe tertiary cementite (black) on the grain boundaries,

Fig. 7: SEM image of the metal sample from Fig. 3 (detail), BSE-mode, nital etched, bright field. The white ferrite grains contain lamellar pearlite (black arrow) and lenticular grey MnS inclusions (red arrow) in between the grain boundaries,

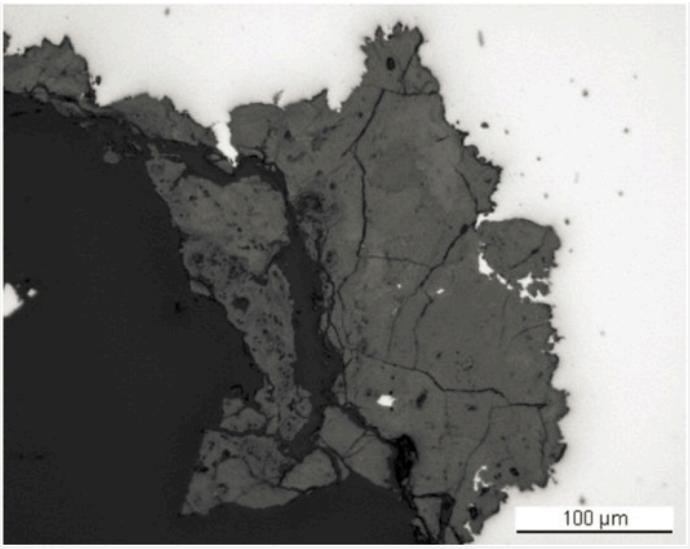
The average thickness of the corrosion products is about 80µm (Figs. 4 and 8). In bright field they appear grey, marbled and heavily cracked (Fig. 8). Under polarised light, the corrosion products appear orange to dark-brown (Fig. 9). At the metal - corrosion products interface they are dark-brown (CP3). The middle part (CP2) is dark-red and the outer part is bright orange (CP1). The elemental mapping of the corrosion layers shows no distinctive stratification, but areas near the metal - corrosion crust interface (CP3) as well as the top surface of the corrosion layer (CP1) seem to have a lower O content (Fig. 10). The O content indicates the presence of iron hydroxides (Table 3). Soil materials (such as rock fragments and dust) are found in the welding seams near the surface.

Fig. 8: Micrograph showing the metal - corrosion crust interface from Fig. 3 (rotated by 270°, detail), unetched, bright field. We observe in white the metal, in grey the corrosion products and in black the resin,

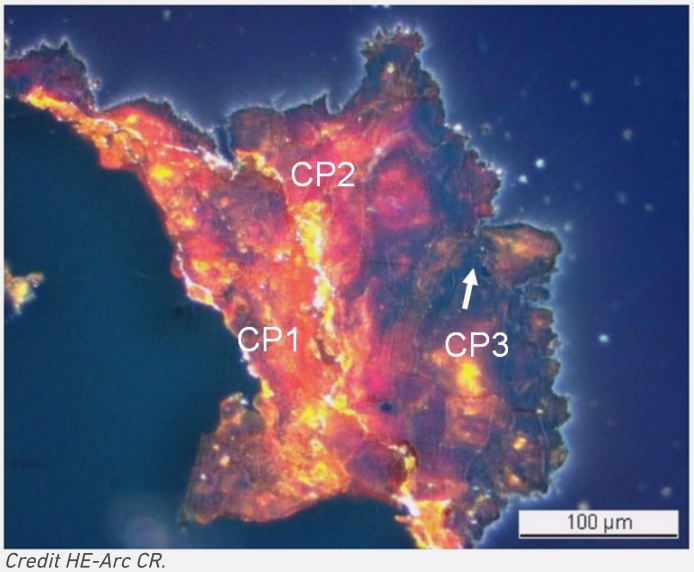
Fig. 9: Micrograph showing the metal - corrosion crust (same as Fig. 8) and corresponding to the stratigraphy of Fig. 11, unetched, polarised light. The corrosion products are dark-brown at the metal - corrosion crust interface and red-orange on the outside,

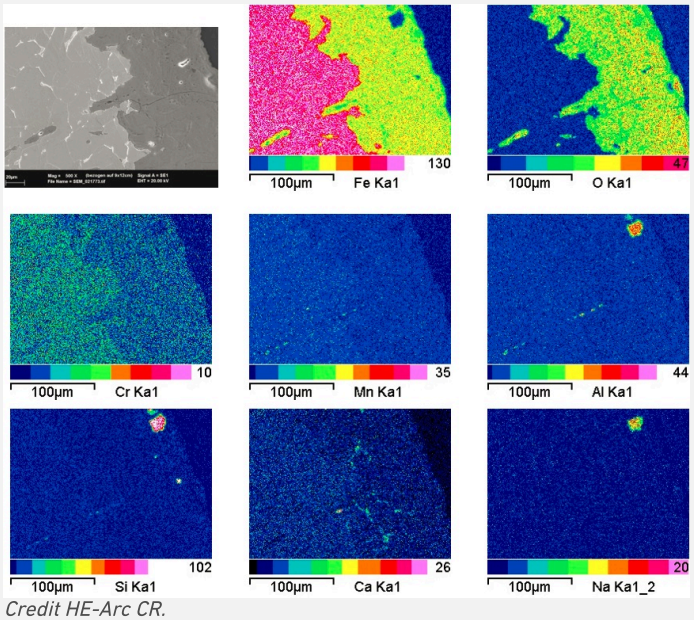
Table 3: Chemical composition (mass %, <: below the detection limit) of the corrosion layer (from Fig. 10). Method of analysis: SEM/EDS, Laboratory of Analytical Chemistry, Empa.

Fig. 10: SEM image, BSE-mode, and elemental chemical distribution of the selected area from Fig. 4 (rotated by 270°, detail). Method of examination: SEM/EDS, Laboratory of Analytical Chemistry, Empa.

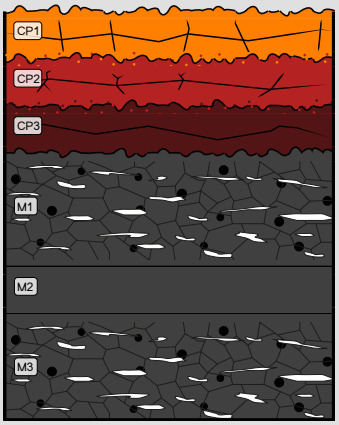
Fig. 11: Stratigraphic representation of the sample taken from the fitting in cross-section (dark field) using the MiCorr application. The characteristics of the strata are only accessible by clicking on the drawing that redirects you to the search tool by stratigraphy representation. This representation showing for the metal part a welding seam (M2) can be compared to Fig. 9, Credit HE-Arc CR.
