CURVED PIN OR TANG FK 2670.20 - TIN BRONZE - LATE BRONZE AGE - SWITZERLAND

Artefact name Curved pin or tang FK 2670.20

Authors Marianne. Senn (Empa, Dübendorf, Zurich, Switzerland) & Christian. Degrigny (HE-Arc CR, Neuchâtel, Neuchâtel, Switzerland)

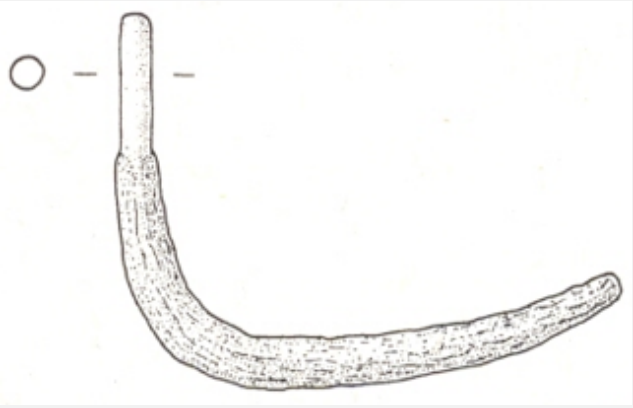
Fig. 1: Curved pin or tang (after Fischer 1997, plate 43),

Description of the artefact Curved pin or tang (Fig. 1). The metal is covered with black corrosion products attributed to a burning process mixed with green corrosion products. Dimensions: L = 114mm; Ø = 4.6mm; WT = 16.7g.

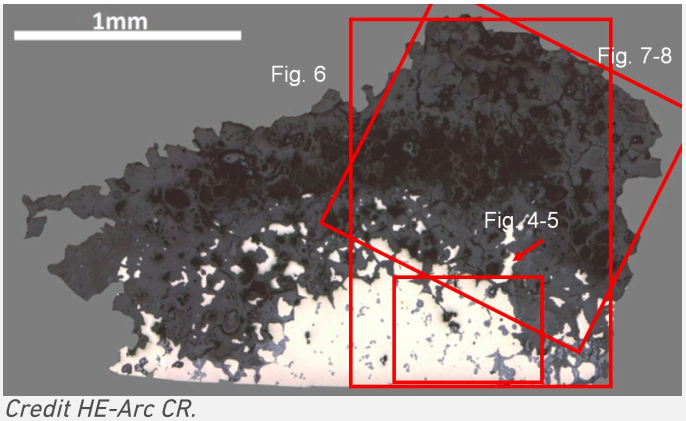
Fig. 3: Micrograph of the cross-section of the sample taken from the curved pin or tang showing the location of Figs. 4 to 8,

Description of sample	Several samples were taken. Only one is presented here (Fig. 2). The sample (Fig. 3) is a section from the pin (or tang). The metal is covered by a thick corrosion crust (blue layer adhering to the metal, topped by a green layer mixed with black corrosion products - Museum report (1992)). Dimensions: L = 1.8mm; W = 1.2mm.
Alloy	Tin Bronze
Technology	Secondary recrystallization (produced by burning)
Lab number of sample	MAH 92-5-4-002
Sample location	Musées d'art et d'histoire, Genève, Geneva
Responsible institution	Musées d'art et d'histoire, Genève, Geneva
Date and aim of sampling	1992, examination of metallography examination

The corrosion crust has an average thickness of 500µm but can in areas be much thicker (Fig. 3). It is divided in two layers. The inner layer is itself divided in two sub-layers: a thin light-grey sub-layer at the interface with the remaining metal surface (CP4, in bright field) which appears red-orange in polarised light (Fig. 6) topped by a medium-grey sub-layer (in bright field) that contains remnant metal (CP3). It turns dark-blue in polarised light (Fig. 6). The outer corrosion layer can also be divided into two sub-layers: a porous sub-layer (CP2) followed by a dark-grey sub-layer in which crystals are outlined by cracks (CP1, in bright field). Under polarized light, the latter turns blue-green while on top it appears olive and brown (Fig. 6). Chemically the corrosion crust is Sn enriched and Cu-depleted (Table 3, Figs. 7 and 8). The maximum of the Sn enrichment occurs on the outer olive and brown sub-layer (CP1). The corrosion layer also contains P, Si, C and O. Inclusions containing Fe or Ag can be found in the corrosion crust (Figs. 7 and 8).

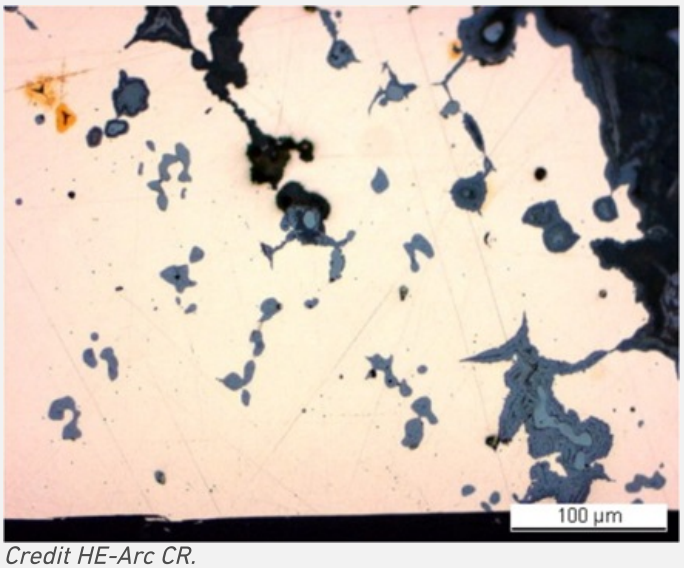
The remaining metal is a tin bronze (Table 1) with copper sulphide inclusions that contain some Fe (Figs. 4 and 5, Table 2). After etching, the tin bronze shows polygonal grains with few twins (Fig. 5). The grain size varies between 70 and 180µm indicating grain growth due to an extended or excessively hot annealing process. The copper sulphide inclusions appear in blue. The average hardness of the metal is HV1 70.

Fig. 4: Micrograph of the metal sample from Fig. 3 (detail), unetched, bright field. In pink the metal, in light-blue the copper sulphide inclusions and in dark- blue corrosion products,

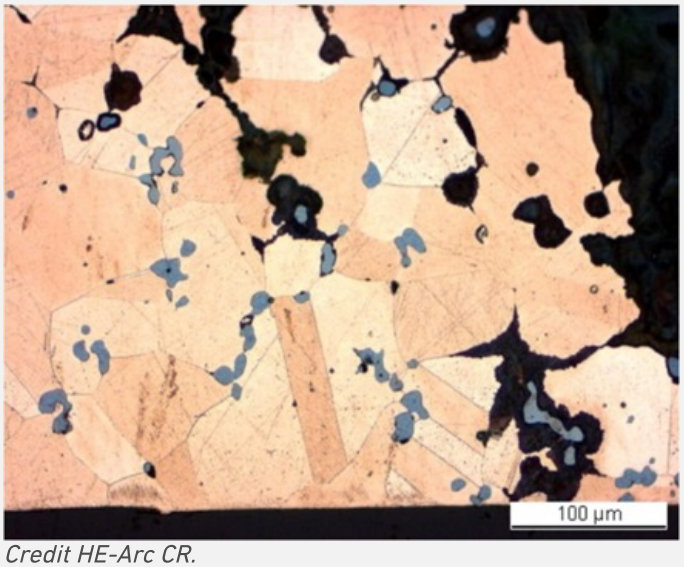
Fig. 5: Micrograph of the metal sample from Fig. 3 (same as Fig. 4), etched, bright field. In pink the metal with few twins, in black the resin and the corrosion products, in light-blue the copper sulphide inclusions,

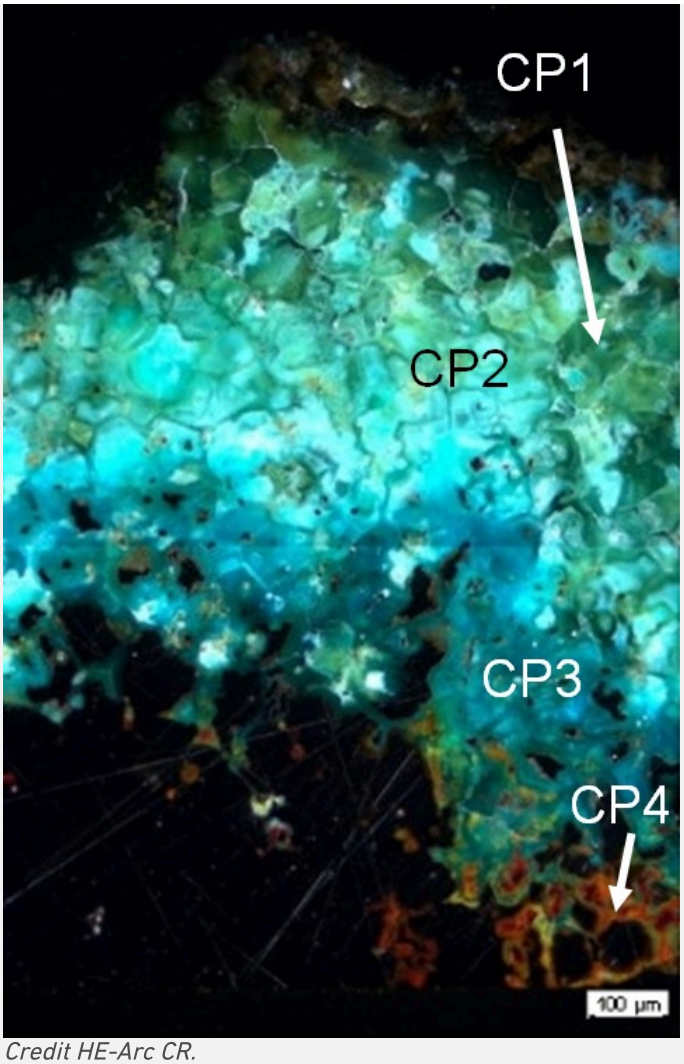
Table 3: Chemical composition (mass %, <: below the detection limit) of the corrosion crust from Fig. 6. Method of analysis: SEM/EDS, Laboratory of Analytical Chemistry, Empa.

Fig. 6: Micrograph of the metal sample from Fig. 3 (detail) and corresponding to the MiCorr stratigraphy of Fig. 9, unetched, polarised light. At the metal - corrosion products interface the colour of the corrosion layer is dark-blue, changing to green-blue in the outer part. The top surface of the corrosion crust is olive to brown,

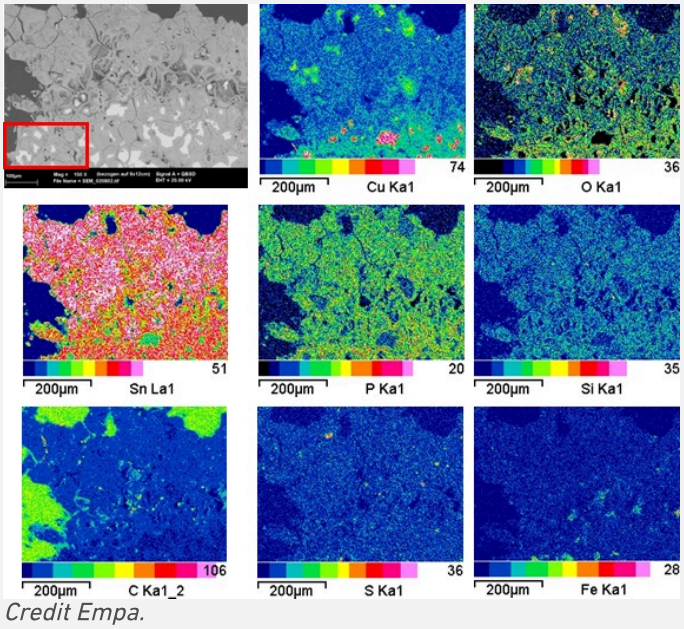
Fig. 7: SEM image, BSE-mode, and elemental chemical distribution of the selected area from Fig. 3 (due to repolishing before SEM/EDX investigation, the SEM image is slightly different from the area indicated in Fig. 3). The rectangle in the SEM image marks the detail mapping of Fig 8. Method of examination: SEM/EDS, Laboratory of Analytical Chemistry, Empa,

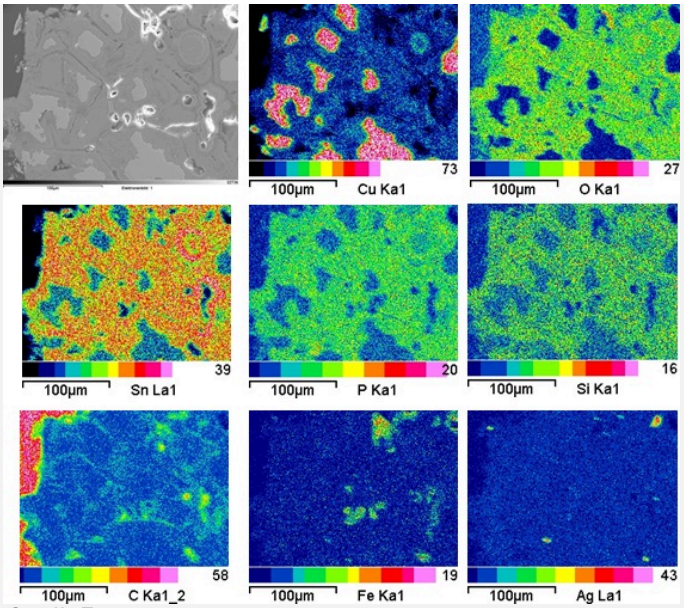
Fig. 8: SEM image, SE-mode, and elemental chemical distribution of the selected area from Fig. 7. Method of examination: SEM/EDS, Laboratory of Analytical Chemistry, Empa,

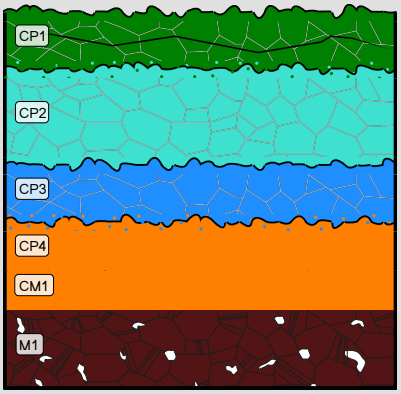
Fig. 9: Stratigraphic representation of the sample taken from the curved pin or tang in cross-section (dark field) using the MiCorr application. The characteristics of the strata are only accessible by clicking on the drawing that redirects you to the search tool by stratigraphy representation. This representation can be compared to Fig. 6, Credit HE-Arc CR.

The tin bronze was exposed to an extended or excessively hot annealing process. This, combined with the extreme thickness of the corrosion crust and the dark surface, confirms that the object originates from a fire burial context. At the metal - corrosion crust interface some copper oxide (cuprite?) occurs. On top copper carbonates (azurite or malachite?) are mixed with tin oxide (cassiterite/SnO2?). Tin oxide dominates in the brown-black extremely Sn-rich outer layer. The P-enrichment in the whole corrosion layer may be due to an environment rich in organic material (for example bones). The original surface of the metal has been destroyed, presenting a type 2 corrosion layer after Robbiola et al. 1998.
