ARMATURE FROM A CLOCK MOVEMENT MIH IV-212 - ZN AL SN CU ALLOY - MODERN TIMES - SWITZERLAND

Artefact name Armature from a clock movement MIH IV-212

Authors Marianne. Senn (Empa, Dübendorf, Zurich, Switzerland) & Christian. Degrigny (HE-Arc CR, Neuchâtel, Neuchâtel, Switzerland)

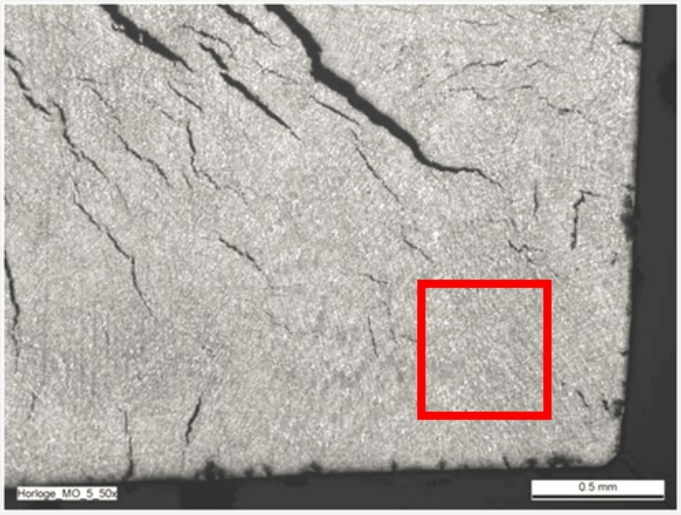
The metal is a Zn-Al-Sn-Cu alloy (Table 1) with an average hardness of HV1 105. A fine dendritic structure is observed (Fig. 4) which consists of clearly separated Zn, Al-Cu and Sn-rich phases (Figs. 5 and 6). Pb is associated with Sn but also forms tiny nodules.

Table 1: Chemical composition (mass %) of the metal (oxygen not shown). Method of analysis: SEM/EDS, Lab of Electronic Microscopy and microanalysis, IMA (Néode), HEI Arc.
