COFFEE FILTER - AL ALLOY - MODERN TIMES - FRANCE

Artefact name	Coffee filter
Authors	Christian. Degrigny (HE-Arc CR, Neuchâtel, Neuchâtel, Switzerland)
Url	/artefacts/1586/

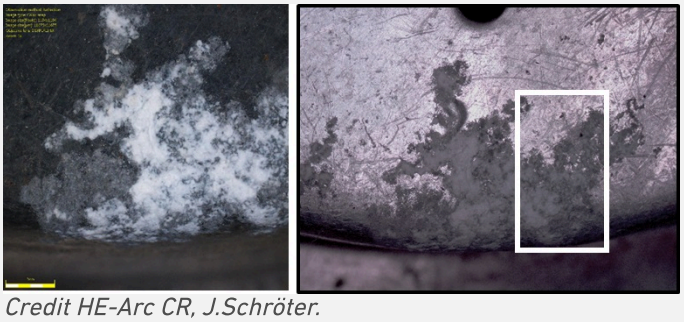
Description of the artefact	Coffee filter with traces of use (deposits, deformation) and presence of local filiform corrosion (Fig. 1). Dimensions: ø.ext. = 10cm.
Type of artefact	Household implement
Origin	Château de Germolles, Mellecey, Bourgogne, France
Recovering date	Unknown
Chronology category	Modern Times
chronology tpq	1960 A.D.
chronology taq	2000 A.D.
Chronology comment	20th century
Burial conditions / environment	Outdoor atmosphere
Artefact location	Château de Germolles, Mellecey, Bourgogne

Fig. 2: Detail of the front (left) and back (right) sides of the coffee filter showing the location of Fig. 3,

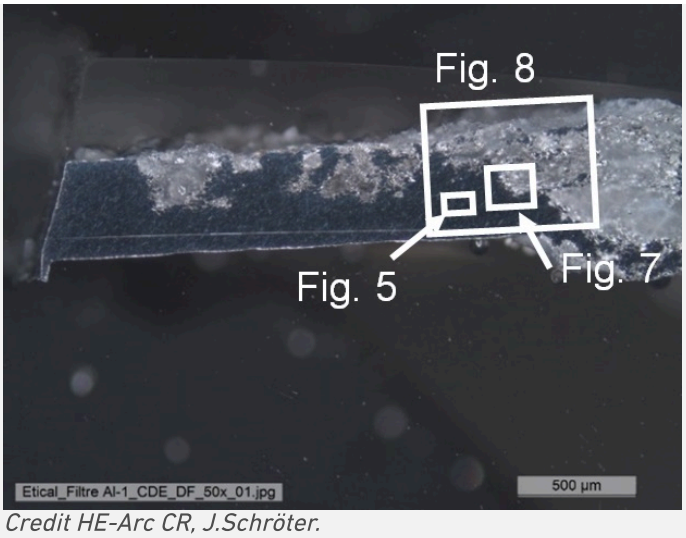
Fig. 3: Detail of the back side of the coffee filter showing the location of the sampling area (white rectangle),

Fig. 4: Micrograph of the cross-section of the fragment sampled from the coffee filter showing the location of Figs. 5, 7 and 8, dark field,

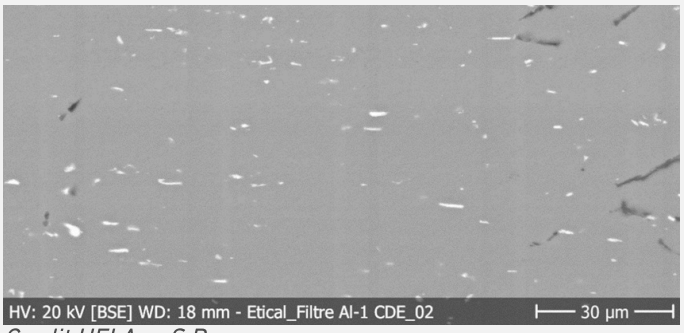
Analyses performed:
Metallography, SEM/EDS.

The metal is a relatively pure aluminium alloy with numerous elongated inclusions (Fig. 5). From their chemical composition they can be interpreted as Al3Fe intermetallic compounds (Fig. 6). Inter- and transgranular corrosion has developed so extensively that some grains (not elongated) are outlined (Fig. 7).

The average thickness of the corrosion layer (CP1) is about 50 micrometers, but may be thinner or thicker depending on the area. Intergranular corrosion developed locally to extend through the entire thickness of the metal. EDS-SEM analysis indicates that the metal is, as expected, covered by a layer rich in Al and O containing chlorides (red spots on Fig. 8) and surprisingly Na (white rectangle on Fig. 8, Figs. 9 and 10). Chlorides do not seem to form active corrosion. A new examination carried out after 4 months (Fig. 11) shows new forms of alteration with a local enrichment of Na, C and O (Na2CO3?).

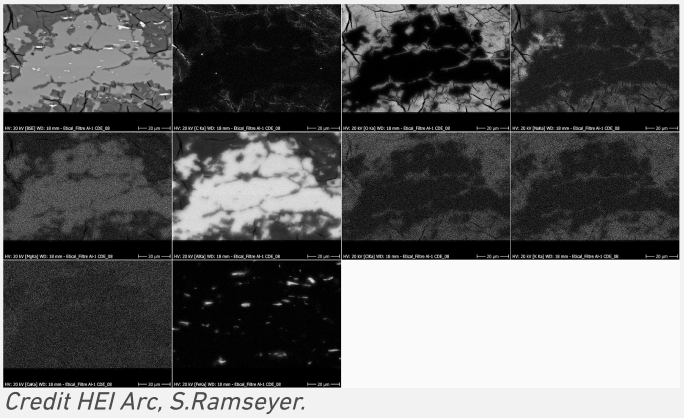
Fig. 10: SEM image, BSE-mode, and elemental chemical distribution of the selected area of Fig. 8. Method of examination: SEM-EDS, Lab of Electronic Microscopy and Microanalysis, IMA (Néode), HEI Arc,

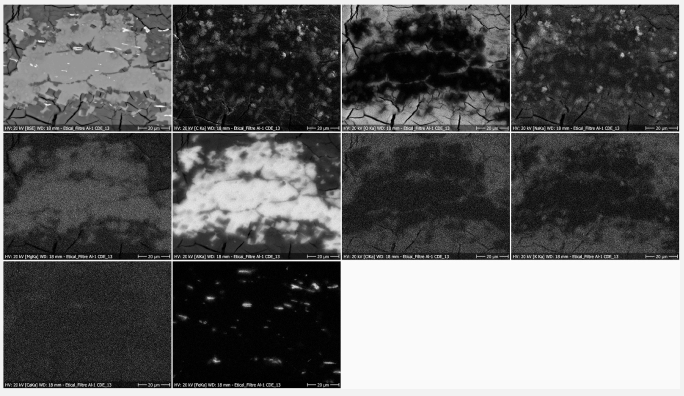
Fig. 11: SEM image,BSE-mode, and elemental chemical distribution of the selected area of Fig. 8 reexaminated after 4 months: new forms of alteration with a local enrichment of Na, C and O are observed,
