LADLE WITH COCKEREL IIB 4016 - LEADED BRONZE - LATE BRONZE AGE - THAILAND

Artefact name Ladle with cockerel IIb 4016

Authors Claire. Foessel (HE-Arc CR, Neuchâtel, Neuchâtel, Switzerland)

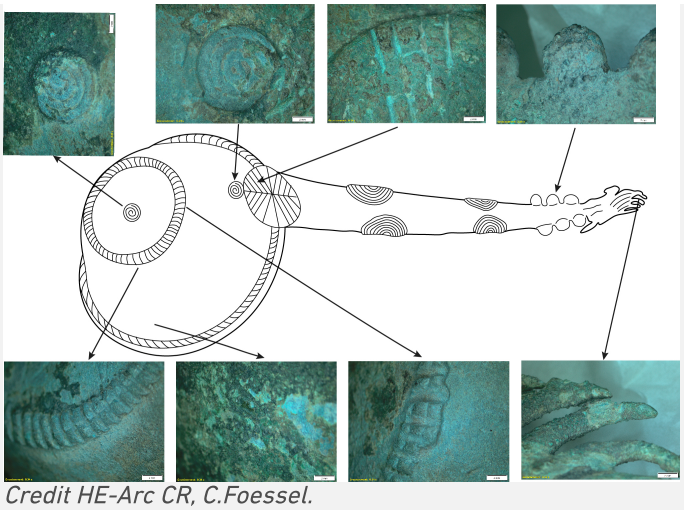
Fig. 1: Ladle, front view, before conservation interventions,

Fig. 2: Ladle, rear view, before conservation interventions,

Description of the artefact	Ladle with long, slightly curved handle topped with a rooster and ending in a round bowl. It is covered with green corrosion products mixed with sediment (Figs. 1 and 2). The handle features decorative ornamentation and has two breaks (Figs. 4 and 5). Dimensions: Length = 30cm, bowl diameter = 10.6cm.
Type of artefact	Ladle

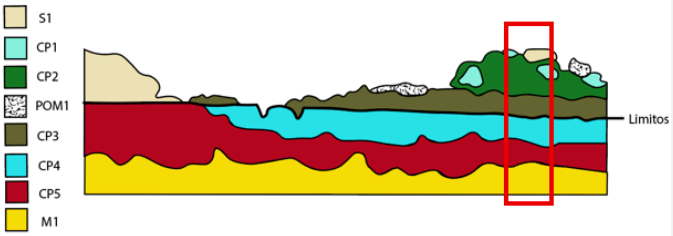
The schematic diagram below provides an overview of the corrosion layers observed on the ladle following an initial examination under a binocular microscope.

Layer	Reasons	Color	Description
S1		Yellow ochre, orange	Powdery yellow sediment
CP1		Turquoise Blue	Turquoise powdery corrosion pustule
CP2		Dark green	Hard spongy corrosion
POM 1 (Fig.10)		-	Vegetable fibers, mineralized rice grains
CP3		Green, Brown/Olive Green	Copper corrosion with a mat and quite powdery appearance
CP4		Light Green / Turquoise	Dense copper corrosion
CP5		Brown / Red	Matte, dense
M1		?	The metal is not visible (yellow -> bronze)

Fig. 9: Stratigraphic representation of the corrosion structure of the laddle by macroscopic and binocular observation with reference to Fig. 10, The red rectangle represents the MiCorr stratigraphy (Fig. 11),

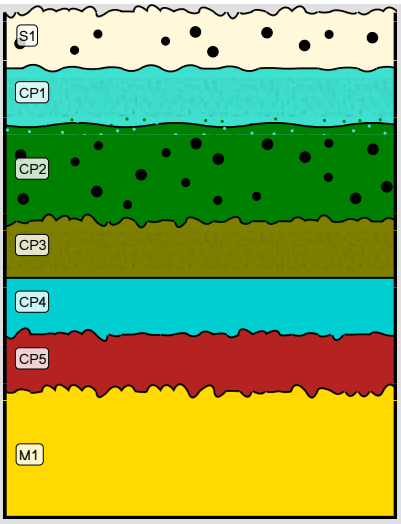
Fig. 11: Stratigraphic representation of the corrosion structure of the ladle, as observed under a binocular microscope (Fig. 9, the red rectangle) using the MiCorr application. The characteristics of the layers can only be accessed by clicking on the image, which redirects you to the stratigraphic search tool. Credit HE-Arc CR, C.Foessel.

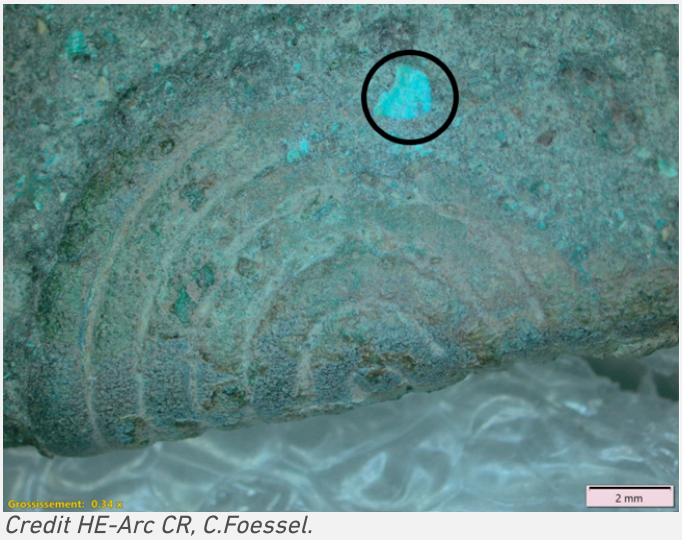
Fig.12: Sample 1 - turquoise powdery corrosion (CP1),

Description of sample	Only one sample (Sample 1) was taken. It corresponds to the powdery turquoise-blue corrosion product found on the handle of the ladle, near a semicircular decoration.
Alloy	Leaded Bronze
Technology	casting and cold working
Lab number of sample	1
Sample location	None
Responsible institution	None
Date and aim of sampling	18.03.2026, chemical analysis

The turquoise-blue sample (Fig. 12) was analyzed using SEM-EDS, which identified the following significant elements: copper, tin, magnesium, and phosphorus (Fig. 16).

Raman spectroscopy performed on this sample revealed the presence of copper hydroxide phosphate, identified as libethene ($Cu_2(OH)(PO_4)$) (Fig. 17). The presence of phosphates on buried metals often indicates the proximity of a burial site, as the decomposition of bones releases phosphorus. This marker, which is also associated with cremation sites and arid climates, supports the hypothesis that the ladle is a funerary object. Similar results were obtained for bracelet IIb 4025.01.

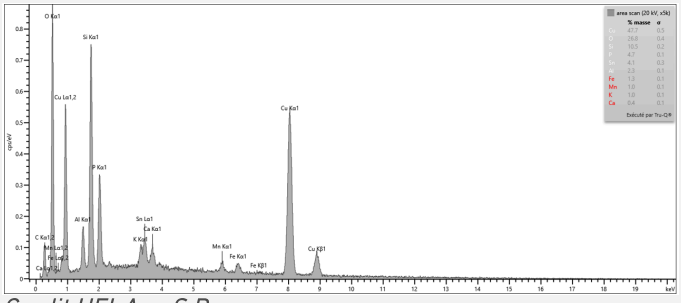
Fig. 16: EDS spectrum of sample 1,

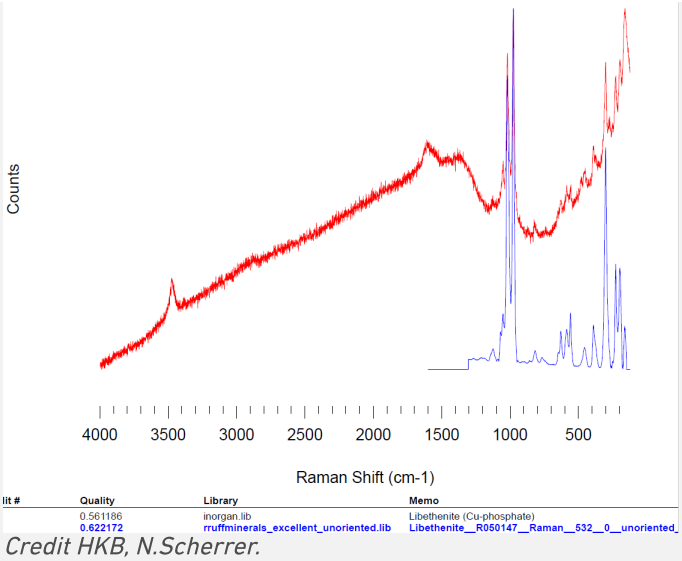
Fig. 17: Raman spectrum of sample 1 showing the presence of libethenite $Cu_2(OH)(PO_4)$,

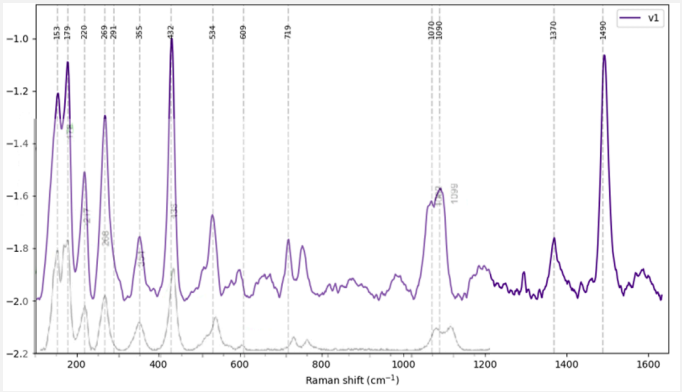
Malachite was also identified on the medallion of the ladle (Fig.18) using Raman spectroscopy.

Fig. 18: Raman spectrum of the corrosion layer covering the medallions of the ladle. Spectrum in grey is standard malachite $Cu_2CO_3(OH)_2$,

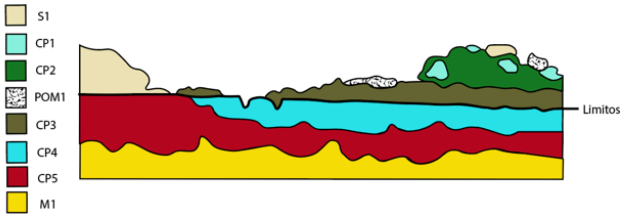
All information concerning corrosion products is shown in the final stratigraphic profile (Fig. 19).

The boundary of the original surface (limitos) lies at the interface between the CP4/CP5 layers and the CP3 layer. However, the pseudomorphs of organic matter (POM) have been preserved. In particular, impressions of rice grains were identifiable.

Fig. 19: Final stratigraphic representation of ladle,

Layer	Reasons	Color	Markers	Description
S1		Yellow ochre, orange	Superior : Earth sediments and sand grains	Powdery yellow sediment
CP1		Turquoise Blue		Turquoise powdery corrosion pustule identified by the Raman as libethenite $Cu_2(PO_4)(OH)$, copper hydroxide phosphate
CP2		Dark green		Hard spongy corrosion (Malachite, $Cu_2CO_3(OH)_2$?)
POM 1 (Fig.10)		-	Superior : Mineralized Organic Products	Vegetable fibers, mineralized rice grains
CP3		Green, Brown/Olive Green	Superior : corrosion	Copper corrosion with a matt and quite powdery appearance (Malachite, $Cu_2CO_3(OH)_2$?)
CP4		Light Green / Turquoise	Corresponding : Smooth surface and incised decorations	Dense copper corrosion identified by Raman as Malachite, $Cu_2CO_3(OH)_2$
CP5		Brown / Red	Matching: Surface Smooth	Matte, dense (cuprite Cu2O ?)
M1		?	Lower	The metal is not visible but was hit during the clearing
