SWORD GRIP NG-1980-27-H-693 - LEADED BRASS - 18TH CENTURY - UNITED KINGDOM

Artefact name Sword grip NG-1980-27-H-693

Authors Amelia. Hammond (The Mariners' Museum and Park, Newport News, Virginia, United States)

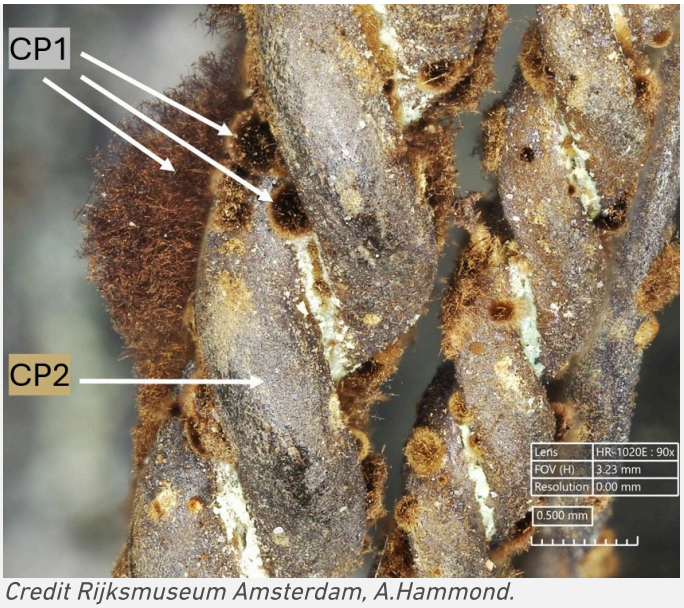
Fig. 2: Macro image of small brown fuzzies, some of which are indicated by arrows,

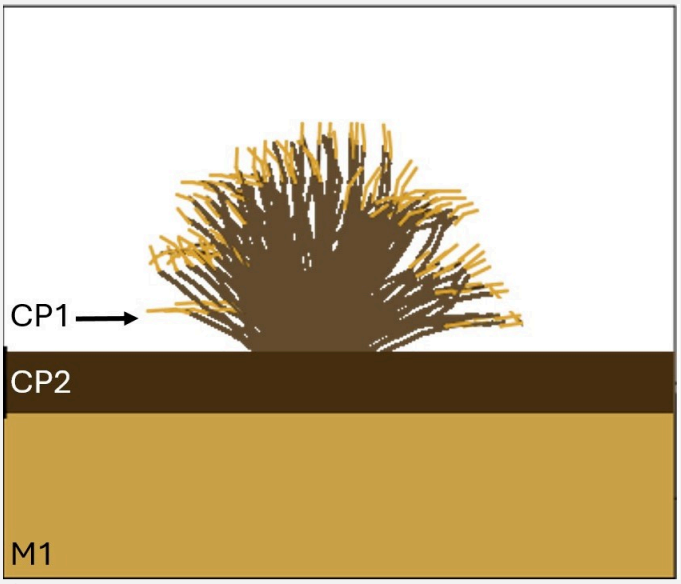
Fig. 4: Stratigraphic representation of brown fuzzies on copper-based wire by macroscopic and binocular observation,

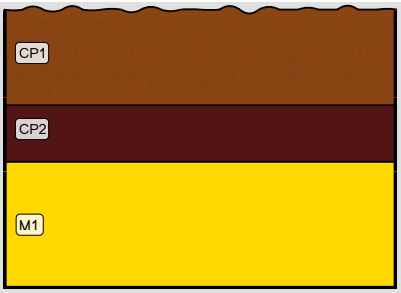
Fig. 5: Stratigraphic representation of the corrosion structure of brown fuzzies observed macroscopically under binocular microscope using the MiCorr application. The characteristics of the strata are only accessible by clicking on the drawing that redirects you to the search tool by stratigraphy representation. This representation can be compared to the stratigraphy in Fig. 4, credit Rijksmuseum Amsterdam, A.Hammond.

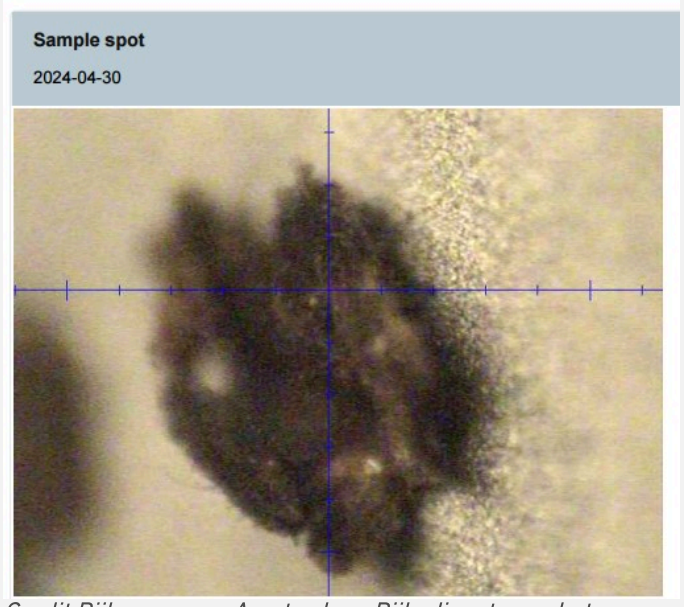
Fig. 6: Spot corrosion (brown fuzzies) was sampled from for SEM-EDX analysis,

Description of sample	Sample of figs. 6 and 7 was collected from the surface of one of the twisted wires, in an area of thick corrosion, using a sterile scalpel blade. It was scraped from the surface of the object directly into a diveted slide, and was covered with a flat slide while being transported for X-ray diffraction.
Alloy	Leaded Brass
Technology	Cast and rolled
Lab number of sample	2024-04-30 (XRD)

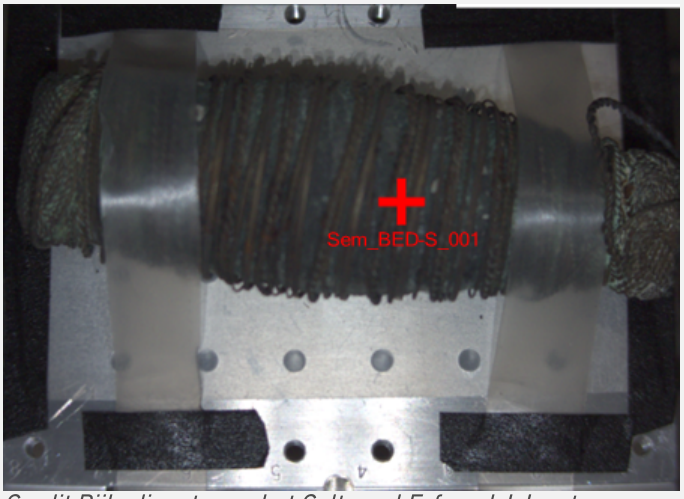
SEM-EDX observation and analysis of the brown fuzzies (Figs. 7 to 9) indicated major peaks of copper and sulfur with lower peaks of oxygen and carbon. XRD diffractograms of brown fuzzies (Fig. 7) matched with copper iron sulfide Bornite, iron oxide Hematite and copper sulfides Covellite CuS and Haycockite $CuFe_5S_8$, the latter might be the most probable due to the absence of iron in EDX analysis (Fig. 10).

Fig. 7: Image indicating spot analyzed in SEM-EDX analysis,

Corrosion form	Bushes, branches, or cauliflours
Corrosion type	Copper sulfide corrosion

This object is afflicted by corrosion known by a few names such as black spots, brown fuzzies, and copper (iron) sulfides, this process is known to cause pitting in copper alloys (Eggert 2023[4]). First published on in 1977 by Brinch-Masden, this process has been studied since, and has been described both as "high in sulphur and unpleasant to look at" and as an “enemy of copper” causing pitting corrosion on metallic substrates (Eggert 2023[4]).

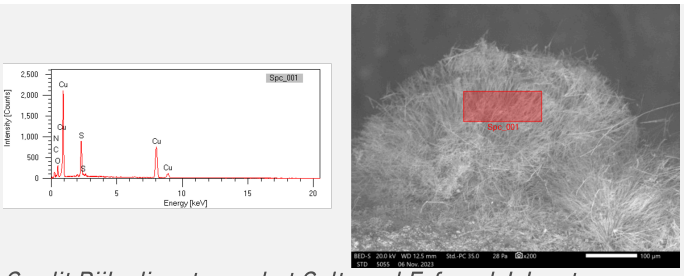
Fig. 9: SEM image of brown fuzzies and corresponding EDX readout,

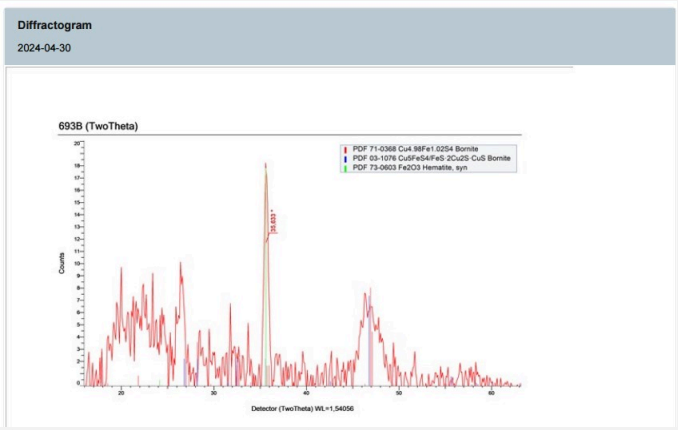
Fig.10: XRD diffractogram of the brown fuzzies,
