BUCKLE YAJ.96.B20.D1.28.BUCKLE-A - CU ZN SN PB - BYZANTINE

Artefact name Buckle Yaj.96.B20.D1.28.buckle-a

Authors Ahmad. Abu-Baker (Yarmouk University, None)

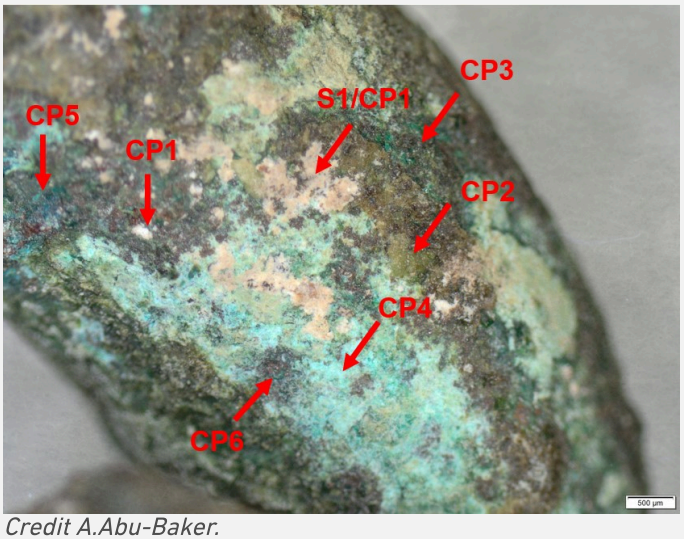
Fig. 1: General view of the front face of buckle-a,

Description of the artefact A complete metallic garment buckle consisting of a frame, a bar and a prong. The buckle's surface is hetereogeously corroded and has green, blue-green, and red-brown corrosion products, with the presence of light yellow soil sediments (Fig. 1).

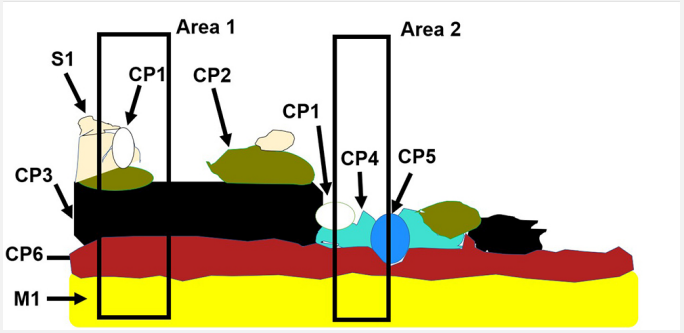
Fig. 3: Binocular observation of the surface deposit and corrosion products of buckle-a,

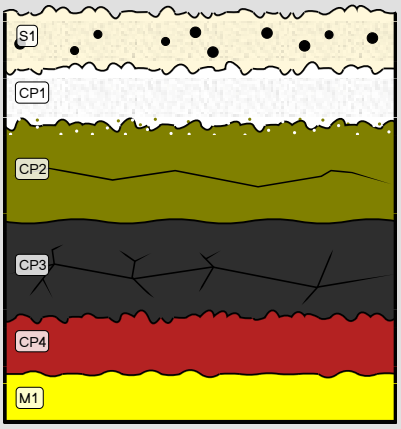
Fig. 5: Stratigraphic representation of the corrosion structure of buckle-a observed macroscopically under binocular microscope using the MiCorr application. The characteristics of the strata are only accessible by clicking on the drawing that redirects you to the search tool by stratigraphy representation. This representation can be compared to Fig. 4 considering that CP4 in Fig. 5 is CP6 in Fig. 4, credit A.Abu-Baker.

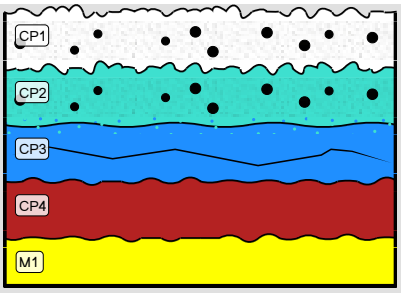
Fig. 6: Stratigraphic representation of the corrosion structure of buckle-a observed macroscopically under binocular microscope using the MiCorr application. The characteristics of the strata are only accessible by clicking on the drawing that redirects you to the search tool by stratigraphy representation. This representation can be compared to Fig. 4 considering that CP2, CP3 and CP4 in Fig. 6 are CP4, CP5 and CP6 respectively in Fig. 4, credit A.Abu-Baker.

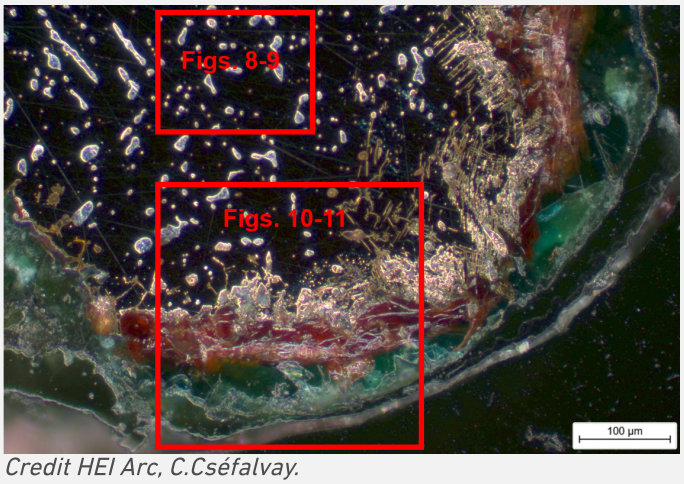
Fig. 7: Micrograph of the cross-section of the sample from Fig. 2 in dark field showing the locations of Figs. 8-9, 10-11,

Description of sample	A cross-section taken from the back-end of the prong of the buckle.
Alloy	Cu Zn Sn Pb
Technology	Cast
Lab number of sample	
Sample location	The Archaeological Museum at the University of Jordan, Amman, Amman
Responsible institution	The Archaeological Museum at the University of Jordan, Amman, Amman
Date and aim of sampling	May 2023. Sampling aimed to study the composition, corrosion, and microstructural properties of the artefact.

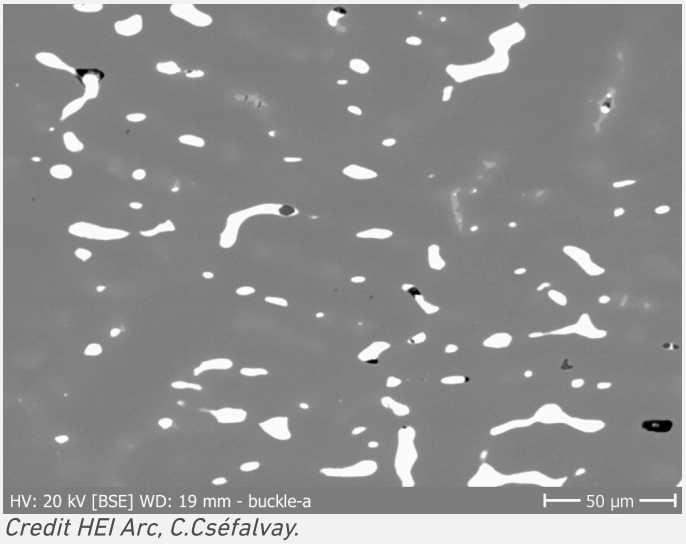
The OM examination of the etched cross-sections of buckle-a revealed an as-cast dendritic microstructure (Fig. 9). The presence of cored dendrites and strain lines suggests that the artifact was cold-worked without annealing (Scott 1991: 7–8; Scott & Schwab 2019: 154). SEM micrograph (Fig. 8) shows the presence of air porosity and lead globules (in white).

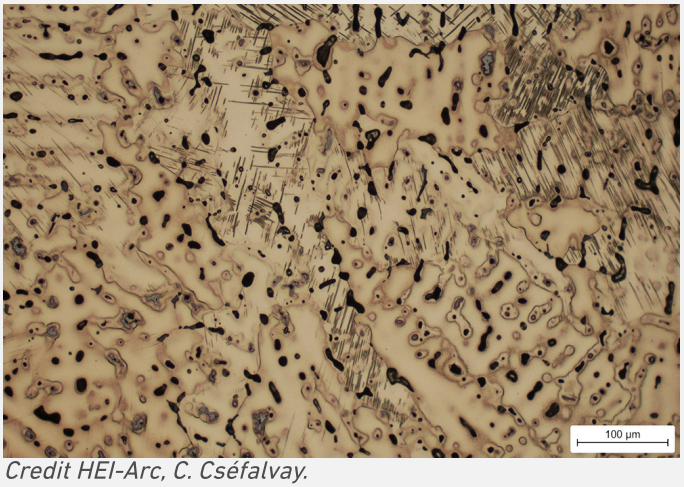
Fig. 8: SEM image of the internal alloy of buckle-a. The dendritic structure appears in the background, while lead inclusions are in white,

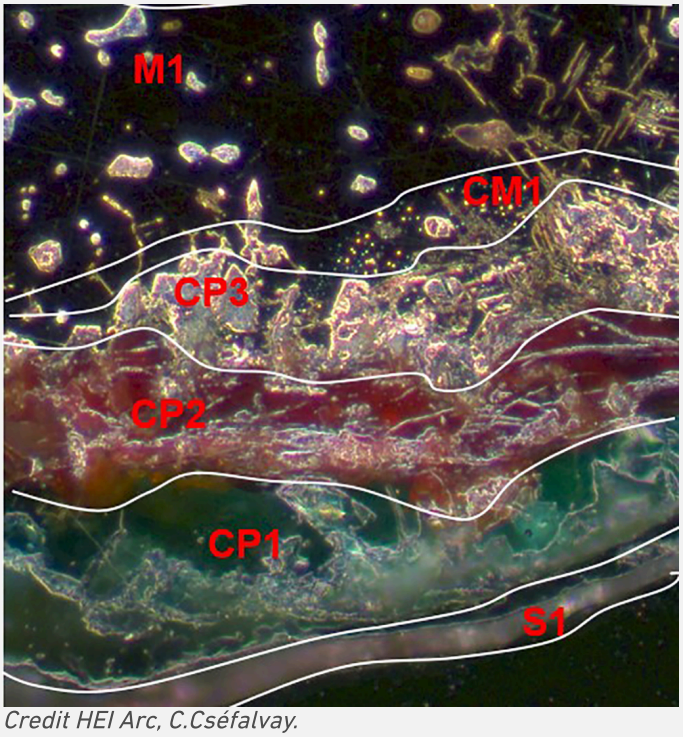
Fig. 9: OM image of the etched cross-section of buckle-a,

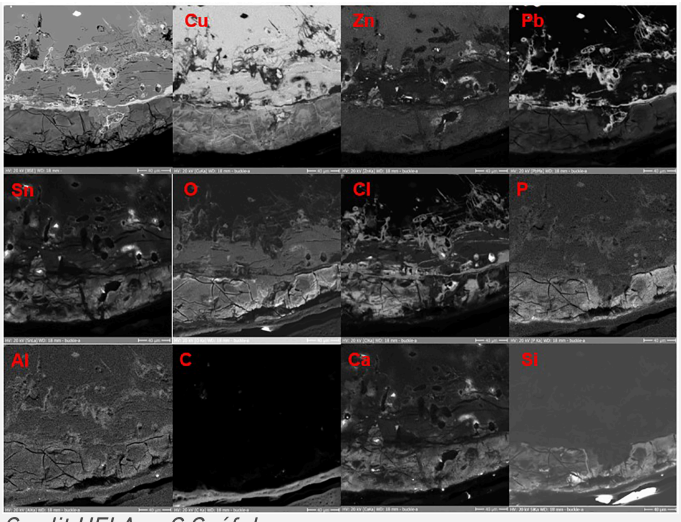
The dark-field OM examination (Fig. 10) and EDS elemental mapping (Fig. 11) of the unetched cross-section of buckle-a showed depletion of zinc from areas in the corroded metal layer (CM1), i.e., CM1 is enriched with Pb and Cl while zinc is missing, indicating selective leaching of zinc from the alloy and the occurrence of dezincification. The external corrosion layer (CP1) showed the presence of Cu, Zn, Pb, C, O, P, and Cl, which could be attributed to the presence of corrosion products of copper, zinc, and lead (carbonates (malachite ($CuCO_3.Cu(OH)_2$) and smithsonite ($ZnCO_3$)), chlorides (atacamite (α-$Cu_2(OH)_3Cl$) and paratacamite (γ-$Cu_2(OH)_3Cl$) and phosphates (cornetite ($Cu_3(PO_4)(OH)_3$)) as indicated by the XRD analysis (Fig. 12). The Si, Al, and Ca in the soil (S1) and CP1 layers are the elements of soil deposits, i.e. aluminosilicate and calcite deposits. The second corrosion layer (CP2) layer showed mainly the presence of Cu and O, which could indicate a cuprous oxide corrosion layer (Cu_2O as indicated by XRD - Fig. 12). It should be noted that the presence of P and Ca in the CP1 layer could also indicate the effect of phosphate species released by the hydrolysis of hydroxyapatite ($Ca_5(PO_4)_3OH$) from the skeletal materials in the neighboring bodies buried in the cemetery where the buckles were excavated, which induced the formation of copper phosphate minerals (cornetite) (Fan et al. 2020; Abu-Baker and Khalil 2022; Abu-Baker 2023b). It seems that the formation of insoluble phosphate corrosion products on the surface of the artifact improved its stability, reduced the risk of activating the chloride-based corrosion, and suppressed the continuation of dezincification from the internal alloy in the uncontrolled environment of the storage area. The original surface has been preserved and corresponds to the interface between CP1 and CP2, i.e., at the top of the cuprite layer (Bertholon 2001). The white spots appearing in the internal sound metal (M1) of buckle-a are the lead globules. The high concentration of Pb below CP1 and below CP2 in buckle-a as observed in the elemental mapping image is probably attributed to the diffusion of Pb towards the exterior of the object during burial and corrosion processes and the manufacturing technique in which the artifact was cast in a mold where it was allowed to slowly cool, and due to gravity segregation, Pb pooled at the bottom of the mold and solidified in the external part of the alloy. In addition, leaching of the soluble zinc corrosion products from the CM1 zone made it enriched with lead or lead chlorides (Scott 2011; Abu-Baker and Khalil 2022; Abu-Baker 2023a; Abu-Baker 2023b). The presence of atacamite/paratacamite and the absence of nantokite (CuCl) in the XRD results suggest that the initially formed nantokite in the burial soil underwent oxidative hydrolysis, which induced the formation of atacamite/paratacamite under the uncontrolled storage conditions. The artifact has either been stabilized by this reaction or is in a metastable state if nantokite is present deeper in the alloy such that it was not collected in the samples obtained for XRD analysis (Scott 1990). The diffused zinc from the alloy reacted with the corrosive burial soil and after a prolonged exposure formed zincite and smithsonite.

Fig. 11: SEM image, BSE-mode, and elemental chemical distribution of the selected area (Fig. 10, detail),

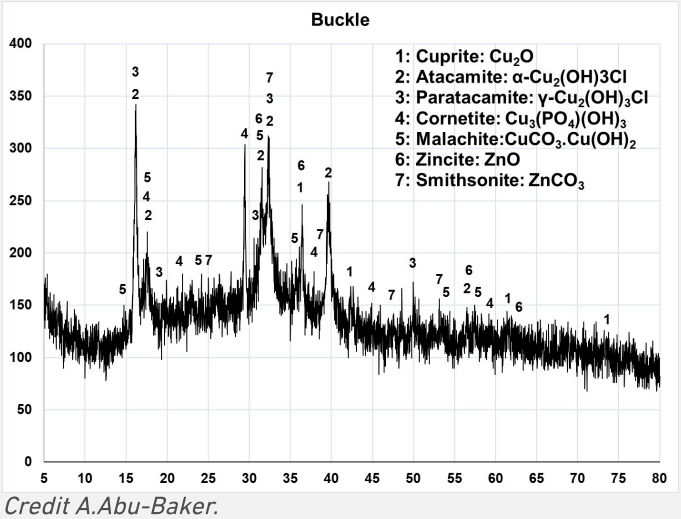
Fig. 12: XRD analysis of the corrosion products of buckle-a,

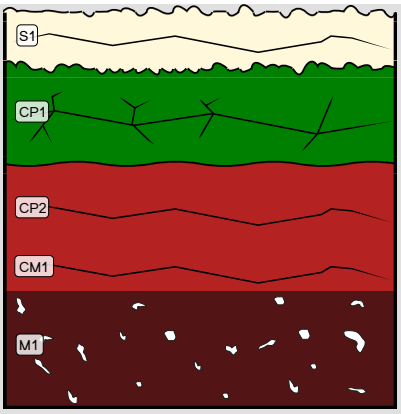
Fig. 13: Stratigraphic representation of the sample from buckle-a in cross-section (dark field) using the MiCorr application. The characteristics of the strata are only accessible by clicking on the drawing that redirects you to the search tool by stratigraphy representation. This representation was build according to Fig. 10, credit A.Abu-Baker.

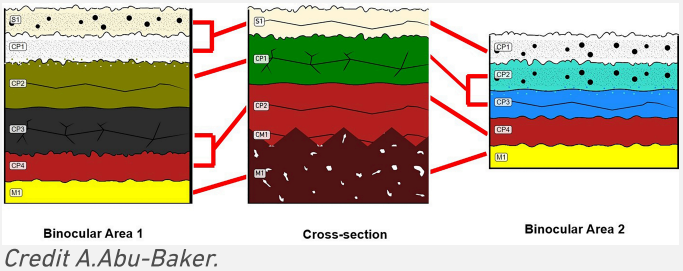
The observation under binocular microscope of the whole artifact led to two different representative stratigraphies (Areas 1 and 2, Fig. 4). The cross-section obtained on a discreet area of the metal surface identified 2 CPs and a CM. With binocular microscope, it is possible to differentiate strata according to texture and light color changes that do not always correspond to significant changes in chemical composition, thus leading to a regrouping of several strata into one in the cross-section observation and physicochemical characterization.

The S1 and CP1 strata under binocular microscope of Area 1 could be grouped and correspond to S1 in cross-section. The CP1 stratum in Area 2 corresponds to S1 in cross-section. CP2 of Area 1 or CP2 and CP3 of Area 2 under the binocular microscope could be grouped and correspond to CP1 in cross-section. Similarly, the CP3 and CP4 of Area 1 or CP4 of Area 2 under binocular microscope probably correspond to CP2 in cross-section. The corroded metal (CM) zone lies between the external corrosion product (CP) zone and the sound metal (M). It is characterized by corrosion that has developed within the metal while preserving remnants of the original metallic structure, i.e., the dezincified copper-rich network, and can therefore only be observed on a cross-section.
