BUCKLE YAJ.96.B20.D1.28.BUCKLE-A - CU ZN SN PB - BYZANTINE

Artefact name Buckle Yaj.96.B20.D1.28.buckle-a

Authors Ahmad. Abu-Baker (Yarmouk University, None)

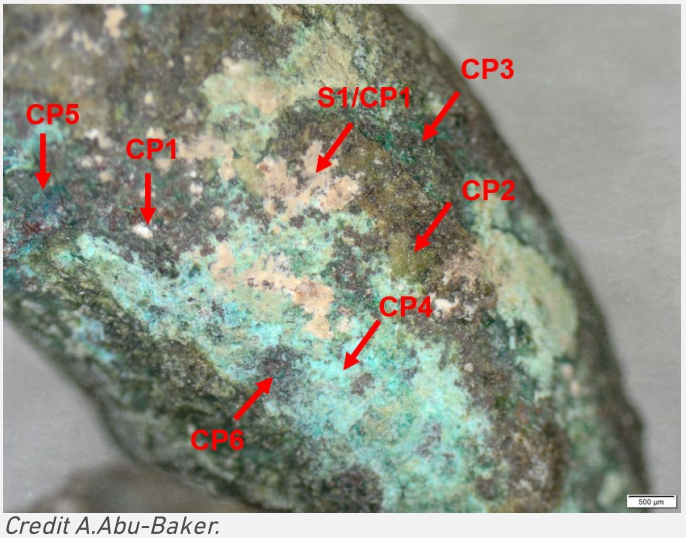
Strata	Type of strata	Principle characteristics
S1	Soil	Light brown soil sediments intermixed with CP1
CP1	Corrosion product	White corrosion spots
CP2	Corrosion product	Olive-green corrosion layer
CP3	Corrosion product	Black corrosion layer
CP4	Corrosion product	Turquoise-blue powdery corrosion products
CP5	Corrosion product	Blue corrosion product
CP6	Corrosion product	Red-brown corrosion product

Fig. 3: Binocular observation of the surface deposit and corrosion products of buckle-a,

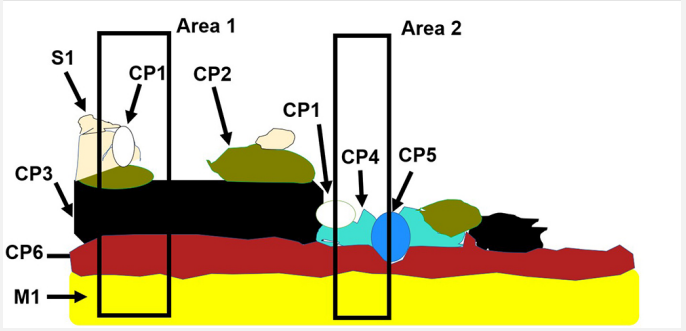
Fig. 4: Stratigraphic representation of the corrosion structure of buckle-a based on visual and binocular observations with indication of Areas 1 and 2 used to construct MiCorr stratigraphies Bi in Figs. 5 and 6,

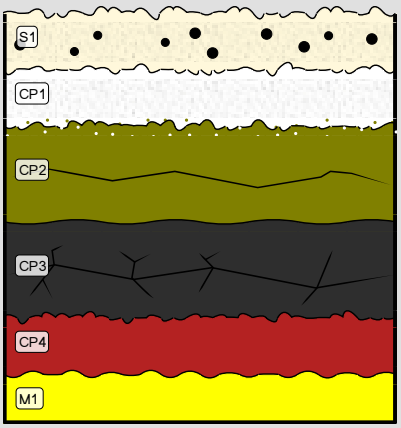
Fig. 5: Stratigraphic representation of the corrosion structure of buckle-a observed macroscopically under binocular microscope using the MiCorr application. The characteristics of the strata are only accessible by clicking on the drawing that redirects you to the search tool by stratigraphy representation. This representation can be compared to Fig. 4 considering that CP4 in Fig. 5 is CP6 in Fig. 4, credit A.Abu-Baker.

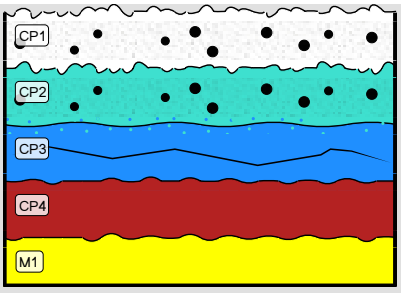
Fig. 6: Stratigraphic representation of the corrosion structure of buckle-a observed macroscopically under binocular microscope using the MiCorr application. The characteristics of the strata are only accessible by clicking on the drawing that redirects you to the search tool by stratigraphy representation. This representation can be compared to Fig. 4 considering that CP2, CP3 and CP4 in Fig. 6 are CP4, CP5 and CP6 respectively in Fig. 4, credit A.Abu-Baker.

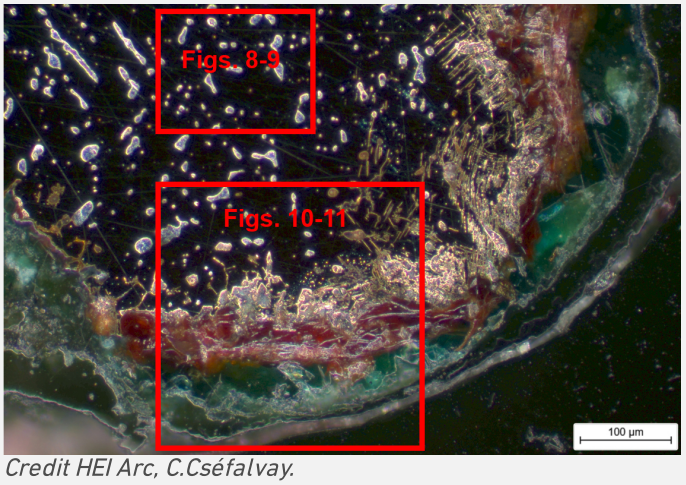
Fig. 7: Micrograph of the cross-section of the sample from Fig. 2 in dark field showing the locations of Figs. 8-9, 10-11,

Description of sample	A cross-section taken from the back-end of the prong of the buckle.
Alloy	Cu Zn Sn Pb
Technology	Cast
Lab number of sample	
Sample location	The Archaeological Museum at the University of Jordan, Amman, Amman
Responsible institution	The Archaeological Museum at the University of Jordan, Amman, Amman
Date and aim of sampling	May 2023. Sampling aimed to study the composition, corrosion, and microstructural properties of the artefact.

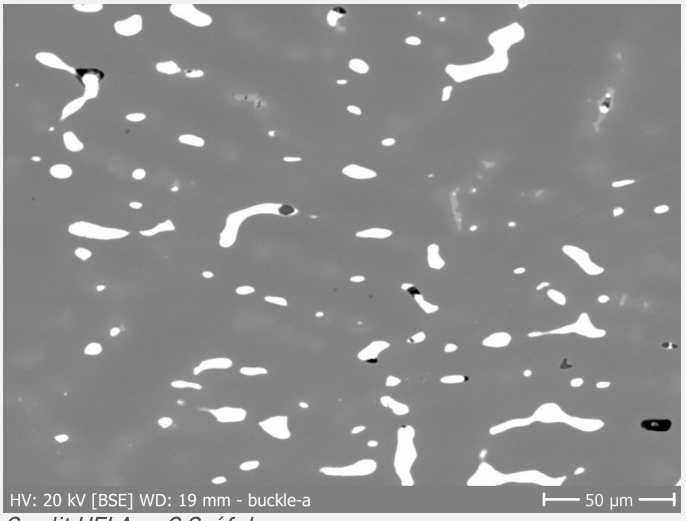
The EDS analysis of the internal alloy of buckle-a showed that it is made from a quaternary Cu-Zn-Sn-Pb alloy. This result is in a good agreement with the non-invasive XRF analysis result.

Element	Wt. %
Cu	83
Zn	9
Sn	3
Pb	5

The OM examination of the etched cross-sections of buckle-a revealed an as-cast dendritic microstructure (Fig. 9). The presence of cored dendrites and strain lines suggests that the artifact was cold-worked without annealing (Scott 1991: 7–8; Scott & Schwab 2019: 154). SEM micrograph (Fig. 8) shows the presence of air porosity and lead globules (in white).

Fig. 8: SEM image of the internal alloy of buckle-a. The dendritic structure appears in the background, while lead inclusions are in white,

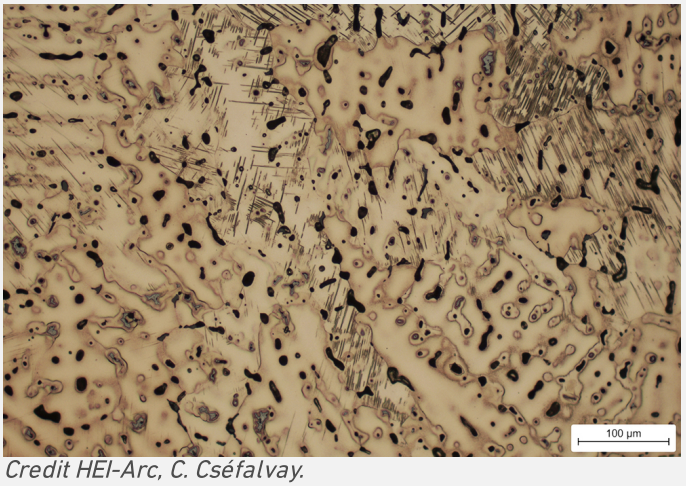
Fig. 9: OM image of the etched cross-section of buckle-a,

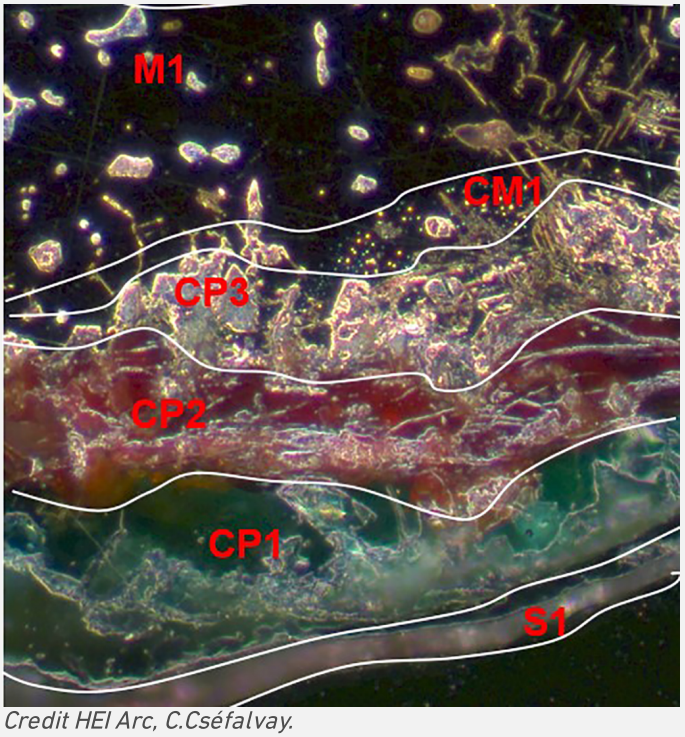
The dark-field OM examination (Fig. 10) and EDS elemental mapping (Fig. 11) of the unetched cross-section of buckle-a showed depletion of zinc from areas in the corroded metal layer (CM1), i.e., CM1 is enriched with Pb and Cl while zinc is missing, indicating selective leaching of zinc from the alloy and the occurrence of dezincification. The external corrosion layer (CP1) showed the presence of Cu, Zn, Pb, C, O, P, and Cl, which could be attributed to the presence of corrosion products of copper, zinc, and lead (carbonates (malachite ($CuCO_3.Cu(OH)_2$) and smithsonite ($ZnCO_3$)), chlorides (atacamite (α-$Cu_2(OH)_3Cl$) and paratacamite (γ-$Cu_2(OH)_3Cl$) and phosphates (cornetite ($Cu_3(PO_4)(OH)_3$)) as indicated by the XRD analysis (Fig. 12). The Si, Al, and Ca in the soil (S1) and CP1 layers are the elements of soil deposits, i.e. aluminosilicate and calcite deposits. The second corrosion layer (CP2) layer showed mainly the presence of Cu and O, which could indicate a cuprous oxide corrosion layer (Cu_2O as indicated by XRD - Fig. 12). It should be noted that the presence of P and Ca in the CP1 layer could also indicate the effect of phosphate species released by the hydrolysis of hydroxyapatite ($Ca_5(PO_4)_3OH$) from the skeletal materials in the neighboring bodies buried in the cemetery where the buckles were excavated, which induced the formation of copper phosphate minerals (cornetite) (Fan et al. 2020; Abu-Baker and Khalil 2022; Abu-Baker 2023b). It seems that the formation of insoluble phosphate corrosion products on the surface of the artifact improved its stability, reduced the risk of activating the chloride-based corrosion, and suppressed the continuation of dezincification from the internal alloy in the uncontrolled environment of the storage area. The original surface has been preserved and corresponds to the interface between CP1 and CP2, i.e., at the top of the cuprite layer (Bertholon 2001). The white spots appearing in the internal sound metal (M1) of buckle-a are the lead globules. The high concentration of Pb below CP1 and below CP2 in buckle-a as observed in the elemental mapping image is probably attributed to the diffusion of Pb towards the exterior of the object during burial and corrosion processes and the manufacturing technique in which the artifact was cast in a mold where it was allowed to slowly cool, and due to gravity segregation, Pb pooled at the bottom of the mold and solidified in the external part of the alloy. In addition, leaching of the soluble zinc corrosion products from the CM1 zone made it enriched with lead or lead chlorides (Scott 2011; Abu-Baker and Khalil 2022; Abu-Baker 2023a; Abu-Baker 2023b). The presence of atacamite/paratacamite and the absence of nantokite (CuCl) in the XRD results suggest that the initially formed nantokite in the burial soil underwent oxidative hydrolysis, which induced the formation of atacamite/paratacamite under the uncontrolled storage conditions. The artifact has either been stabilized by this reaction or is in a metastable state if nantokite is present deeper in the alloy such that it was not collected in the samples obtained for XRD analysis (Scott 1990). The diffused zinc from the alloy reacted with the corrosive burial soil and after a prolonged exposure formed zincite and smithsonite.

Fig. 10: OM micrograph of the corrosion structure of the sample from Fig. 7 (detail), unetched, dark field. The strata S1 to M1 are indicated and also shown in the digital stratigraphy in Fig. 13,

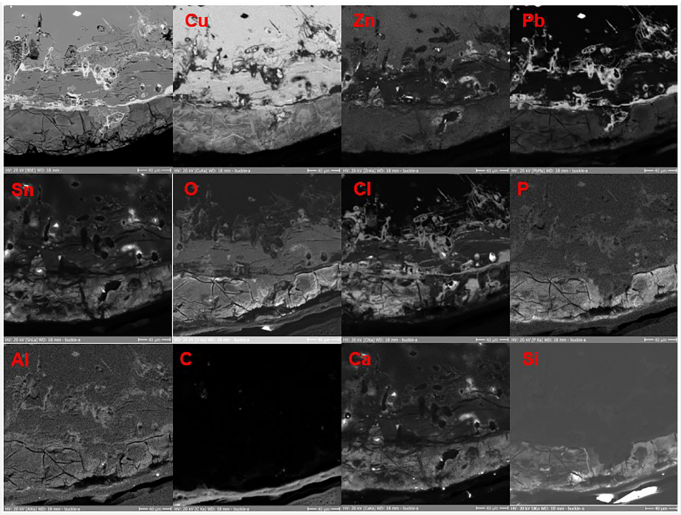
Fig. 11: SEM image, BSE-mode, and elemental chemical distribution of the selected area (Fig. 10, detail),

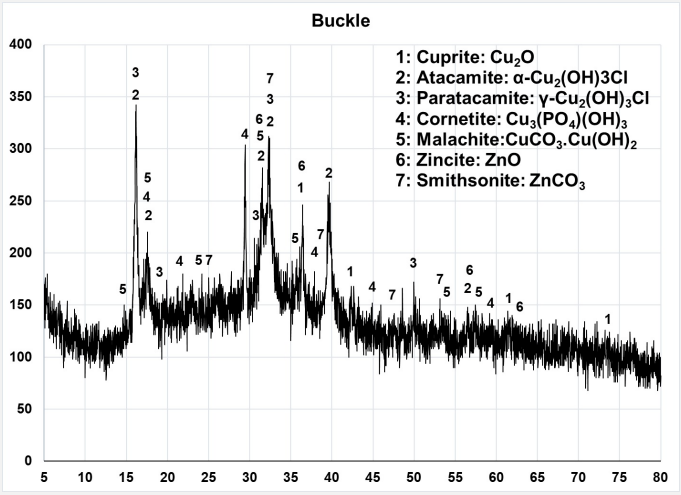
Fig. 12: XRD analysis of the corrosion products of buckle-a,

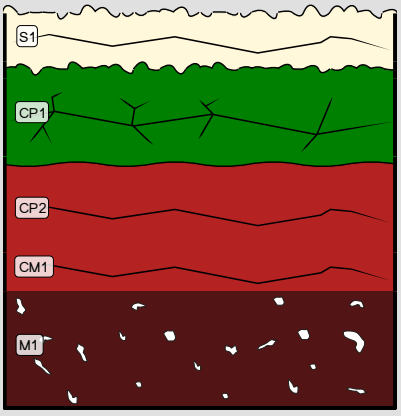
Fig. 13: Stratigraphic representation of the sample from buckle-a in cross-section (dark field) using the MiCorr application. The characteristics of the strata are only accessible by clicking on the drawing that redirects you to the search tool by stratigraphy representation. This representation was build according to Fig. 10, credit A.Abu-Baker.

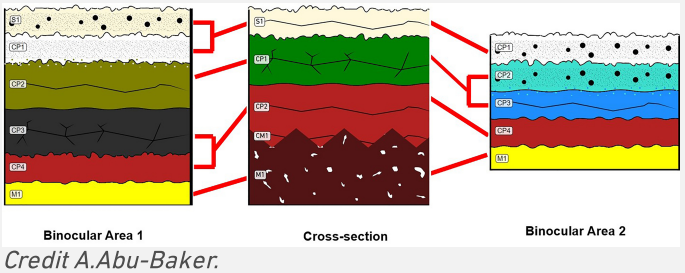
The S1 and CP1 strata under binocular microscope of Area 1 could be grouped and correspond to S1 in cross-section. The CP1 stratum in Area 2 corresponds to S1 in cross-section. CP2 of Area 1 or CP2 and CP3 of Area 2 under the binocular microscope could be grouped and correspond to CP1 in cross-section. Similarly, the CP3 and CP4 of Area 1 or CP4 of Area 2 under binocular microscope probably correspond to CP2 in cross-section. The corroded metal (CM) zone lies between the external corrosion product (CP) zone and the sound metal (M). It is characterized by corrosion that has developed within the metal while preserving remnants of the original metallic structure, i.e., the dezincified copper-rich network, and can therefore only be observed on a cross-section.

Fig. 14: Stratigraphic representation side by side of binocular views and cross-section (dark field) of buckle-a,
