MILITARY ID TAG 5668-MXX-1008-1 - ZN PB ALLOY - MODERN TIMES - FRANCE

Artefact name	Military ID tag 5668-MXX-1008-1
Authors	Christian. Degrigny (HE-Arc CR, Neuchâtel, Neuchâtel, Switzerland) & Marie-Jeanne. Scholl (HE-Arc CR, Neuchâtel, Neuchâtel, Switzerland) & Valentin. Boissonnas (HE-Arc CR, Neuchâtel, Neuchâtel, Switzerland)
Url	/artefacts/213/

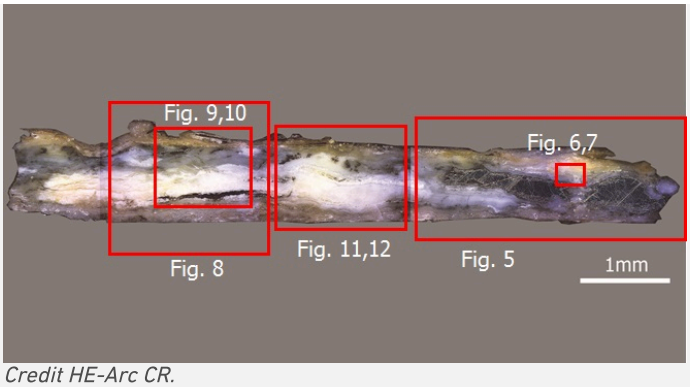
Fig. 4: Micrograph of the cross-section showing the locations of Figures 5-12. Unetched, dark field, 50x,

Description of sample	This sample was cut out of fragment b in Fig. 1. The cross-section shows the entire thickness of the plate (L = 8 mm, W= 1 mm). The corrosion goes through the whole metal thickness but a metallic core remains (Fig. 4).
Alloy	Zn Pb Alloy
Technology	Cold worked (laminated)
Lab number of sample	-
Sample location	HE-Arc CR, Neuchâtel, Neuchâtel
Responsible institution	Pôle d'Archéologie Interdépartemental Rhénan, Sélestat, Alsace
Date and aim of sampling	2013, metallography and chemical analyses

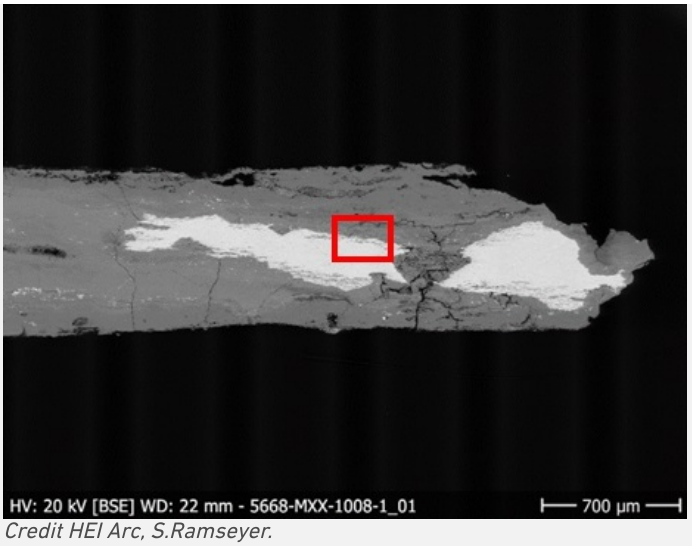
The remaining metal is an almost pure zinc alloy (Table 1) containing 1.8% in weight lead. Lead appears in the metal in the form of small flattened white Pb inclusions (Figs. 5 and 6), confirming the manufacturing technique, namely lamination. The etched metal does not show any specific microstructure (Fig. 7).

Fig. 5: SEM image of the cross-section, from Fig. 4 (detail), BSD-mode. Note the presence of Pb inclusions all through the thickness of the heavily cracked corrosion layers,

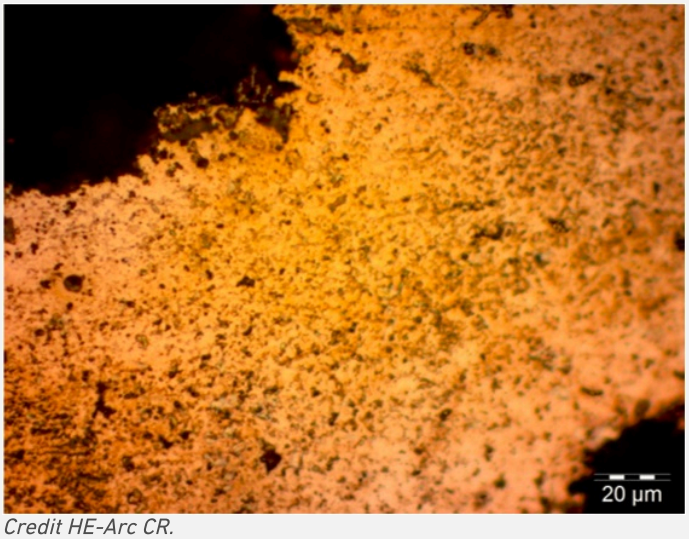
Fig. 6: SEM image of the cross-section, from Fig. 5 (detail), BSD-mode,

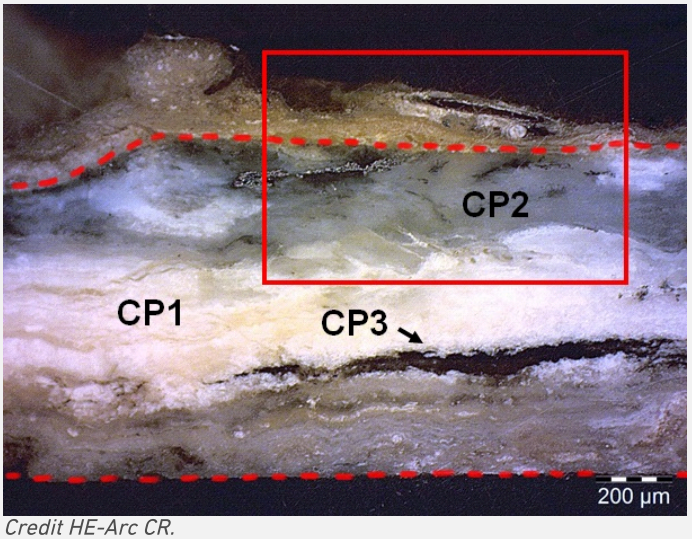
The corrosion structure is multi-layered: several corrosion products overlap. However they are not all continuous layers, since some of them are isolated. Most of the corrosion products layers show structural voids (up to 100 µm thick) and some cracks inside. Three layers can be distinguished (Fig. 8) which have the same elements but in different proportions (Figs. 9, 10 and table 2):

Fig. 8: Micrograph of the cross-section, from Fig. 4 (detail), unetched, dark field, 50x. View of the inner layers and the limit of the original surface (red line). We can see that the interfaces between the different layers are not well defined: some of the white corrosion product is found inside the inner grey layer. The micrograph of Fig. 9 is marked by a rectangular,

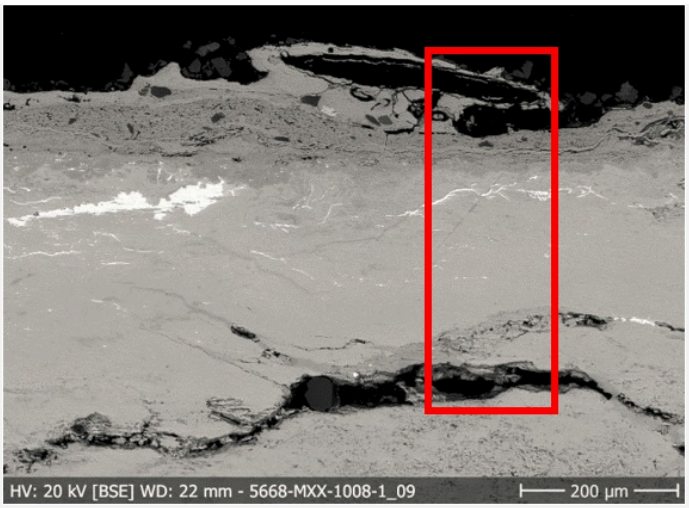
Fig. 9: SEM image of the cross-section from Fig. 8 (detail), BSD-mode. The mapped area (Fig. 10) is marked by a rectangle,

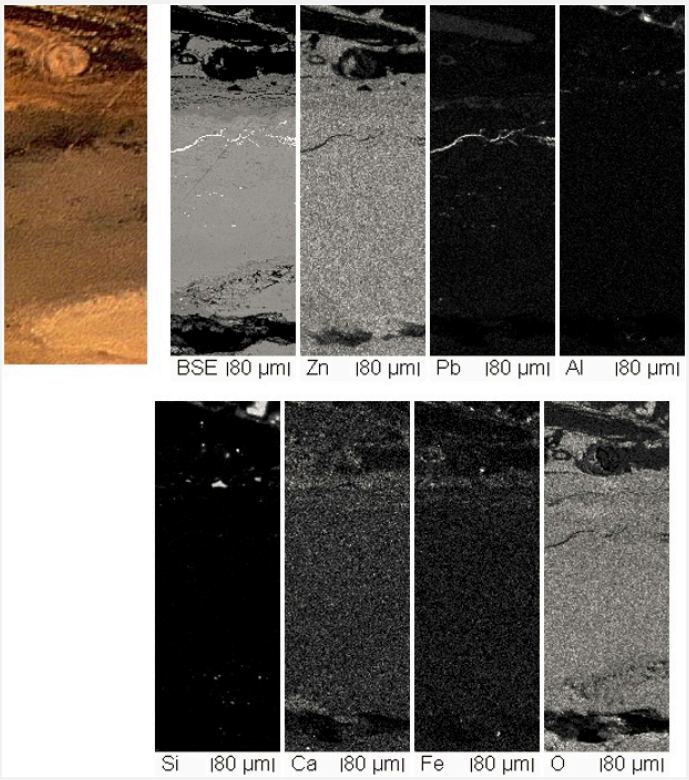
Fig. 10: SEM image of the cross-section from Fig. 9 (detail), SE-mode, and elemental chemical distribution. Method of examination: SEM/EDX, Lab of Electronic Microscopy and microanalysis, IMA (Néode), HEI Arc,

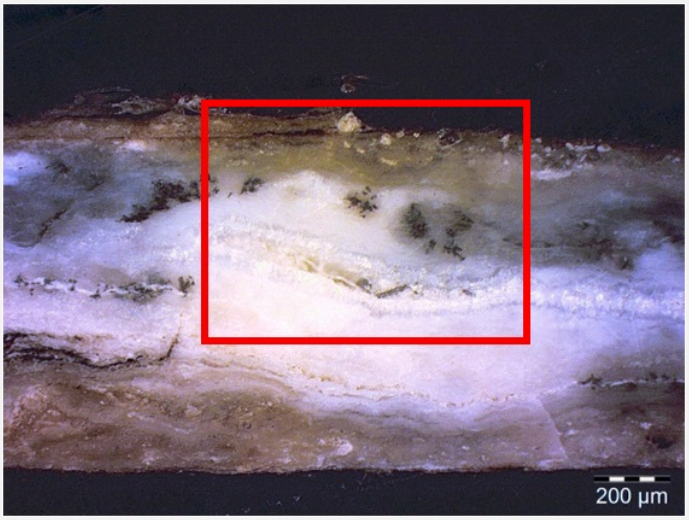
- Inner grey layer – CP2 (up to 1 mm thick) is a translucent, compact layer and constitutes most part of the corrosion products. Corroded metal appears inside this layer as lead inclusions within a black corrosion product (Figs. 11 and 12). Sulphur has also been detected by SEM-EDX inside this layer, near the surface, where the colour turns into grey-orange (zinc sulfide or sulphates but to be confirmed, table 2).

Fig. 11: Micrograph of the cross-section, from Fig. 4 (detail), unetched, dark field, 50x. The micrograph of Fig. 12 is marked by a rectangular,

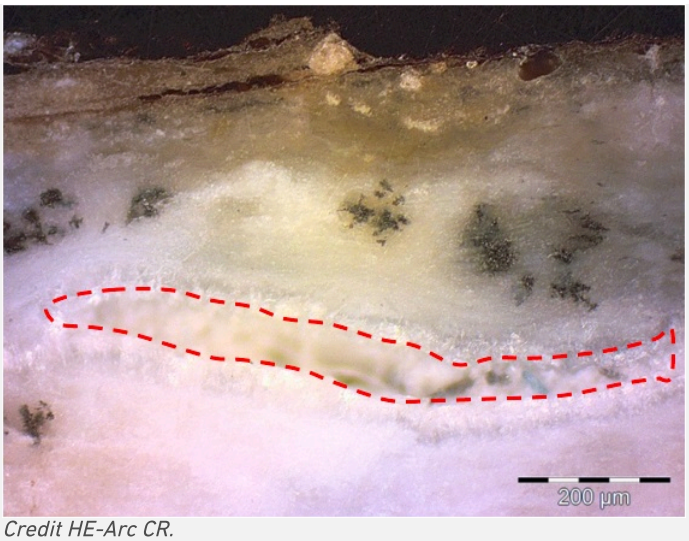
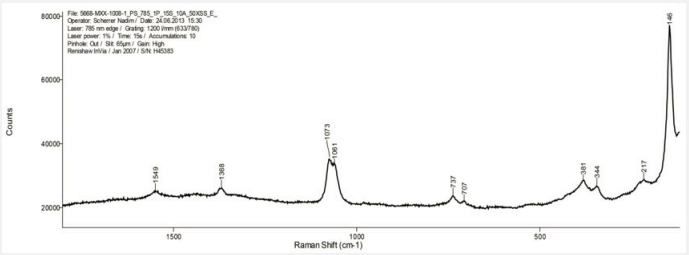
- Inner white layer – CP1 (up to 0.6 mm thick) is an opaque and powdery heap, occurring in different places inside inner grey layer and sometimes near the surface, as pitting corrosion. The interface between inner layers grey and white is diffuse. Localized aggregates showing a crystalline microstructure of thickness of 50 µm are located against the walls of a structural void, inside the white corrosion product (Fig. 12).

Fig. 12: Micrograph of the cross-section, from Fig. 9 (detail) unetched, dark field, 100x. Structural void (dotted red line) with aggregates,

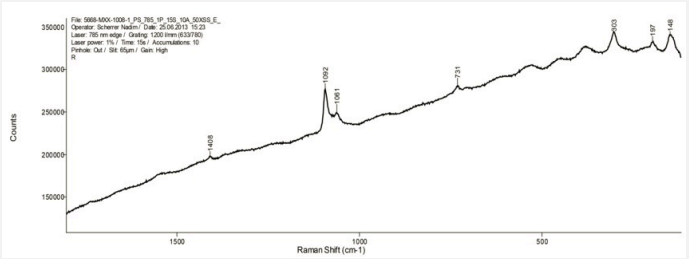
The inner grey layer has been identified by FTIR as a zinc carbonate (smithsonite), mixed with other unidentified corrosion products. Raman spectra seems to confirm it (Fig. 13). The exact composition of inner white layer is unknown. Inner white layer shows a bluish fluorescence under UV light and has been identified by FTIR as a mixture of zinc oxides and carbonates, that could be zinc hydroxycarbonates (hydrozincite). Raman spectroscopy shows also a mixture of carbonates and other corrosion products (Fig. 14). The inner black layer is a zinc carbonate as well, identified by FTIR and Raman spectroscopy (Fig. 15) appearing as a vein between layers grey and white (Fig. 8).

Fig. 13: Raman spectrum of inner grey layer (ZnCO3 – smithsonite?). Settings: laser wavelength 532nm, acquisition time 10s, one accumulation, filter D2 (0.75-0.8mW), hole 500, slit 80, grating 600. Method of analysis: Raman spectroscopy, Art Technological Laboratory, Departement Conservation HKB,

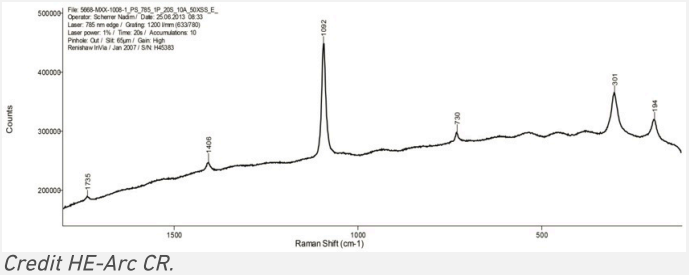
Fig. 14: Raman spectrum of inner white layer (zinc hydroxycarbonate?). Settings: laser wavelength 532nm, acquisition time 10s, one accumulation, filter D2 (0.75-0.8mW), hole 500, slit 80, grating 600. Method of analysis: Raman spectroscopy, Art Technological Laboratory, Departement Conservation HKB,

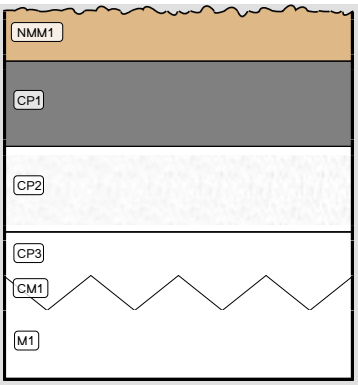
Fig. 5: Stratigraphic representation of the object in cross-section using the MiCorr application. This representation can be compared to Fig. 10.

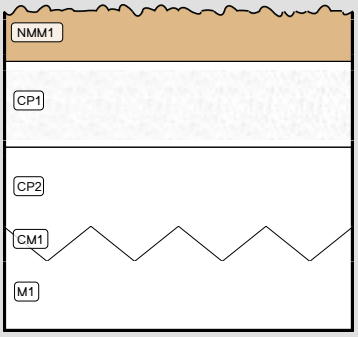
Fig. 6: Stratigraphic representation of the object in cross-section using the MiCorr application. This representation is different from Fig. 10 due to the inversion of CP1 and CP2. Furthermore, CP3 is not represented.

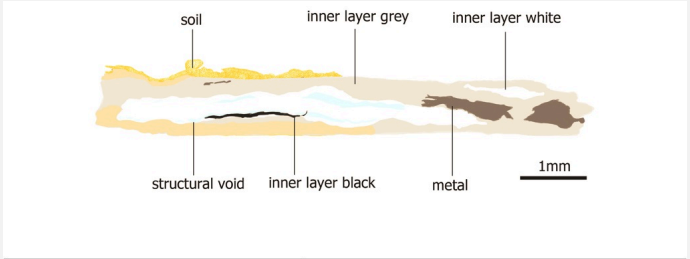
Based on the analyses carried out, the schematic representation of the stratigraphy of the military tag has been corrected.

Fig. 16: Improved stratigraphic representation of the stratigraphy of corrosion layers on the military tag from visual observations and analyses,
