MOIL CHISEL DEV 995 762 PR – STEEL – EARLY MEDIEVAL TIMES – SWITZERLAND

Artefact name	Moil chisel DEV 995 762 PR
Authors	Marianne. Senn (EMPA, Dübendorf, Zurich, Switzerland) & Christian. Degrigny (HE-Arc CR, Neuchâtel, Neuchâtel, Switzerland)
Url	/artefacts/214/

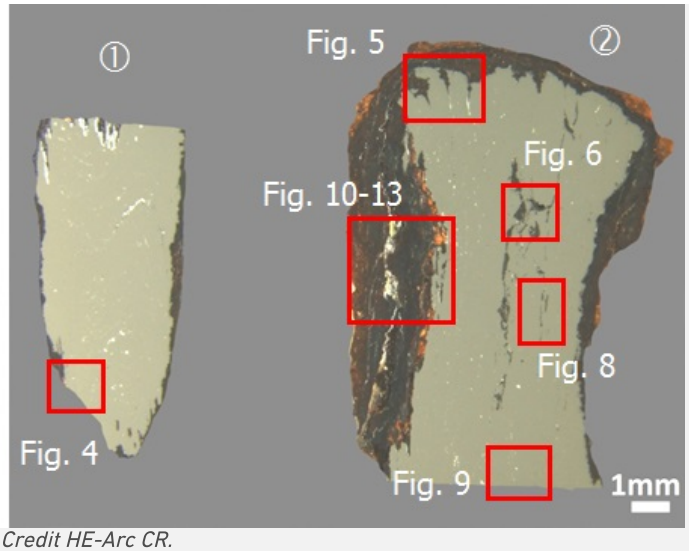
Fig. 3: Micrograph of the cross-sections from samples 1 and 2 showing the locations of Figures 4 to 6 and 8 to 13,

The remaining metal is a soft steel rich in P, Ni and As (P 0.1, Ni 0.2, As 0.1 mass%, Table 1). This composition and the ratio Ni/Co is typical for metal worked in the smithies of the settlement Develier-Courtételle. The unetched metal shows cracks filled with corrosion (Fig. 3). There are many slag inclusions forming rows in the metal and delineating the welding seams (Figs. 4 and 5). After the sample preparation numerous slag inclusions have lost their slag filling and are now empty (Fig. 4). The welding seams are preferentially attacked (Fig. 5). There are two types of slag inclusions (Table 2): along the central, primary welding seam we observe large inclusions with a structure of coarse and fine wüstite/FeO dendrites (Fig. 6) which can be interpreted as the result of an incomplete compacting of the metal in this strip. Small inclusions are mostly enclosed in a glassy matrix. The CaO and K_2O content in the large ones is remarkable: it is low and of similar value. This criterion is typical for ores, smelting slag and clay. This slag composition shows little or no influence of the charcoal in the composition, whereas in charcoal enriched slag the CaO often has the double concentration of K_2O. The small slag inclusions are extremely rich in CaO (8-31 mass%) and P_2O_5 (below detection limit-16 mass%). These high percentages cannot be explained by the presence of charcoal ash in the slag formation process. Here the question arises as to whether bones were used instead of charcoal for firing. Bones are rich in CaO and P_2O_5. In any case, neither

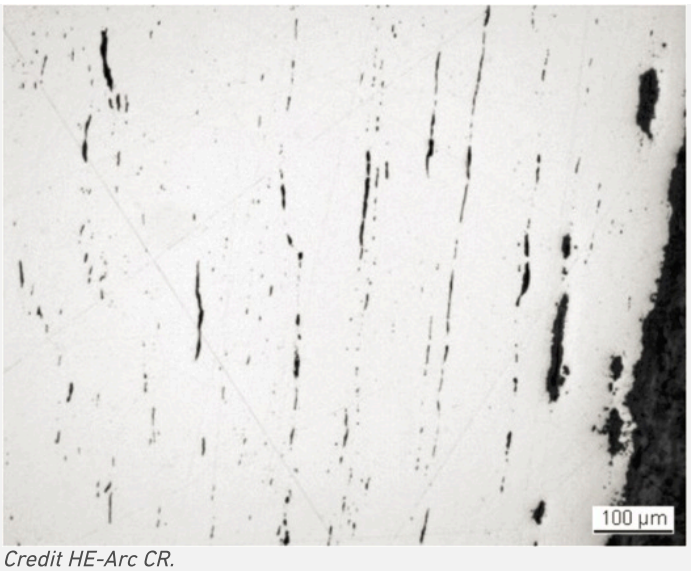
Fig. 5: Micrograph of metal sample 2 from Fig. 3 (reversed picture, detail), unetched, bright field. Corrosion has penetrated along the welding seams,

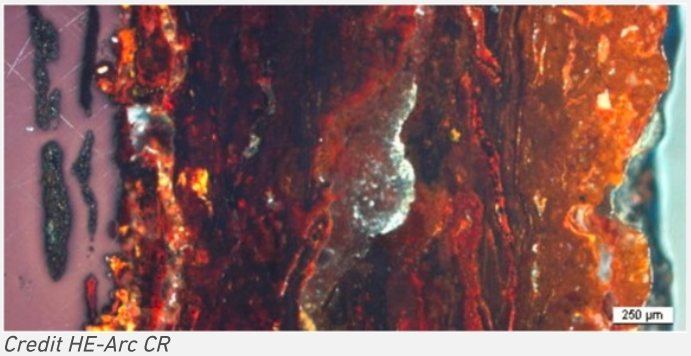
The metal - corrosion products interface is irregular (Fig. 3) and the average thickness of the corrosion crust is about 0.6mm. However, on the left side of the sample taken from the head of the chisel (Fig. 3) the corrosion crust is deeper with an average thickness of about 2mm. This area is further detailed below (Figs. 10 and 11). The corrosion crust can be divided into several layers. In bright field, and in the BSD-mode of the SEM image, darker and lighter regions are visible (Figs. 10, 12 and 13). In this area the corrosion layer contains typical trace elements of the metal (As and P, Table 3). In polarised light we see a dark-red zone in which different grey zones are included. The element mapping and the analyses show that at the metal - corrosion crust interface iron chlorides occur (Figs. 12 and Table 3). Only the outer zone, which has reacted with the soil, has a different colour (orange) and incorporates many rock inclusions (Si, Al and Ca) (Fig. 13 and Table 3).

Fig. 10: Micrograph showing the metal - corrosion crust interface from Fig. 3 (reversed picture, detail), unetched, bright field. The micrographs of Fig. 12 (left) and Fig. 13 (right) are marked by rectangles,

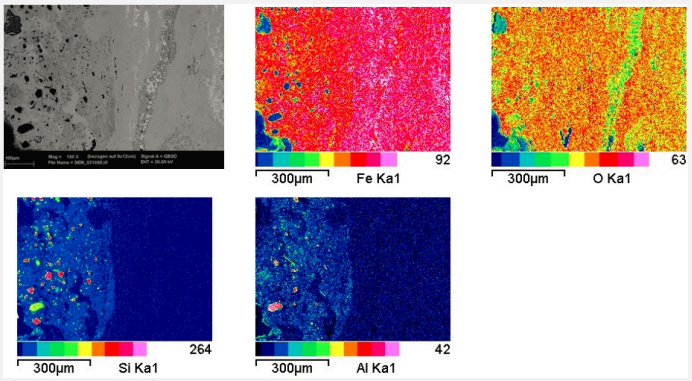
Fig. 13: SEM image, BSD-mode, and elemental chemical distribution of the selected area from Fig. 10 (reversed picture). Method of examination: SEM/EDX, Laboratory of Analytical Chemistry, Empa,

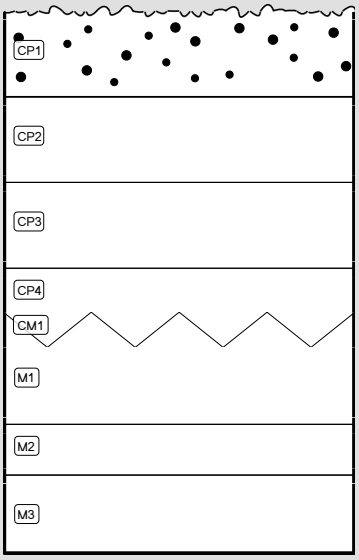
Fig. 4: Stratigraphic representation of the object in cross-section using the MiCorr application. This representation can be compared to Fig. 12.
