SACRIFICIAL ANODE VHS-8339 - ZN ALLOY - MODERN TIMES

Artefact name	Sacrificial anode VHS-8339
Authors	Marianne. Senn (EMPA, Dübendorf, Zurich, Switzerland) & Christian. Degrigny (HE-Arc CR, Neuchâtel, Neuchâtel, Switzerland)
Url	/artefacts/218/

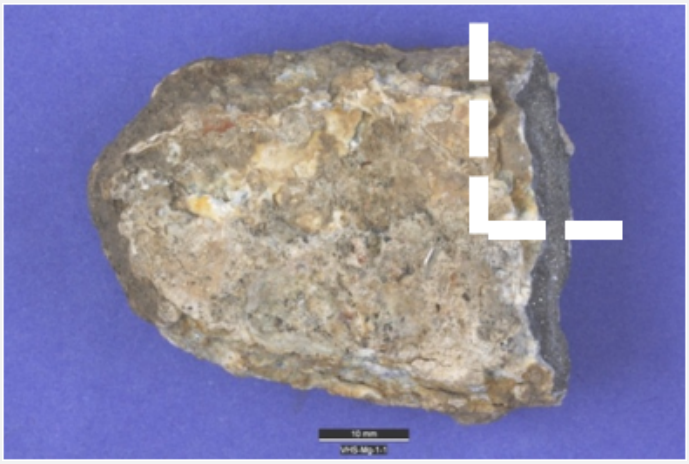
Fig. 1: Submarine and the anode (www.verkehrshaus.ch),

Description of the artefact	Half of possibly a weight or sacrificial anode. It is surrounded by a whitish brown-grey corrosion crust, the broken metal has a greyish shining colour, whereas the cut metal part is silvery. Dimensions: L = 4.9cm ; WT = 95g.
Type of artefact	Submarine part
Origin	Submarine "Mesoscaph" from Auguste Piccard
Recovering date	The sacrificial anodes (?) might have been added when the submarine was used in the sea.
Chronology category	Modern Times
chronology tpq	1970 A.D.
chronology taq	1974 A.D.
Chronology comment	1970 _ 1974
Burial conditions / environment	Outdoor atmosphere
Artefact location	Swiss Museum of Transport, Luzern, Lucerne
Owner	Swiss Museum of Transport, Luzern, Lucerne
Inv. number	VHS-8339
Recorded conservation data	Not conserved

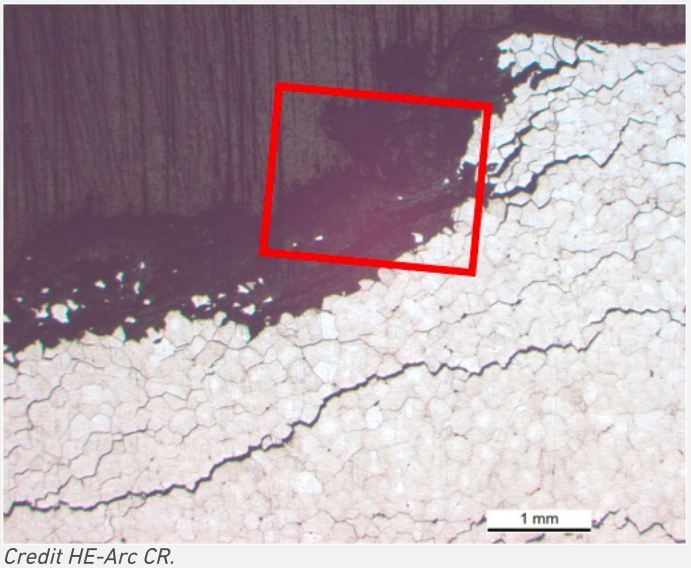
Fig. 3: Micrograph of the cross-section showing the locations of Figures 4 to 8,

The sample shows a cross-section from the sacrificial anode. The thickness of the corrosion crust is variable. Dimensions: L = 17mm; W = 14mm.

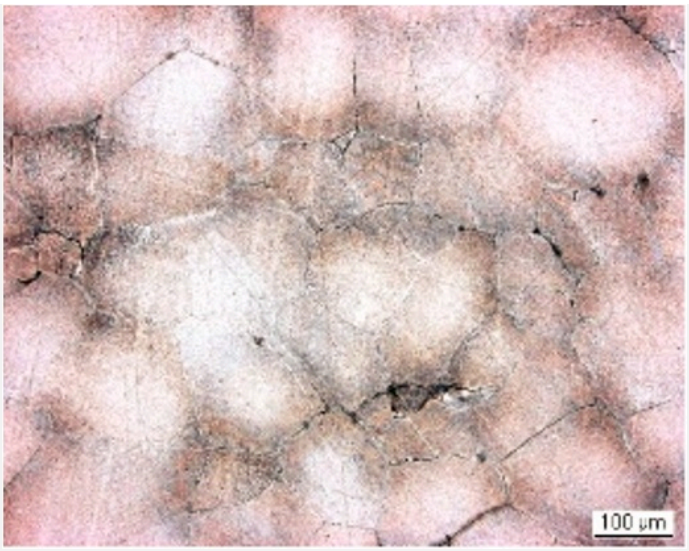
The remaining metal is an almost pure zinc alloy (Table 1). The oxygen content is not from the original alloy, but is due to secondary corrosion. The metal grains are visible without etching and present a polygonal structure (Figs. 4 and 5). The structure is recrystallised after annealing. The recrystallization of zinc alloys begins at room temperature.

Fig. 4: Micrograph of the metal sample from Fig. 3 (reversed picture, detail), unetched, bright field. Extensive intergranular corrosion is visible.The rectangle marks Fig. 6,

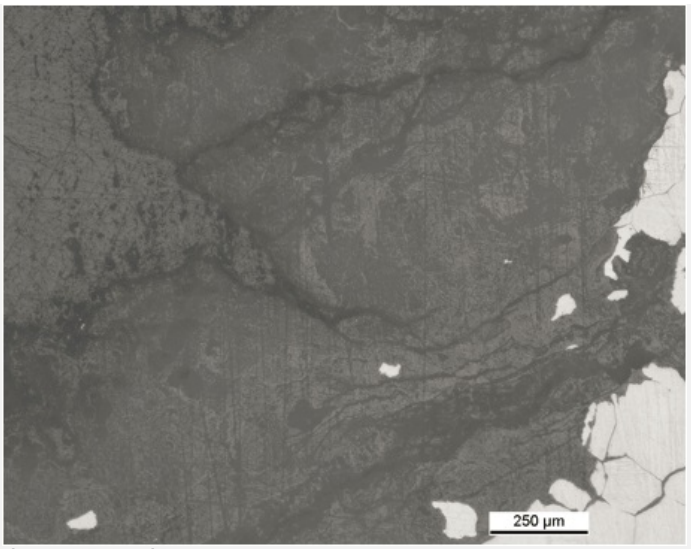
Fig. 5: Micrograph of the metal sample from Fig. 3 (detail), etched,

Extended intergranular corrosion has developed in the metal structure (Figs. 4, 5 & 6). The metal is covered by a corrosion crust that is hard to see in bright field and which contains remnant metal (Fig. 5). On most of the sample the corrosion crust is uniform. In areas we see cracks appearing as brown lines separating the corrosion crust (Figs. 6 and 7). In bright field the corrosion crust appears grey containing dark-grey zones (Fig. 6). Under polarized light, the corrosion crust appears white with darker parts including remnant metal (Fig. 7). It contains Zn and O as well as S along some cracks (Fig. 9). The cracks appear in brown.
