SITULA EMT09-554.665 - TIN BRONZE - IRON AGE - SWITZERLAND

Artefact name	Situla EMT09-554.665
Authors	Christian. Degrigny (HE-Arc CR, Neuchâtel, Neuchâtel, Switzerland) & Marie-Jeanne. Scholl (HE-Arc CR, Neuchâtel, Neuchâtel, Switzerland) & Valentin. Boissonnas (HE-Arc CR, Neuchâtel, Neuchâtel, Switzerland)
Url	/artefacts/221/

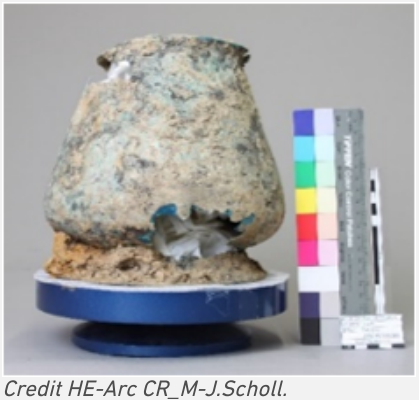
Fig. 1: Tin bronze Celtic situla (Archeodunum (Gollion), 2009) inverted as found in situ,

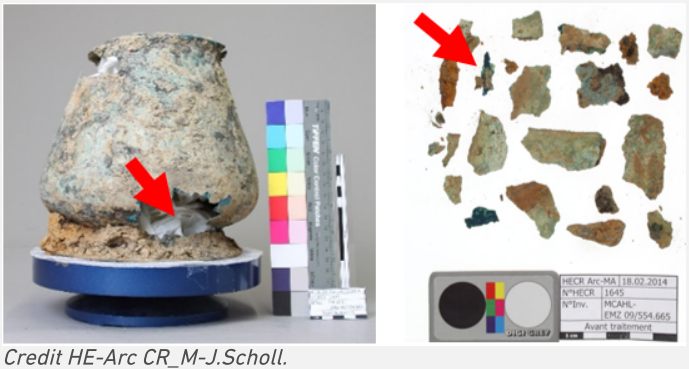
Fig. 2: Location of sampling area and sample selected from detached fragments,

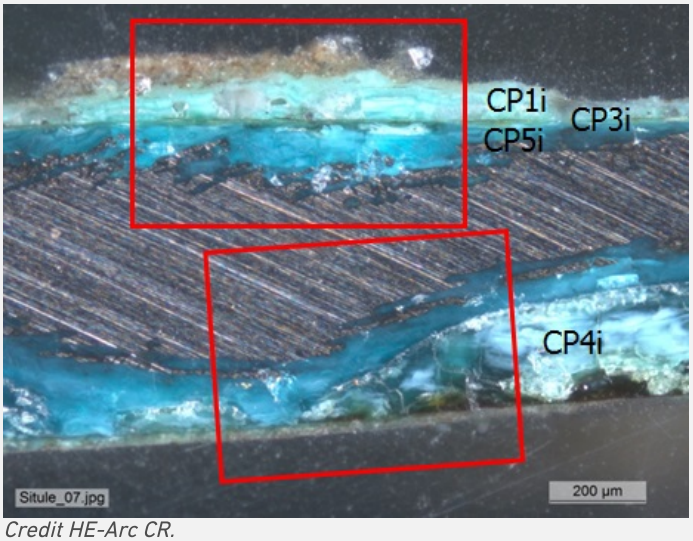
Fig. 6: Micrograph of the etched metal structure from Fig. 5 (detail), etched, bright field, 50x. The alpha phase of the alloy shows polygonal grains. Area of Fig. 7 is marked by a rectangle,

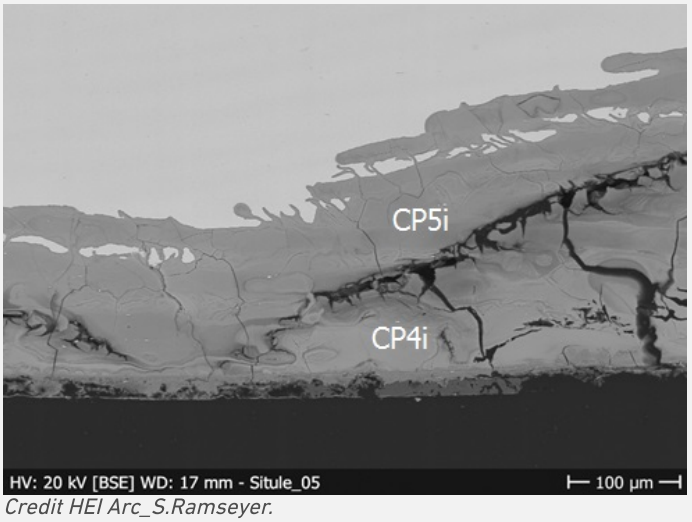
The corrosion crust is heterogeneous and has in places completely replaced the metal. The metal – corrosion products interface is irregular due to transgranular corrosion (Figs 5-6). In most cases, the corrosion crust can be divided in three main layers: an inner compact blue layer directly on the metal core. In areas of extensive corrosion this blue layer coexists with a friable green layer (Figs. 8 and 9). Depending on the area either a very fine dark green or red corrosion layer marks the limit of the original surface. It is followed by an external fourth layer, consisting of friable and sometimes curly pale green corrosion products intermingled with soil products (Fig. 8 & 11). In heavily worked and fragile parts of the object a cleavage between the inner layers of blue and green corrosion is present, rendering the green corrosion vulnerable to loss (Fig. 9).

Fig. 8: Micrograph of the metal sample from Fig. 4, unetched, dark field, 50x. Areas of Fig. 9 (bottom) and Figs. 10 and 11 (top) are marked by a rectangle,

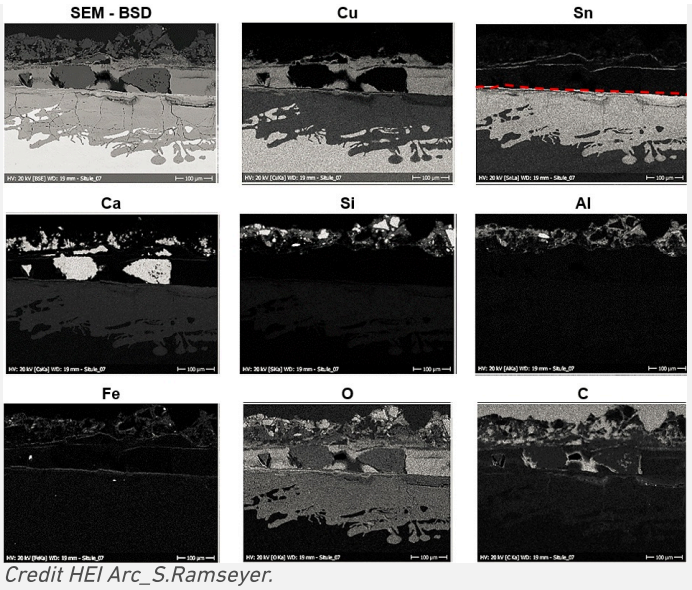
Fig. 9: SEM image, BSD-mode of the metal sample from Fig. 8 (detail) showing cleavage between the inner blue (CP5i) and green (CP4i) layers,

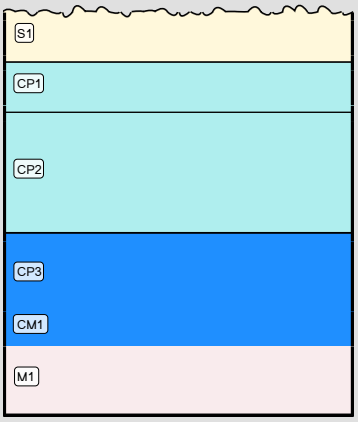
Fig. 5: Stratigraphic representation of the object in cross-section using the MiCorr application. This representation shows the exterior face and can be compared to Fig. 10 (bottom square)

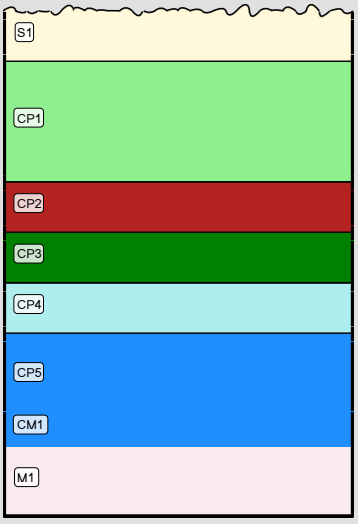
Fig. 6: Stratigraphic representation of the object in cross-section using the MiCorr application. This representation shows the interior face and can be compared to Fig. 10 (top square).
