TANG FRAGMENT OF A KNIFE HR-6567 - LEADED BRONZE - LATE BRONZE AGE - SWITZERLAND

Artefact name	Tang fragment of a knife HR-6567
Authors	Marianne. Senn (EMPA, Dübendorf, Zurich, Switzerland) & Christian. Degrigny (HE-Arc CR, Neuchâtel, Neuchâtel, Switzerland)
Url	/artefacts/223/

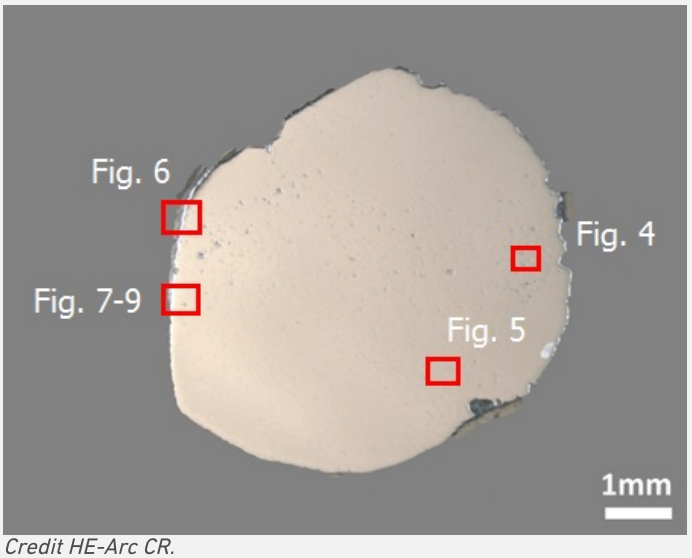
Fig. 3: Micrograph of the cross-section showing the locations of Figures 4 to 9,

Description of sample	This cross-section shows a lateral cut through the tang (Fig. 2). Most of the corrosion crust is absent.
Alloy	Leaded Bronze
Technology	Cold worked after annealing
Lab number of sample	MAH 87-196
Sample location	Musées d'art et d'histoire, Genève, Geneva
Responsible institution	Musées d'art et d'histoire, Genève, Geneva
Date and aim of sampling	1987, metallography and corrosion characterisation

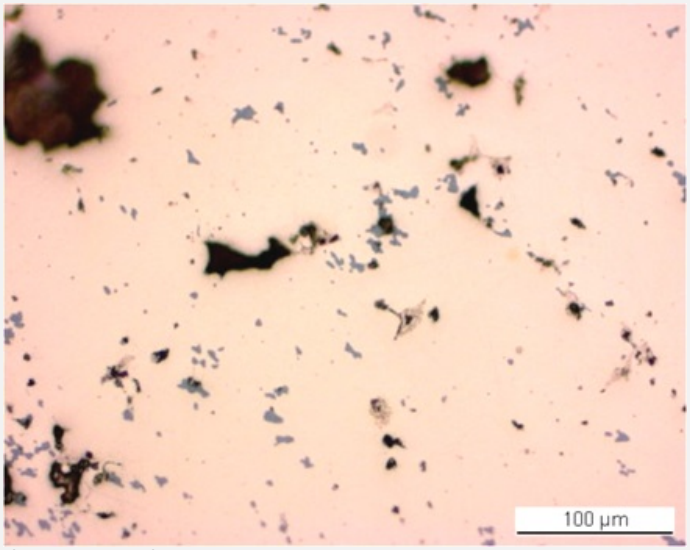
Fig. 4: Micrograph of the metal sample from Fig. 3 (detail), unetched, bright field. In pink the metal, in black the porosity and in dark-grey copper sulphide inclusions,

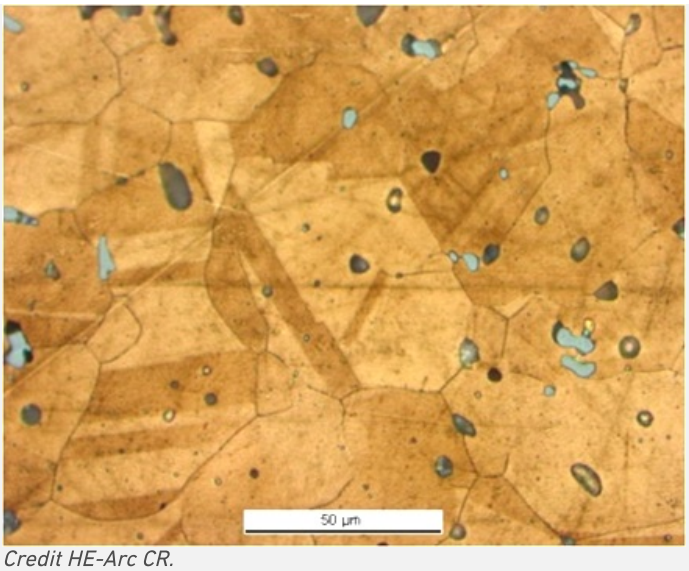
Fig. 5: Micrograph of the metal sample from Fig. 3 (detail), etched, bright field. Angular and twinned grains are revealed as well as copper sulphide inclusions in grey,

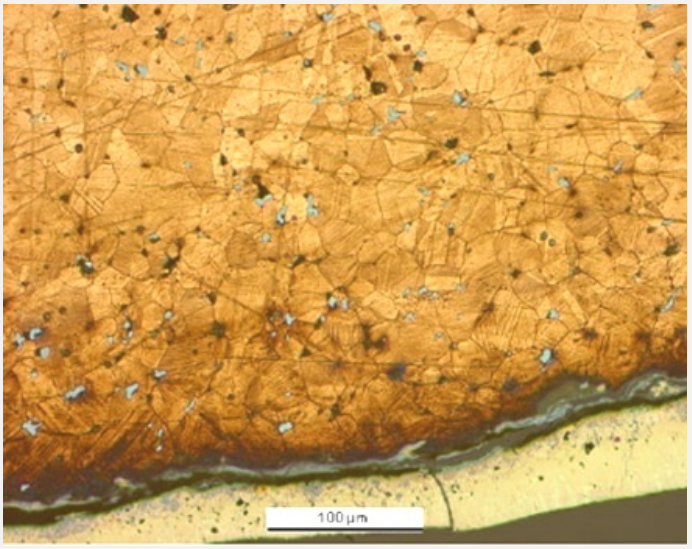
Fig. 6: Micrograph of the metal sample from Fig. 3, etched, bright field (rotated by 270°, detail). Angular grains with strain lines can be seen as well as copper sulphide inclusions in grey,

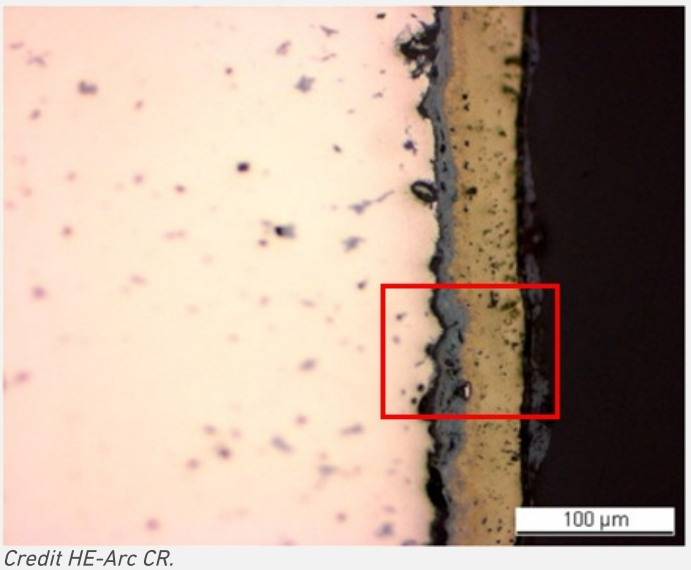
Fig. 7: Micrograph of the metal sample from Fig. 3 (reversed picture, detail), unetched, bright field. From left to right: metal (in pink), inner light-grey layer, intermediate brown layer and top dark-grey layer. The mapped area of Fig. 9 is marked by a square,

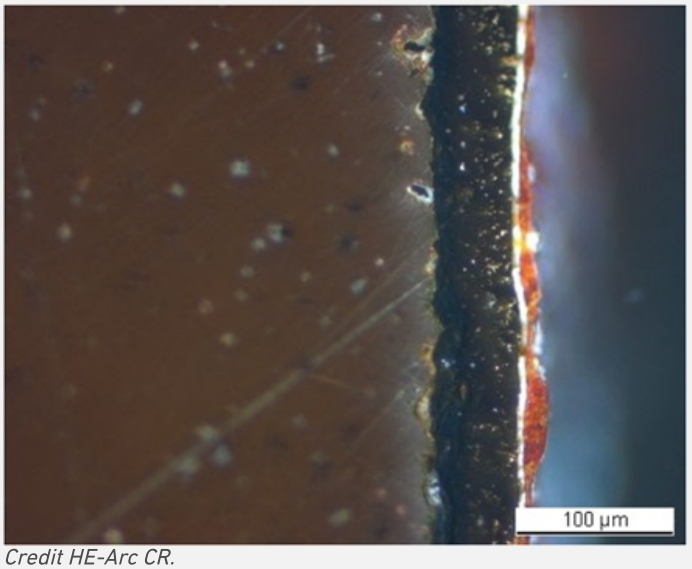
Fig. 8: Micrograph of same area as Fig. 7, polarized light. From left to right: metal (in brown) covered with a corrosion crust consisting of a black layer, an intermediate brown layer with bright spots, a crack (white line) and a red layer with white particles,

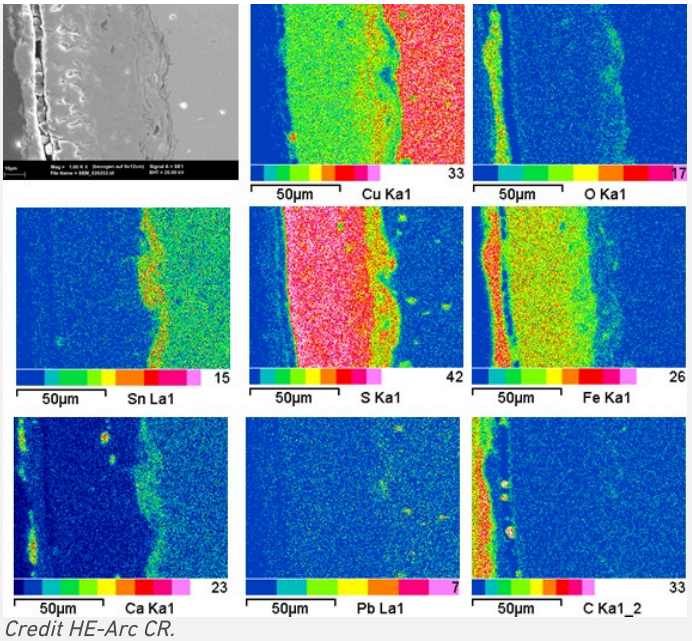
Fig. 8: SEM image, SE-mode, and elemental chemical distribution of the selected area of Fig. 6 (reversed picture). Method of examination: SEM/EDX, Laboratory of Analytical Chemistry, Empa,

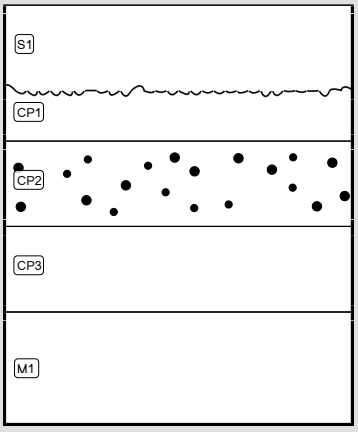
The metal has lost most of its original corrosion crust, the remainder having an average thickness between 60 and 190µm (Fig. 3). In some areas up to three corrosion layers are visible (Fig. 7). In polarised light (Fig. 8), the corrosion stratigraphy appears more clearly: it is composed of a dense black inner layer, an intermediate thick brown layer with bright spots (indicating porosity) and an outer red layer with white particles. The elemental chemical distribution of the SEM image reveals that the black inner layer is Sn-rich but contains Cu, O, Ca, S and Fe (Table 3, Fig. 9). The brown layer contains S, Fe, and Cu and has a composition similar to chalcopyrite/$CuFeS_2$ (Table 3, Fig. 9). The red layer is an iron oxide (main elements Fe and O) and is contaminated with calcite/$CaCO_3$ particles (Table 3, Fig. 9). XRD analyses of the brown layer by Schweizer confirms the presence of chalcopyrite (1994, museum report (1987)).

Corrosion form	Uniform - pitting
Corrosion type	Type I (Robbiola)

Fig. 4: Stratigraphic representation of the object in cross-section using the MiCorr application. This representation can be compared to Fig. 9.

The tang fragment is made from a leaded bronze and has been cold worked on the top surface after annealing. The SEM/EDX examination and past XRD analyses indicate the presence of chalcopyrite in the corrosion crust, typical of lake context (Schweizer 1994), enriched with Sn close to the metal surface and depleted of Cu on the outer surface. This object was certainly abandoned rather quickly in an anaerobic, humid and S and Fe-rich environment, favouring then the formation of chalcopyrite. The limit of the original surface most probably lies between the Sn-rich inner layer and the Fe and S-rich outer layers. The presence of iron oxides on top of the copper corrosion crust has not yet been explained. The corrosion is a type 1 according Robbiola et al. 1998.
