TANG FRAGMENT OF A KNIFE HR-6246 - TIN BRONZE - LATE BRONZE AGE - SWITZERLAND

Artefact name Tang fragment of a knife HR-6246

Authors Marianne. Senn (EMPA, Dübendorf, Zurich, Switzerland) & Christian. Degrigny (HE-Arc CR, Neuchâtel, Neuchâtel, Switzerland)

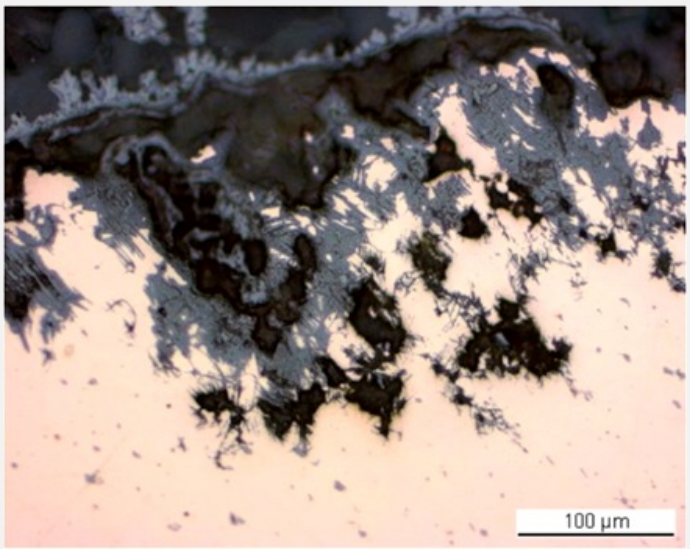
Fig. 3: Micrograph of the cross-section showing the locations of Figures 4 to 10,

The remaining metal is a tin bronze (Table 1) with high porosity and large cracks both on the left and right edges of the sample (Fig. 3). The metal contains small, elongated copper sulphide (Table 2) and Pb inclusions that are oriented parallel to the cracks. Near the metal surface, slip lines are outlined by the development of intergranular corrosion (Fig. 4). The etched metal shows small, elongated grains with slip lines (Fig. 5). Annealing is visible in areas near the surface. The average hardness of the metal is HV1 145, but significant variations are observed, depending on where the measurements are taken.

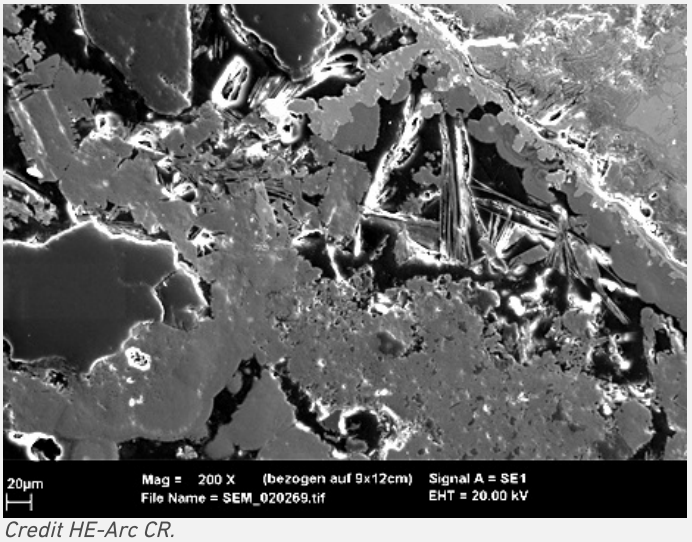
The corrosion crust has a thickness between 0.1mm and 0.7mm (Fig. 3). In bright field (Fig. 6), one can observe that the metal has been replaced by light-grey corrosion products. Adjacent to the metal is a thick, heterogeneous, dark-grey layer with a band of light-grey corrosion products. In polarised light (Fig. 7), all corrosion products which were previously light-grey appear brown-orange, the dark-grey layer turquoise. The elemental chemical distribution of the SEM image (Figs. 8 and 9) reveals that the inner corrosion products are Sn-rich whereas the adjacent band is Cu and S-rich (Fig. 10). The outer layer contains large inclusions (quartz and others, Si, Al and Na, see Figs. 9-10) and is most probably composed of malachite/Cu2(CO3)(OH)2 (only Cu and O are detected – Fig. 10). S is distributed throughout this layer. XRD analyses indicated the presence of posnjakite/Cu4SO4(OH)6H2O, chalcocite/CuS and djurleïte/Cu1.93S (Schweizer 1994).

Fig. 6: Micrograph of the metal sample from Fig. 3 (detail), unetched, bright field. The inner light-grey corrosion products extend into the metal surface (in pink) and appear as a line within the dark-grey corrosion layer,

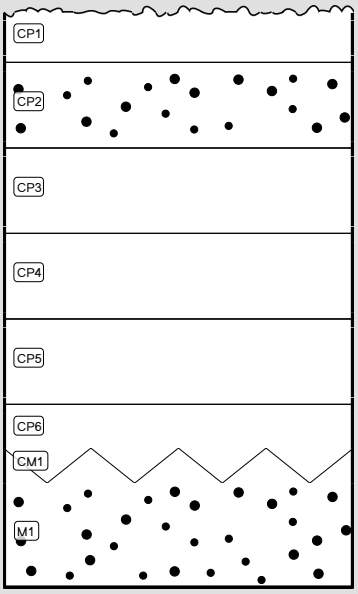
Fig. 4: Stratigraphic representation of the object in cross-section using the MiCorr application. This representation can be compared to Fig. 8.
