VOTIVE FIGURE OF A BAT IVB4168 – GILDED BRASS

Artefact name	Votive figure of a bat IVb4168
Authors	Christian. Degrigny (HE-Arc CR, Neuchâtel, Neuchâtel, Switzerland) & Naima. Gutknecht (HE-Arc CR, Neuchâtel, Neuchâtel, Switzerland) & Valentin. Boissonnas (HE-Arc CR, Neuchâtel, Neuchâtel, Switzerland)
Url	/artefacts/310/

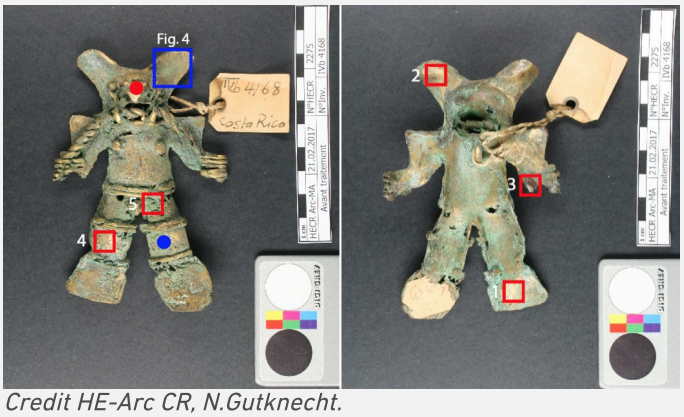
Fig. 1: Votive figure of a bat consisting of a Cu-alloy, front and back view,

Description of the artefact	The object represents a bat-like figure holding and chewing a rope (Fig. 1). The copper alloy was most likely cast using the lost wax process. There are remains of a surface gilding. The object has a red-brown adherent layer where the gold has flaked off with a heterogenous green and white loosely bound layer on top. Dimensions: Length = 110 mm; Width = 73mm; Height = 25mm; WT = 60g.
Type of artefact	Votive figure
Origin	Costa Rica
Recovering date	Unknown, acquisition in 1970
Chronology category	None
chronology tpq	----
chronology taq	1500 A.D.
Chronology comment	Before 1500 A.D (if original), 20th century (if replica)

The metal seems to have been heavily attacked (acid dissolution). There are several perforations on the lower part of the object, and where the gold layer is absent the surface is unevenly pitted by corrosion (Figs. 1, 2 and 7). The submetallic core is not visible from the surface.

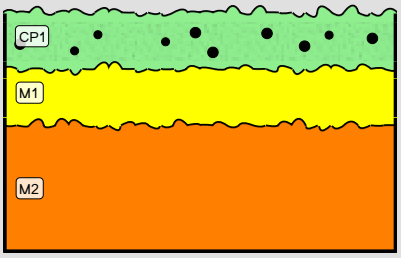
Fig 5: MiCorr stratigraphy 1 from Fig. 4, Credit HE-Arc CR, N.Gutknecht.

The dissolution of the metal and the subsequent formation of the patina is most likely the result of a forced attack with concentrated nitric acid. The holes and pits in the metal are unnatural for a natural corrosion process which would produce a stratified, adherent and thick corrosion crust (Craddock, P. (2009) p. 349-351). The copper nitrates could have formed over time from residual acidic solution that was left on the surface.

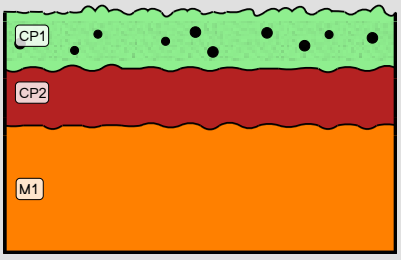
Fig. 6: MiCorr stratigraphy 2 from Fig. 4, Credit HE-Arc CR, N.Gutknecht.

There are two corrosion products (Figs. 7, 8 and 9). The red one (CP2) has a submetallic brightness and is opaque, non-magnetic, compact, hard and adherent. It is very thin (less than a few microns thick) and only appears where the

The light green to white corrosion product (CP1) has a waxy consistency and is thin, translucent, non-magnetic, powdery and very soft. It is very loosely bound. It is distributed on the whole object (front and back) as disparate clumps. It is mainly located on the cavities and irregularities of the surface. Its FTIR analysis (ATR mode) (Fig. 11) was performed on green and white areas of CP1. The two compounds have similar spectra and were identified as copper nitrate (Fig. 11b).

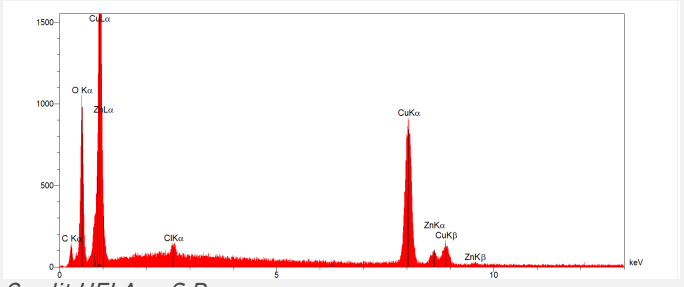
gold layer has been lost. The EDX spectrum (Fig. 10) shows that it is a Cu- and O rich product, probably cuprite (Cu2O).

Figs. 8 and 9: SEM images of the metal on the nose of the object as indicated on Fig. 2. The blue point represents the area for the EDS point analysis (Fig. 10),

Fig. 10: EDS analysis of the red corrosion product. Method of analysis: SEM-EDS, Lab of Electronic Microscopy and Microanalysis, Néode, HEI Arc,

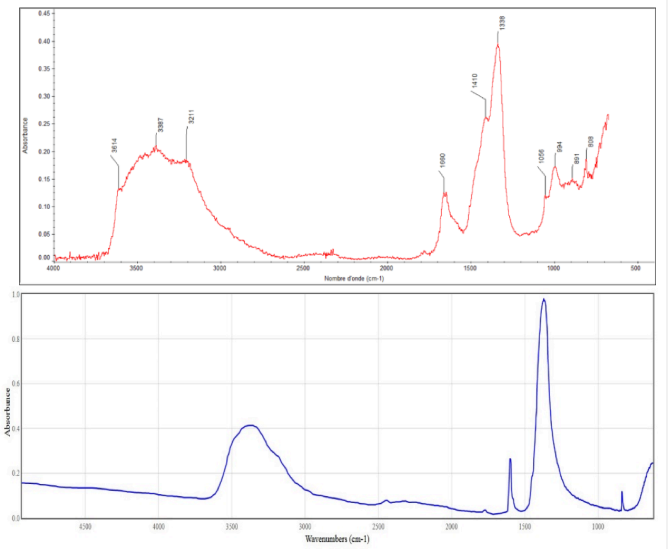
Fig. 11: FTIR spectrum (ATR mode) of the white corrosion product product (top), and of synthesized copper nitrate (Cu(NO3)2 * 3H2O) (bottom),

FTIR analysis of the green/white corrosion product suggests that it is a copper nitrate, a highly water soluble corrosion product that cannot be found in an archaeological context. However, it has been recorded on artificially patinated copper alloys (Scott, D. (2000) p. 250-251 ; Craddock, P. (2009) p. 365).
