COOKING POT HANDLE FRAGMENT V.008.2/2948.1. - LEADED BRONZE - ROMAN TIMES - SWITZERLAND

Artefact name Cooking pot handle fragment V.008.2/2948.1.

Authors Christian. Degrigny (HE-Arc CR, Neuchâtel, Neuchâtel, Switzerland) & Lucile. Ruynat (HE-Arc CR, None) & Valentin. Boissonnas (HE-Arc CR, Neuchâtel, Neuchâtel, Switzerland)

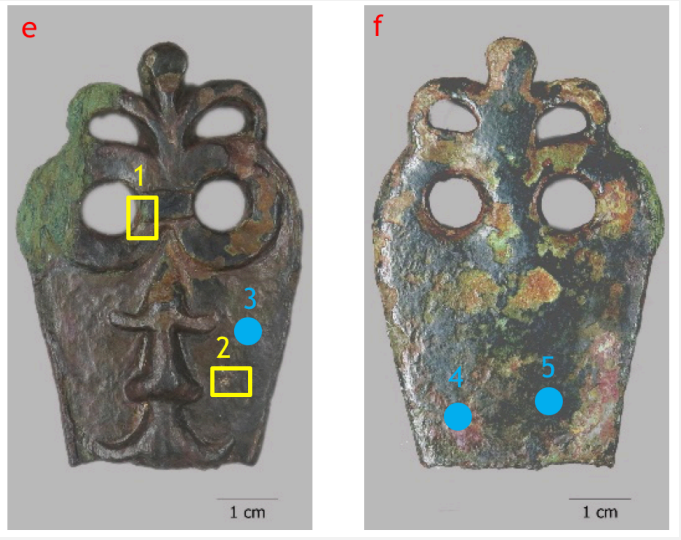
Fig. 2: Cooking pot handle after treatment: front (e) and back (f). Location of sampling for SEM-EDS, Raman (yellow square 1), XRD analyses (yellow square 1 and 2), as well as the location of the XRF analyses (blue points 3, 4, 5),

The mechanical removal of corrosion products stopped at the limitos, so the metal was not directly observed. XRF analysis carried out after the cleaning process (Fig. 2, blue dot 3) showed that the metal is a leaded bronze (Table 1). Theoretically the metal is as-cast and should present a dendritic structure.

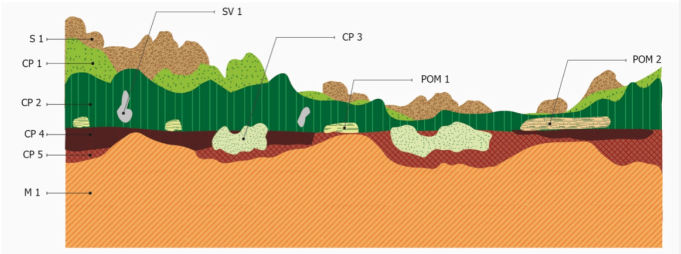
The stratigraphy below gives an overview of the corrosion layers encountered on the object from visual macroscopic observation. The stratigraphy was created before treatment by observation under a binocular microscope and modified during the mechanical removal of corrosion products.

Fig. 3: Stratigraphic representation of the artefact in cross-section based on macroscopic global observation of the object. global observation of the object. S = structural void, CP = corrosion product, POM = pseudomorph of organic material, M = metal,

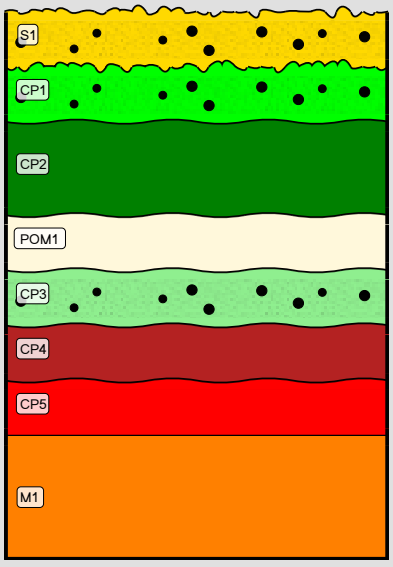
Fig. 4: Stratigraphic representation of the object in cross-section using the MiCorr application (to be compared to Fig. 3). The stratum is missing because it is integrated in CP2 and it was not possible to represent it in MiCorr while POM1 and POM2 are merged as POM1, Credit HE-Arc CR, L.Ruynat.
