COOKING POT HANDLE FRAGMENT V.008.2/2948.1. - LEADED BRONZE - ROMAN TIMES - SWITZERLAND

Artefact name Cooking pot handle fragment V.008.2/2948.1.

Authors Christian. Degrigny (HE-Arc CR, Neuchâtel, Neuchâtel, Switzerland) & Lucile. Ruynat (HE-Arc CR, None) & Valentin. Boissonnas (HE-Arc CR, Neuchâtel, Neuchâtel, Switzerland)

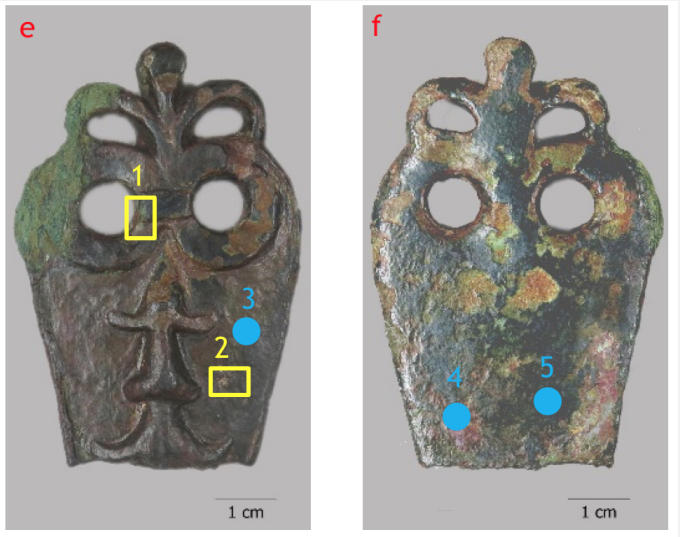
Fig. 2: Cooking pot handle after treatment: front (e) and back (f). Location of sampling for SEM-EDS, Raman (yellow square 1), XRD analyses (yellow square 1 and 2), as well as the location of the XRF analyses (blue points 3, 4, 5),

The mechanical removal of corrosion products stopped at the limitos, so the metal was not directly observed. XRF analysis carried out after the cleaning process (Fig. 2, blue dot 3) showed that the metal is a leaded bronze (Table 1). Theoretically the metal is as-cast and should present a dendritic structure.

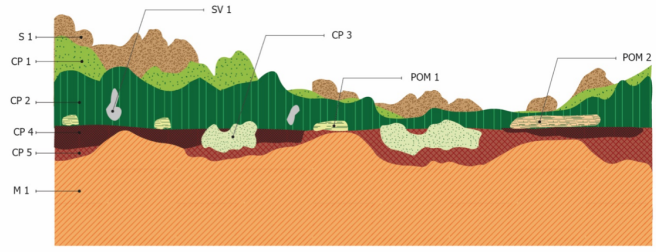
Fig. 3: Stratigraphic representation of the artefact in cross-section based on macroscopic global observation of the object. global observation of the object. S = structural void, CP = corrosion product, POM = pseudomorph of organic material, M = metal,

S1	Sediments with sand forming isolated and highly porous ochre-colored clusters
CP1	Scattered clusters of highly porous medium green corrosion product
CP2	Continuous layer of compact dark green corrosion product
SV1	Structural voids within CP2
POM1	Pseudomorphs of organic remains
POM2	Pseudomorphs of wood remains
CP3	Scattered clusters of highly porous light green corrosion product
CP4	Discontinuous layer of compact dark-red corrosion products
CP5	Discontinuous layer of compact red corrosion product
M1	Continuous and compact metal

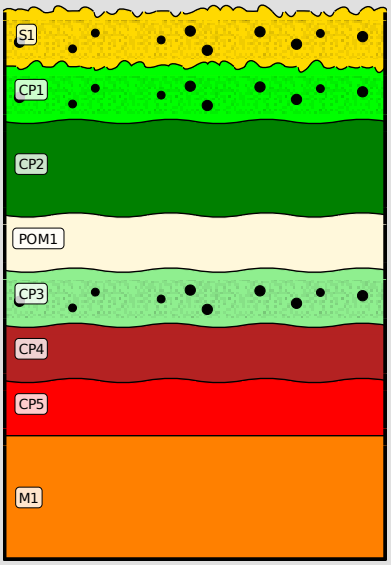
Fig. 4: Stratigraphic representation of the object in cross-section using the MiCorr application (to be compared to Fig. 3). The stratum is missing because it is integrated in CP2 and it was not possible to represent it in MiCorr while POM1 and POM2 are merged as POM1, Credit HE-Arc CR, L.Ruynat.

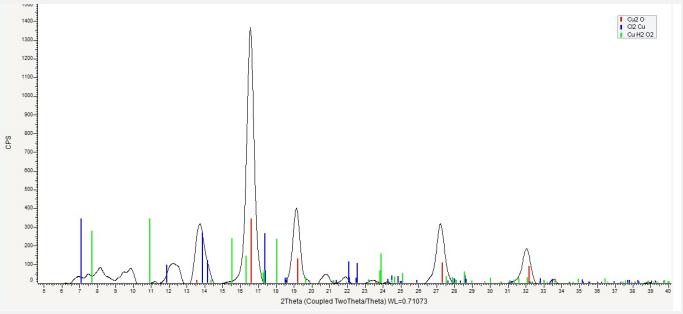
Above the well-preserved metal core, CP4 is discontinuously interlocked in CP5. The XRD analysis done on a sample (Fig. 2, yellow square 2) of both corrosion products, shows that they are mainly constituted of cuprite (Cu2O), (Fig. 5). The colour difference can be explained by a tin enrichment in the darker CP4, as measured by XRF. XRF analysis of CP4 (Fig. 2, blue dot 5) and CP5 (Fig. 2, blue dot 4) is given in Table 2. The EDS analysis of the light green CP3 (yellow square 1 Fig. 2) layer did not reveal the presence of chlorides (Fig. 6). Complementary XRD analysis validated the absence of nantokite. Indeed the XRD and Raman indexing was not successful probably because the compound has a large

Fig.5: XRD spectrum of CP4 and CP5, Method of analysis: XRD, Center for X-ray Analytics, Empa,

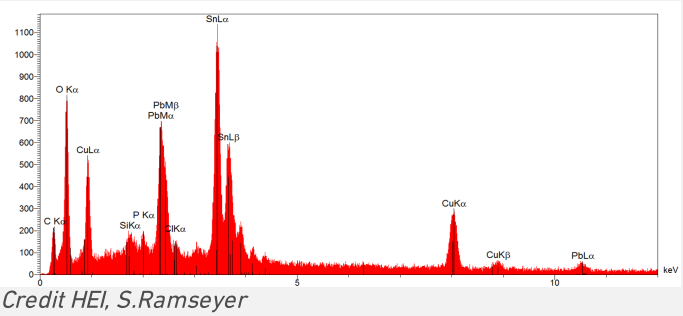
Fig. 6: EDS spectrum representative of the light green corrosion product (CP3). Method of analysis: SEM-EDS, Lab of Electronic Microscopy and Microanalysis, IMA (Néode), HEI Arc,

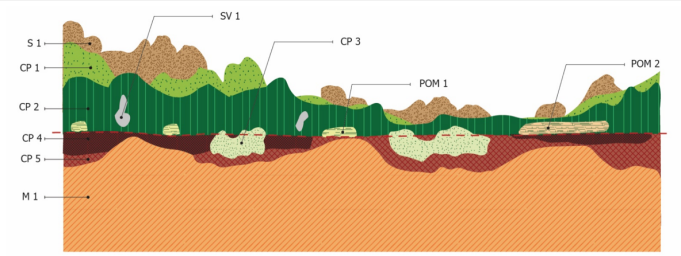
S1: Sediments	Soil and sand
CP1: Outer light green corrosion clusters	Malachite?
CP2: Outer dark green corrosion layer	Malachite?
SV1	Structural voids within CP2
POM1: Pseudomorphs of organic remains	Stems, grass within CP2
POM2: Pseudomorphs of organic remains	Wood within CP2
CP3: Outer/inner isolated light green corrosion product	No Nantokite, No Malachite
CP4: Inner black-dark red corrosion layer	Main phase: Cuprite Tin enrichment
CP5: Inner red corrosion layer	Main phase: Cuprite
M1: Orange Metal	Bronze with high lead content, probably with dendrites (as-cast)

Fig. 7: Improved stratigraphic representation of the artefact from visual observations and analyses,

The object is a leaded bronze with a well-preserved metal core. Covering the metal are two strata (CP4 and CP5) composed of cuprite, the darker (CP4) appears enriched in tin. The superior interface of these layers represents the limitos. In areas the limitos, CP4 and CP5 have been replaced by a light green porous corrosion product (CP3). The following layers CP2 and CP1 are probably malachite.

The powdery green corrosion layer CP3 has frequently been observed on bronzes of Vindonissa where it can be located within cuprite or malachite layers. It is typically developed below the limitos and renders the latter extremely fragile. The nature of this corrosion product has not yet been determined. However, the absence of chlorine indicates that it is not a chlorinated corrosion product such as atacamite or paratacamite. The aggressive urban soil could be a reason for the transformation of these naturally grown and stable corrosion layers.
