SWORD M-SCH-B2735 - P-RICH IRON - IRON AGE - SWITZERLAND

Artefact name	Sword M-Sch-B2735
Authors	Marianne. Senn (EMPA, Dübendorf, Zurich, Switzerland) & Christian. Degrigny (HE-Arc CR, Neuchâtel, Neuchâtel, Switzerland)
Url	/artefacts/316/

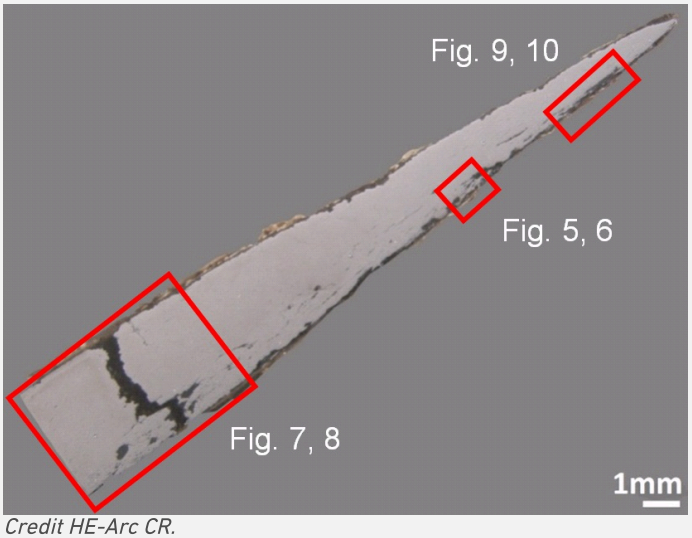
Fig. 3: Micrograph of the cross-section showing the location of Figs. 5 to 10,

Description of sample	The sample includes half of the sword blade (Figs. 2 and 3). The corrosion layer is thin (Fig. 3).
Alloy	P-rich iron
Technology	Forged, annealed and cold worked
Lab number of sample	M-SCH-B2735
Sample location	Empa (Marianne Senn)
Responsible institution	Schweizerisches Landesmuseum, Zürich, Zurich
Date and aim of sampling	1969, metallography

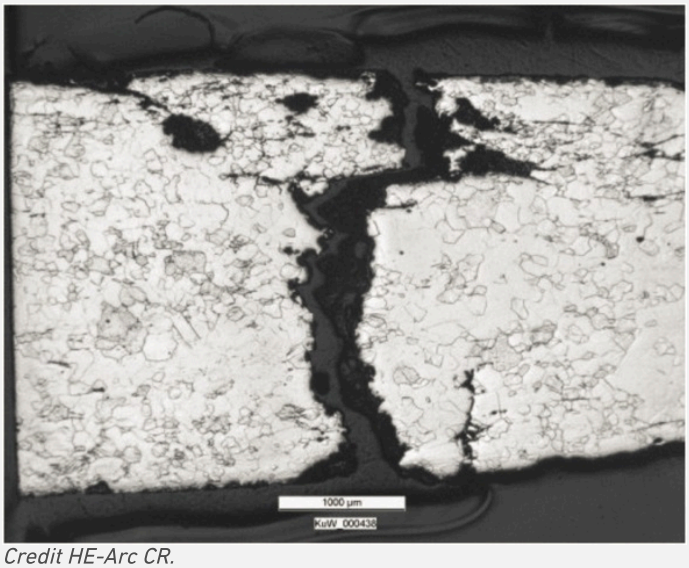
Fig. 7: Micrograph of the metal sample from Fig. 3 (reversed picture, rotated by 225°, detail), etched, bright field. Metal with a large pre-existing crack and ferritic, recrystallized structure. Grains have different sizes,

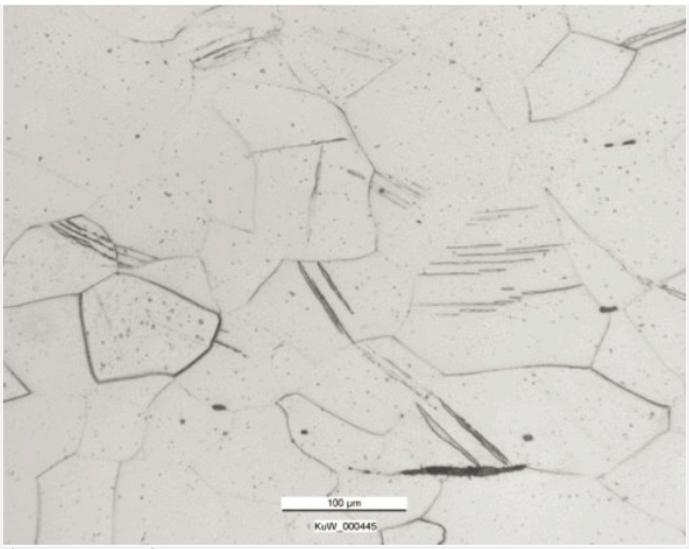
Fig. 8: Micrograph (detail of Fig. 7), etched, bright field. Ferrite grains including Neumann bands formed after cold working in a P-rich iron,

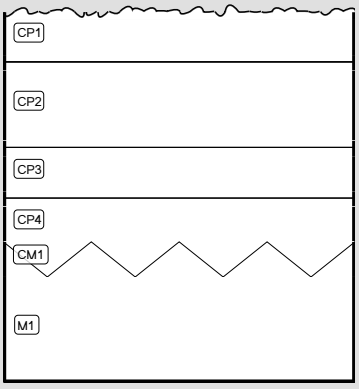
Fig. 4: Stratigraphic representation of the object in cross-section using the MiCorr application. This representation can be compared to Fig. 9.
