TANG FRAGMENT OF A KNIFE HR-6246 - TIN BRONZE - LATE BRONZE AGE - SWITZERLAND

Artefact name Tang fragment of a knife HR-6246

Authors Marianne. Senn (EMPA, Dübendorf, Zurich, Switzerland) & Christian. Degrigny (HE-Arc CR, Neuchâtel, Neuchâtel, Switzerland)

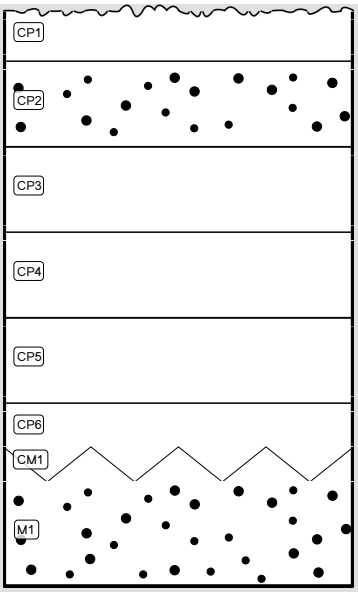
Fig. 4: Stratigraphic representation of the object in cross-section using the MiCorr application. This representation can be compared to Fig. 8.
