ROUND BRACELET WITH UNIFORM INCLINED INDENTATIONS B3482 – LEADED BRONZE – LATE BRONZE AGE – SWITZERLAND

Artefact name	Round bracelet with uniform inclined indentations B3482
Authors	Marianne. Senn (EMPA, Dübendorf, Zurich, Switzerland) & Christian. Degrigny (HE-Arc CR, Neuchâtel, Neuchâtel, Switzerland)
Url	/artefacts/323/

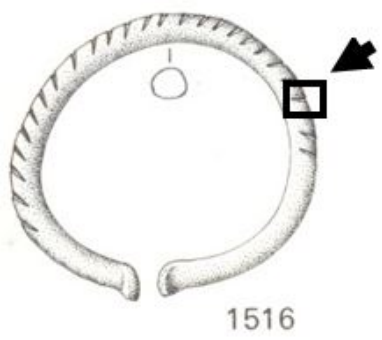
Fig. 2: Location of sampling area,

Description of sample	The sample is a section from the central part of the bracelet (Fig. 2). Its dimensions are: L = 2.5mm and W = 0.65mm. The corrosion layer is relatively thin (Fig. 3).
Alloy	Leaded Bronze
Technology	As-cast
Lab number of sample	MAH 77-110-5
Sample location	Musées d'art et d'histoire, Genève, Geneva

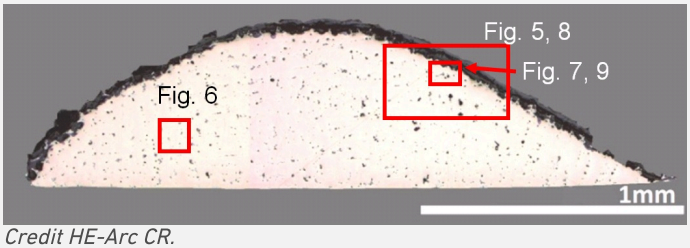
Fig. 3: Micrograph of the cross-section showing the location of Figs. 5 to 9,

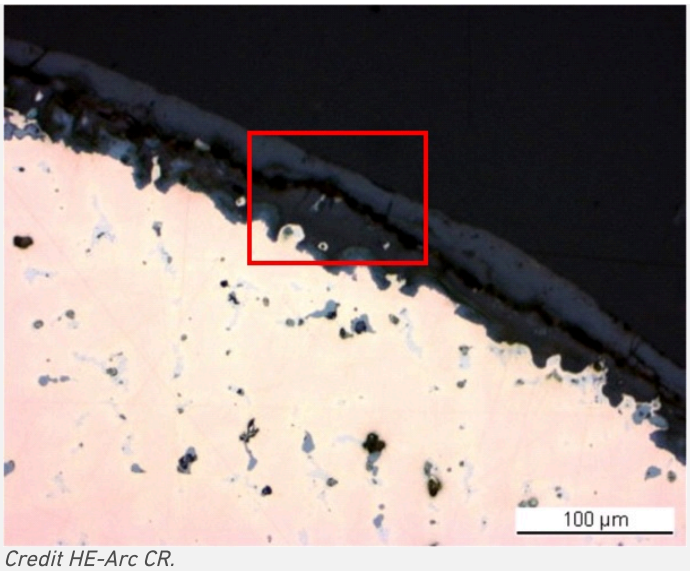
The remaining metal is a porous leaded bronze (Fig. 5 and Table 1). In bright field dark-blue copper sulphide (Fig. 5, Table 2) and tiny dark-grey Pb inclusions (Fig. 5) can be seen. The Sn-rich eutectoid alpha + delta phase appears in light-blue (Fig. 5) and incorporates Pb-rich inclusions. The etched leaded bronze has the dendritic structure of an as-cast metal (Fig. 6) with an average hardness HV1 90. After etching the inclusions have turned darker (Fig. 6) while the eutectoid phase appears whiter.

Fig. 5: Micrograph of the metal sample from Fig. 3 (detail), unetched, bright field. In pink the metal with porosity (black), light-blue the alpha-delta eutectoid, dark-grey lead inclusions and dark-blue copper sulphide inclusions. The rectangle marks the detail image of Fig. 7,

The interface between the metal and corrosion products is irregular (Fig. 5). The corrosion crust has an average thickness of 70µm and is composed of two layers separated by a large fissure (Fig. 5). In bright field, the inner layer includes remnant metal (Sn-rich eutectoid phase, Figs. 5 and 7) and is dark-grey (Fig. 5) while in polarised light it is orange-brownish (CP3, Fig. 8). This Cu depleted layer is rich in Sn, Fe, Si and O (Table 3 and Fig. 8). At the metal - inner layer interface a corrosion product (CP4, light-grey in bright field, greenish in polarised light) shows a slight increase in Cu and Sn content but a decrease of the Fe content (Table 3). In bright field, the outer dense layer is light-grey (CP2, Fig. 5) while in polarised light it appears black with superimposed red to orange areas (CP1, Fig. 8). It is depleted of Cu and richer in Fe. The Sn content is variable but increases in the top brown areas (Table 3 and Fig. 9).

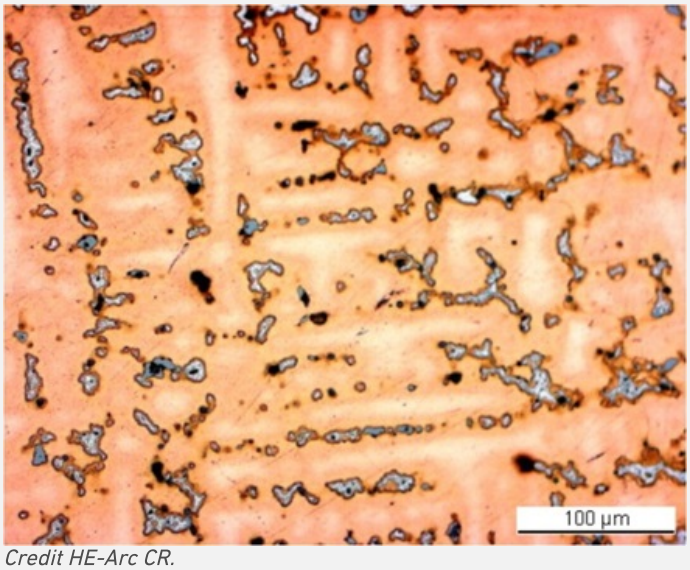
Fig. 6: Micrograph of the metal sample from Fig. 3 (detail), etched, bright field. The leaded bronze has the dendritic structure of an as-cast metal with the Sn-rich eutectoid alpha + delta phase appearing in white at the dendrites borders,

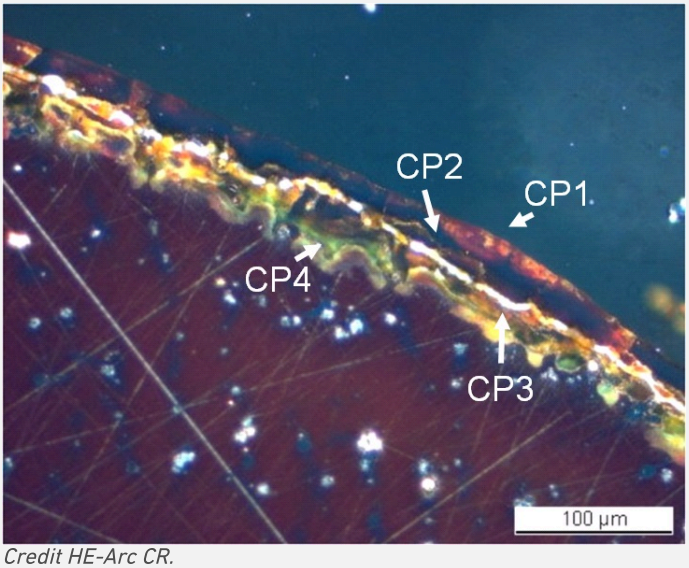
Table 3: Chemical composition (mass %) of corrosion layers from Fig. 8. Method of analysis: SEM/EDS, Laboratory of Analytical Chemistry, Empa.

Fig. 8: Micrograph similar to Fig. 5 and corresponding to the stratigraphy of Fig. 4, polarised light. From bottom left to top right: the metal with blue inclusions and porosities in white, the inner corrosion layer in green, red and orange waves, the fissure in white and the outer corrosion layer in black and red (top zone),

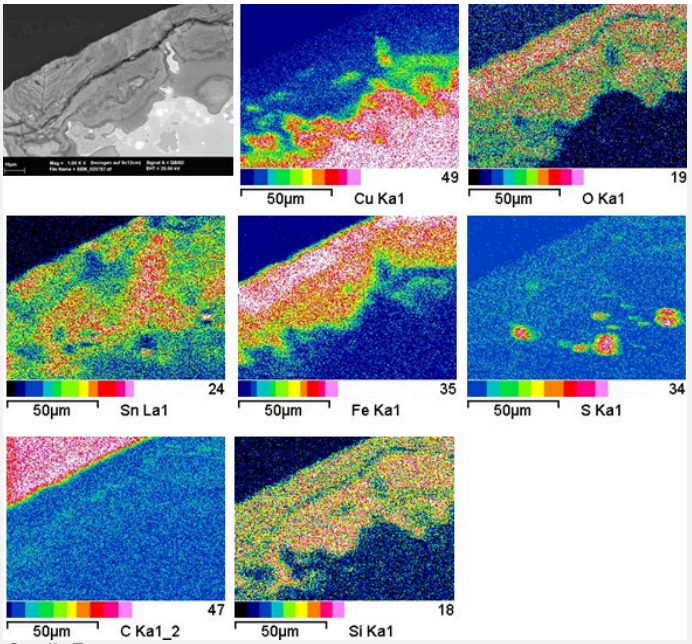
Fig. 9: SEM image, BSE-mode, and elemental chemical distribution of the selected area of Fig. 7. The S mapping includes the copper sulphide and Pb inclusions, because of a peak interference. Method of examination: SEM/EDS, Laboratory of Analytical Chemistry, Empa,

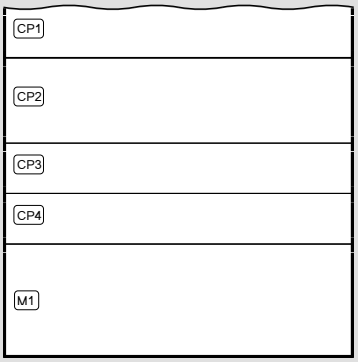
Fig. 4: Stratigraphic representation of the object in cross-section using the MiCorr application. This representation can be compared to Fig. 8.
