KNIFE WITH A GROOVE ON BOTH SIDES DEV 995 814 PR – FE ALLOY – EARLY MEDIEVAL TIMES – SWITZERLAND

Artefact name	Knife with a groove on both sides DEV 995 814 PR
Authors	Marianne. Senn (EMPA, Dübendorf, Zurich, Switzerland) & Christian. Degrigny (HE-Arc CR, Neuchâtel, Neuchâtel, Switzerland)
Url	/artefacts/326/

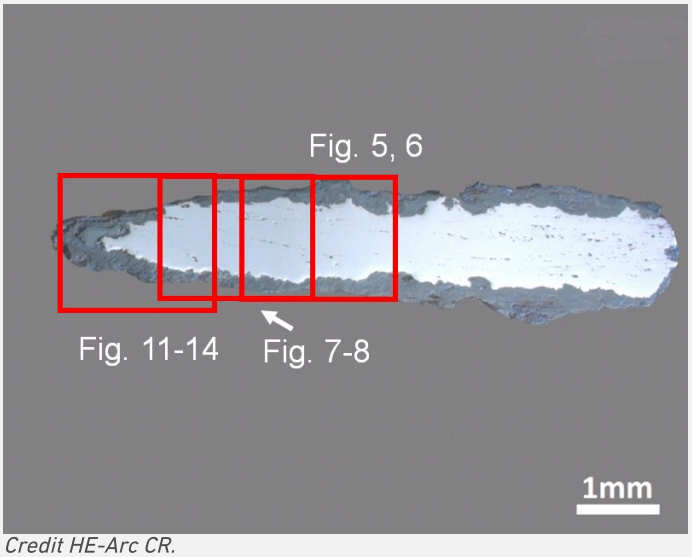
Fig. 1: Iron and steel knife (after Eschenlohr et al., 2007, 266 & 302),

Description of the artefact	Knife, with a groove on both sides of the blade spine (Fig. 1). Dimensions: L = 20.1cm; WT = 30g.
Type of artefact	Household implement
Origin	Settlement Develier, Courtételle, Jura, Switzerland
Recovering date	Excavated in 1995, farm 1
Chronology category	Early medieval times
chronology tpq	550 A.D.
chronology taq	750 A.D.
Chronology comment	550 _ 750 AD
Burial conditions / environment	Soil
Artefact location	Office de la Culture, Porrentruy, Jura
Owner	Office de la Culture, Porrentruy, Jura
Inv. number	DEV 995/814 PR
Recorded conservation data	Conserved between 1995 and 2000: desiccation below 80°C, mechanical cleaning, passivation with tannic acid and protection with Paraloid B72® (Eschenlohr et al. 2007, 75).

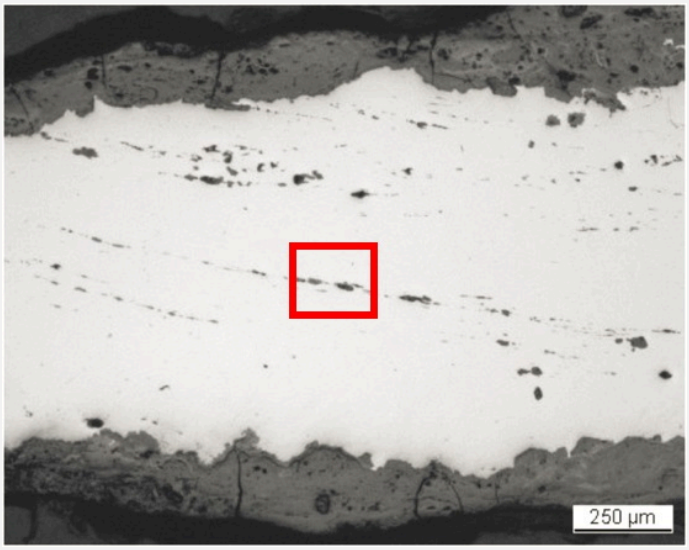
Table 2: Chemical composition of the slag inclusions (mass%) at the tip (pearlite) and the body (ferrite) of the knife. Method of analysis: SEM/EDS, Laboratory of Analytical Chemistry, Empa.

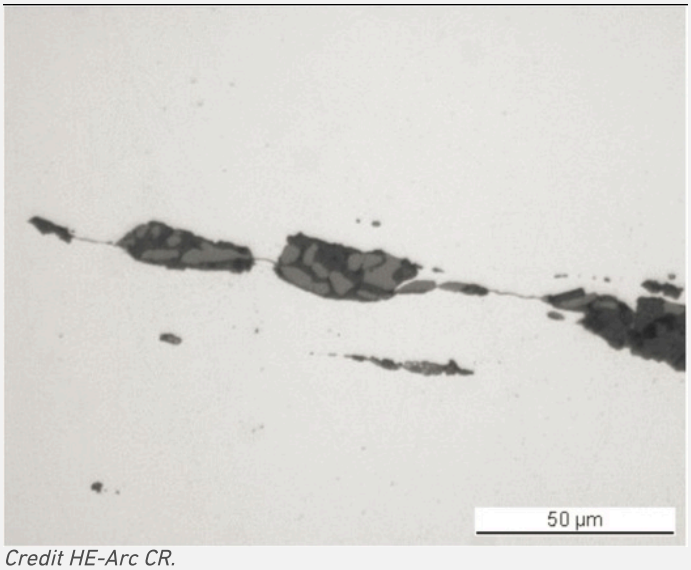
Fig. 5: Micrograph of the metal sample from Fig. 3 (detail), unetched, bright field. In white the metal, in light-grey the slag inclusions and the corrosion layer. The micrograph of Fig. 6 is marked by a rectangle,

The metal - corrosion products interface is irregular (Figs. 3, 5 and 11) and the average thickness of the corrosion crust is 200µm. In bright field, the corrosion appears grey, rather heterogeneous and heavily cracked. A thin light-grey layer (indicated by an arrow in Fig. 11) can be detected. Under polarised light the corrosion is more clearly stratified, the thin layer mentioned before is black (CP3) and surrounded by dark-brown (CP2) and orange-red (CP1) corrosion layers (Figs. 12 and 13). It contains less O (magnetite or hematite?) than the orange-brown corrosion products (iron hydroxides?) (Table 3 and Fig. 14). The outer corrosion layer (covering the aforementioned thin black layer) contains external markers such as quartz grains and other rock fragments (Ca, Fig. 14). The shape of the blade is preserved in the corrosion crust (Fig. 14, arrows on the SEM image). The absence of P, an external marker, highlights where the limit of the original surface was located (interface CP1 / CP2).

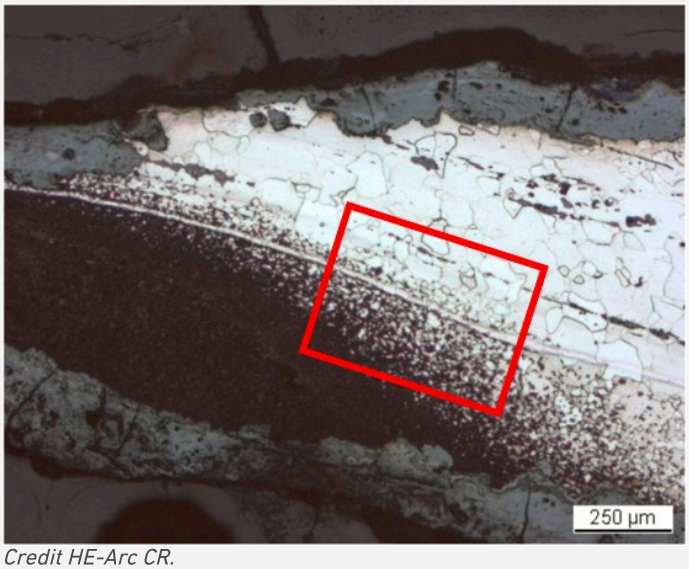
Fig. 6: Micrograph (detail of Fig. 5), unetched, bright field. The slag inclusions have a structure of wüstite dendrites (light-grey) in a glassy matrix (dark-grey),

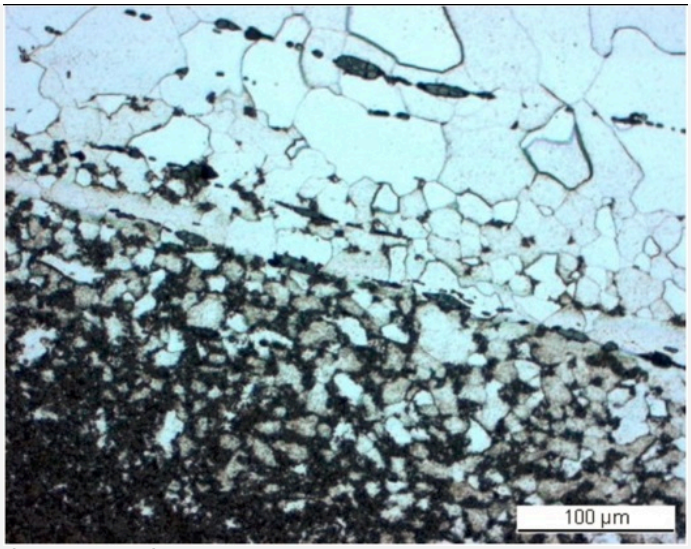
Fig. 7: Micrograph of the metal sample from Fig. 3 (detail), nital etched, bright field. In white we observe the ferrite, in black or dark-grey the pearlite and bainite. The micrograph of Fig. 8 is marked by a rectangle,

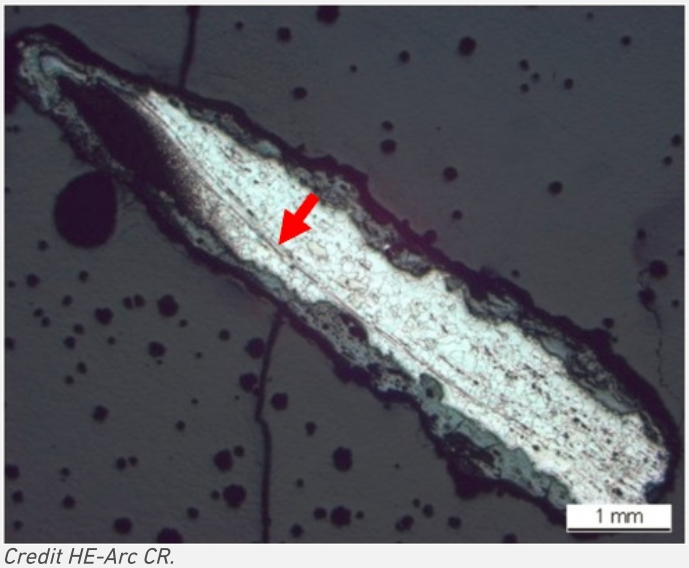
Fig. 8: Micrograph (detail of Fig. 7), nital etched, bright field,

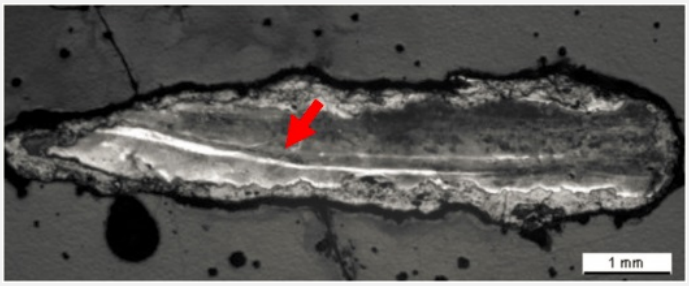
The remaining metal consists of two forged wrought iron bars, one of which includes a carburized tip (M1, Table 1). They are separated by a welding seam (M2, Figs. 9 and 10). The ferritic part (M3) is Cu-rich, whereas the carburized tip has a low and medium content of trace elements (Table 1). The metal contains elongated slag inclusions (Fig. 5) showing a structure of wüstite (FeO) in a glassy matrix (Fig. 6 and Table 2). Most of the slag inclusions are arranged in rows, marking the welding seam (Figs. 5 and 9) and following the forging direction. Their chemical composition differs in the Mn content (Table 2): the latter is higher in the slag inclusions of the carburized tip. The high P content of the slag in the ferritic part must be noted since the metal in general has a medium P content (Tables 1 and 2). Etching with Oberhoffer's reagent solution makes the P distribution visible (Fig. 10). Dark areas are depleted of P whereas P-rich zones, such as those found in the welding seam, appear in white. After nital etching, the very fine steel microstructure of the tip shows the transition from hypoeutectoid to eutectoid steel (ferrite component in white and pearlite component in black, partly bainite, Figs. 7, 8 and 9). The body of the knife is made of wrought iron with an annealed, irregular ferritic structure (Figs. 7 and 8). The average hardness of the wrought iron (HV1 130) is a little higher than expected, whereas the hardness of steel in the hypoeutectoid-eutectoid tip (HV1 360) is an indication of quench-hardening followed by tempering.

Fig. 9: Micrograph of the metal sample from Fig. 3 (rotated by 45°), nital etched, bright field. In white we observe the ferrite, in black or dark-grey the pearlite. The red arrow shows the welding seam,

Fig. 10. Micrograph of the metal sample from Fig. 3, etched with Oberhoffer's reagent. The welding seam appears in white (red arrow),

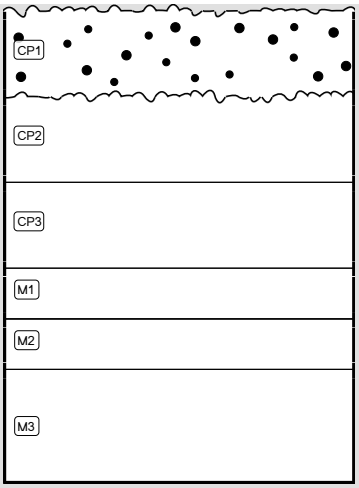
Fig. 4: Stratigraphic representation of the object in cross-section using the MiCorr application. This representation can be compared to Fig. 13.
