FITTING ON BACK PANEL OF A MILITARY CARRIAGE – THOMAS STEEL – MODERN TIMES – SWITZERLAND

Artefact name	Fitting on back panel of a military carriage
Authors	Marianne. Senn (EMPA, Dübendorf, Zurich, Switzerland) & Christian. Degrigny (HE-Arc CR, Neuchâtel, Neuchâtel, Switzerland)
Url	/artefacts/329/

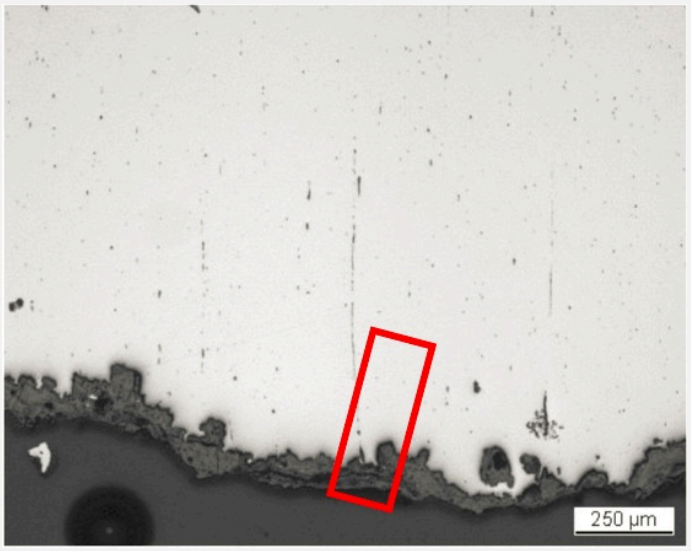
Fig. 3: Micrograph of the cross-section showing the location of Figs. 5 and 7 to 11,

Description of sample	This sample is a cut from the corner of one of the two fittings on the back panel (Fig. 2). The metal is covered by a thin corrosion layer (Fig. 3).
Alloy	Thomas steel
Technology	Piled from several strips, hot rolled and annealed
Lab number of sample	POINT-Fe2
Sample location	Empa (Marianne Senn)
Responsible institution	Historical Swiss Army Material Foundation, Burgdorf, Bern
Date and aim of sampling	05/2009 metallography

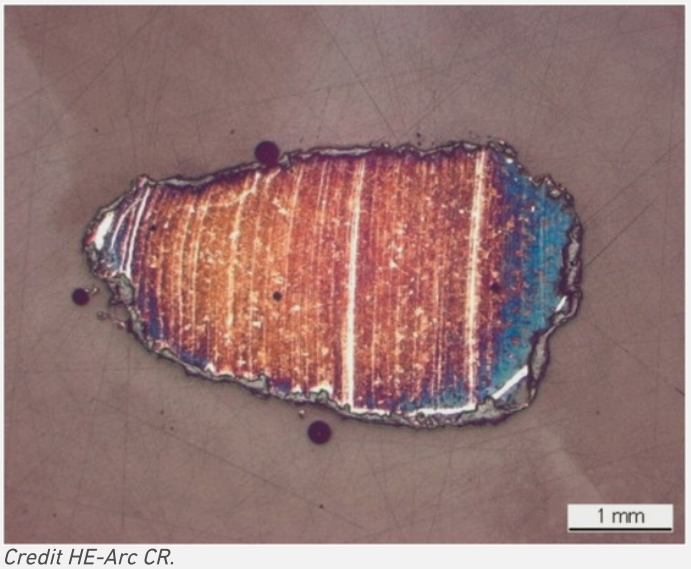
The remaining metal is a Mn-rich soft steel (C content around 0.1 mass%) containing manganese sulphide inclusions with a varying Fe content (Tables 1 and 2). The numerous inclusions form parallel rows (Fig. 5). This orientation is typical for hot rolled metal. After etching with Oberhoffer's reagent, three main welding seams (P-rich) become visible (Fig. 6). Near the surface they are also outlined by corrosion (Figs. 5 and 11). After nital etching, the metal shows a ferritic structure with tertiary cementite and lamellar pearlite at the grain boundaries (Figs. 7 and 8). The grains are small with an ASTM grain size of 10 and are recrystallized due to annealing after hot rolling. The average hardness of the metal is HV1 165. The hardness is slightly high for such a structure and this is due to the Mn content of the metal. The chemical composition, especially the Mn content and the presence of carbo-nitrides (not analysed here), is typical for Thomas steel.

Fig. 5: Micrograph of the metal sample from Fig. 3 (rotated by 270°, detail), unetched, bright field. We observe the metal including welding seams outlined by corrosion products and MnS inclusions. The mapped area of Fig. 11 is marked by the rectangle,

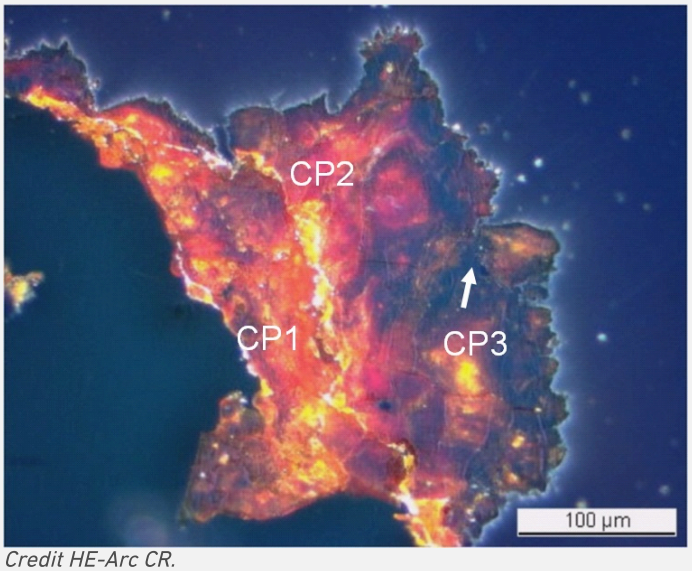
The average thickness of the corrosion products is about 80µm (Figs. 5 and 9). In bright field they appear grey, marbled and heavily cracked (Fig. 9). Under polarised light, the corrosion products appear orange to dark-brown (Fig. 10). At the metal - corrosion products interface they are dark-brown (CP3). The middle part (CP2) is red-orange and the outer part is bright orange (CP1). The elemental mapping of the corrosion layers shows no distinctive stratification, but areas near the metal - corrosion crust interface (CP3) as well as the top surface of the corrosion layer (CP1) seem to have a lower O content (Fig. 11). The O content indicates the presence of iron hydroxides (Table 3). Soil materials (such as rock fragments and dust) are found in the welding seams near the surface.

Fig. 9: Micrograph showing the metal - corrosion crust interface from Fig. 3 (rotated by 270°, detail), unetched, bright field. We observe in white the metal, in grey the corrosion products and in black the resin,

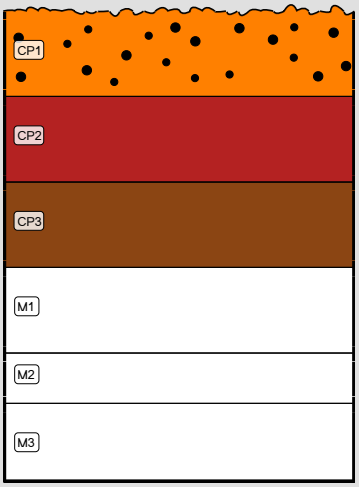
Fig. 4: Stratigraphic representation of the object in cross-section using the MiCorr application. This representation showing for the metal part a welding seam (M2) can be compared to Fig. 10.
