FRAGMENT OF THE SUPPORT STRUCTURE OF AN ENGINE VHS-404 - GREY CAST IRON - MODERN TIMES

Artefact name	Fragment of the support structure of an engine VHS-404
Authors	Marianne. Senn (EMPA, Dübendorf, Zurich, Switzerland) & Christian. Degrigny (HE-Arc CR, Neuchâtel, Neuchâtel, Switzerland)
Url	/artefacts/330/

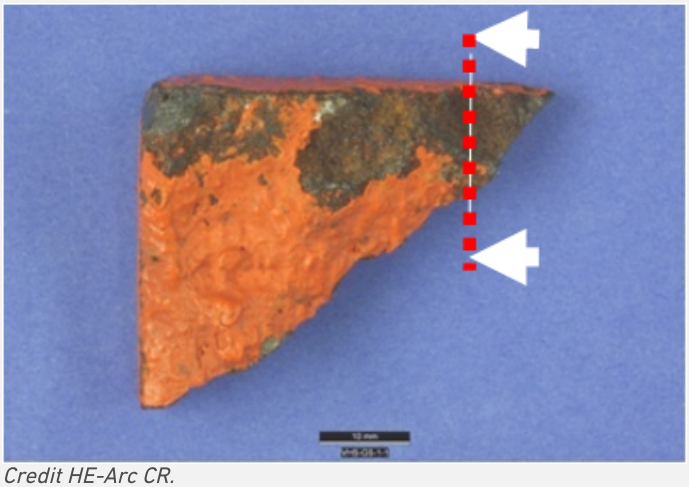
Fig. 2: Location of sampling area,

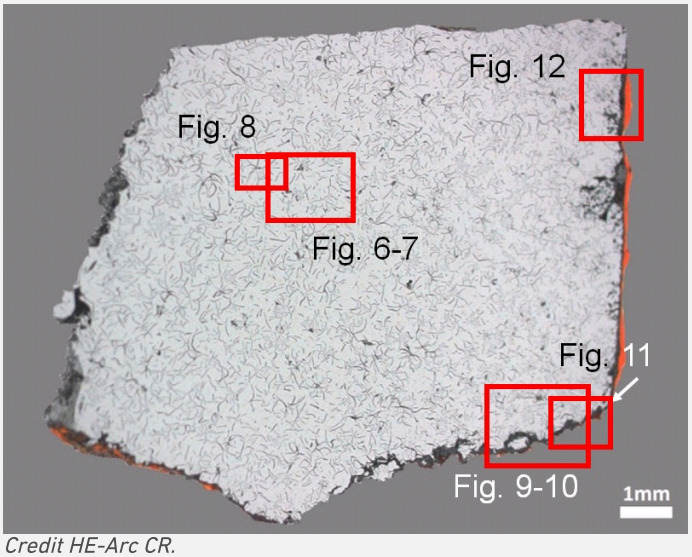
Fig. 3: Micrograph of the cross-section showing the location of Figs. 5 to 12,

The thin corrosion crust (CP1) is limited to three sides of the sample and some remains of a paint coating (orange) are visible (Fig. 3). In bright field, the corrosion crust appears light-grey (Fig. 9), under polarised light-orange (Fig. 10). It is mainly composed of iron oxides (Table 3 and Fig. 11). The Pb and Ba-rich paint system has been applied directly onto the oxidized Fe, Si and Mn-rich casting skin (Fig. 11). The paint layer is probably an anodic inhibitor made from minium (red lead) with a barium sulphate filler. Because of the interference of Pb with S in the EDS spectra S is difficult to detect.

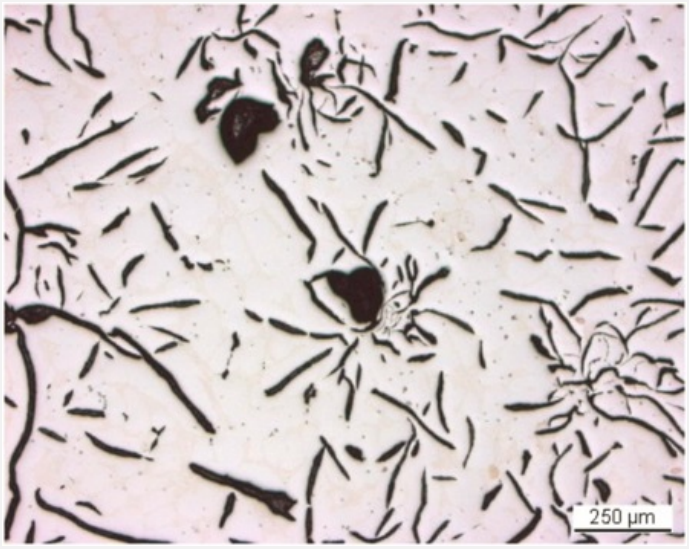
The remaining metal is a high P and Si grey cast iron with elevated Mn and V contents (Tables 1 and 2). The structure contains black graphite flakes and graphite nodules (Fig. 5) as well as angular grey manganese sulphide inclusions which can contain a dark alumina-rich centre (Fig. 5 and Table 1). The graphite flakes are irregular and vary in size. At low magnification the flakes are evenly spread over the entire surface with a tendency to form clusters. Some porosity is noticeable. Under SEM, in the BSD-mode, an additional eutectic phase is visible (Fig. 6). After etching one can see how the graphite is surrounded by alpha-iron in a pearlite matrix (Figs. 7 and 8). The lamellar pearlite includes steadite (Fe_3P) and manganese sulphide (MnS) inclusions. According to the cast iron diagram after Maurer (Bargel and Schulze 2008, 257), the structure is typical for a hypoeutectic pearlitic grey cast iron (C content <4.3 mass%, Si content ca. 2.0 mass%) including pearlite, steadite and graphite. The slow cooling rate and the higher Si level have favoured the formation of graphite. The high P content favours the growth of interconnected networks of steadite. The average hardness of the metal is HV1 160. This hardness is only approximate. Normally cast iron hardness is determined with a Brinell test, but due to the small size of the sample this could not be carried out. The calculated HB is about 150.

Fig. 5: Micrograph of the metal sample from Fig. 3 (inverted picture, detail), unetched, bright field. We observe graphite flakes and irregular nodules in black and the metal in white. The small grey spots are manganese sulphide inclusions,

Fig. 6: SEM image from Fig. 3 (detail), BSE-mode, unetched. We observe the graphite flakes in black, the manganese sulphide inclusions in grey and the eutectic mixture in light-grey,

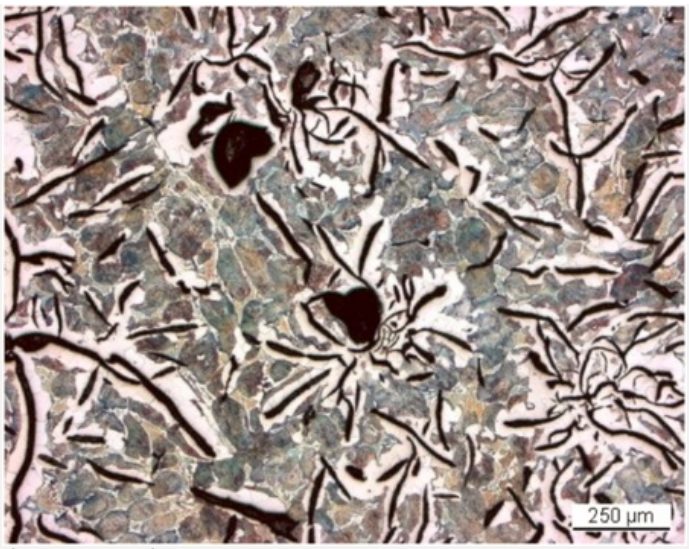
Fig. 7: Micrograph (same as Fig. 5), etched, bright field. In between the black graphite flakes we observe alpha-iron in white and pearlite / steadite in grey,

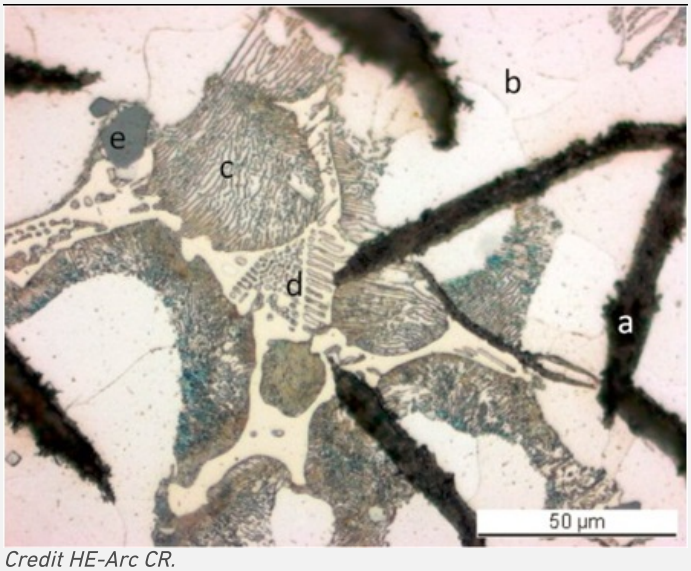
Fig. 8: Micrograph of the metal sample from Fig. 3 (detail), etched, bright field. The structure is composed of graphite (a), ferrite (b), pearlite (c), steadite (d) and MnS inclusions (e),

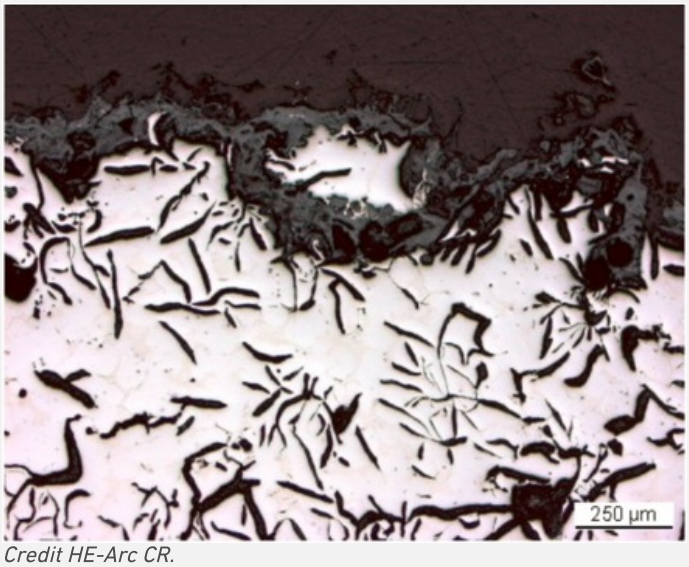
Fig. 9: Micrograph showing the metal - corrosion layer interface from Fig. 3 (inverted picture, detail), unetched, bright field. We observe in white the metal, in light-grey the corrosion layer, in black the graphite flakes,

Fig. 10: Micrograph (same as Fig. 9) corresponding to the stratigraphy of Fig. 4, unetched, polarised light. We observe in violet the metal, in orange the corrosion, in blue the resin,

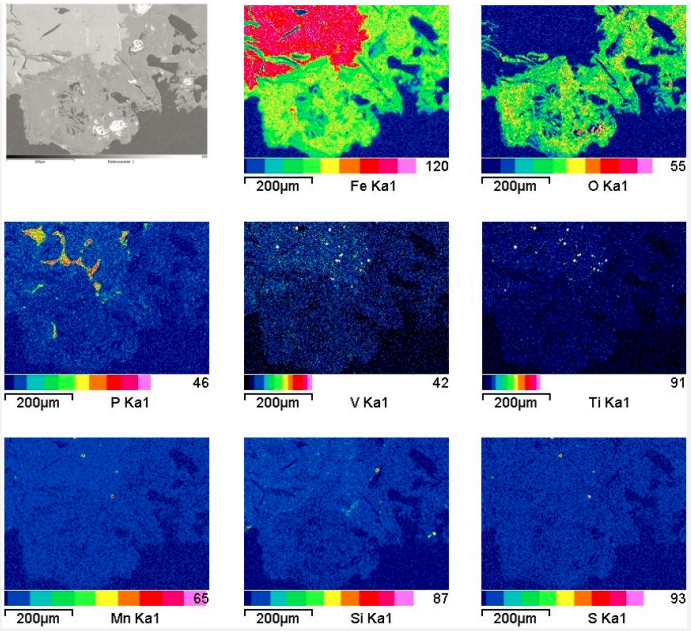
Fig. 11: SEM image, SE-mode, and elemental chemical distribution of the selected area from Fig. 3 (detail). Method of examination: SEM/EDS, Laboratory of Analytical Chemistry, Empa,

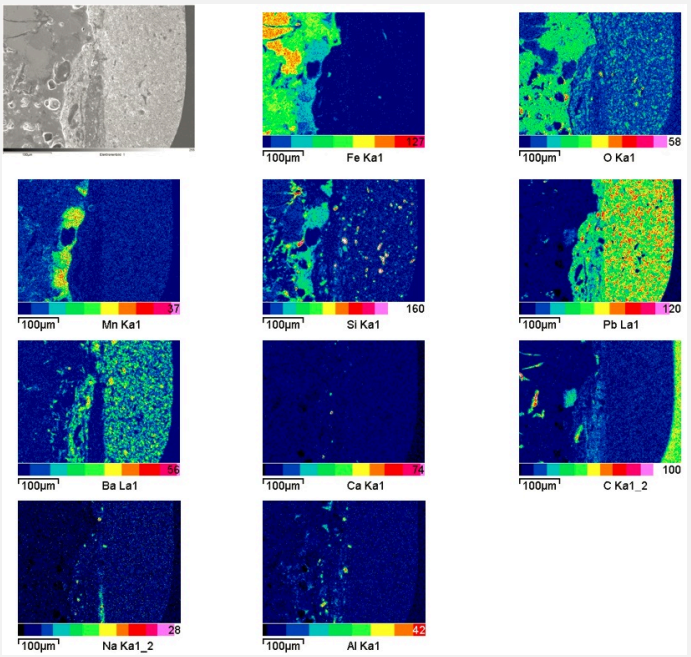
Elements	O	Mg	Si	P	S	Mn	Fe	Ba	Pb	Total
Inner light-grey corrosion layer (Fig. 12)	20	<	<	<	<	1.3	76	<	<	98

Dark-grey casting skin (Fig. 12)	27	<	14	<	<	21	33	<	<	95
Paint system (Fig. 12)	20	<	<	<	<	<	<	18	55	93
Grey corrosion layer (Fig. 11)	35	<	1.1	<	0.6	<	59	<	<	97

Fig. 12: SEM image, SE-mode, and elemental chemical distribution of the selected area from Fig. 3 (detail). Method of examination: SEM/EDS, Laboratory of Analytical Chemistry, Empa,
