AIRCRAFT FRONT FASTENING PLATE VHS-497 (2) - AL CU SN ZN SI ALLOY - MODERN TIMES

Artefact name	Aircraft front fastening plate VHS-497 (2)
Authors	Marianne. Senn (EMPA, Dübendorf, Zurich, Switzerland) & Christian. Degrigny (HE-Arc CR, Neuchâtel, Neuchâtel, Switzerland)
Url	/artefacts/332/

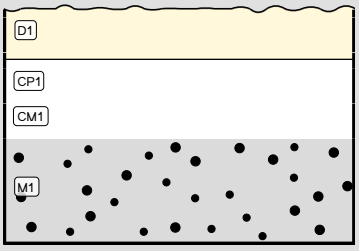
No corrosion layer can be seen on the metal surface (Figs. 3 and 7). Under polarized light small white and brown particles are visible on the broken edge (D1, Fig. 8). Their analysis reveals the presence of silica particles surrounded by dirt (Table 2 and Fig. 9). The metal surface is covered by a thin oxygen bearing skin (CP1, Fig. 9).

Fig. 4: Stratigraphic representation of the object in cross-section using the MiCorr application. This representation can be compared to Fig. 8.

Although not common at the beginning of the 20th, this Al-Cu-Sn-Zn-Si cast alloy was extensively used on the Dufaux IV plane. No corrosion layer has been found on the metal surface except adherent silica-rich particles and the thin oxidised skin typical of Al alloys. The presence of these materials might be explained by the regular maintenance of the metal using abrasive silicon carbide paper.
