FRAGMENT OF A BED STRUCTURE 03 12751-20.2.5 - TIN BRONZE - ROMAN TIMES - SWITZERLAND

Artefact name	Fragment of a bed structure 03 12751-20.2.5
Authors	Marianne Senn. (Empa, None) & Christian. Degrigny (HE-Arc CR, Neuchâtel, Neuchâtel, Switzerland)
Url	/artefacts/336/

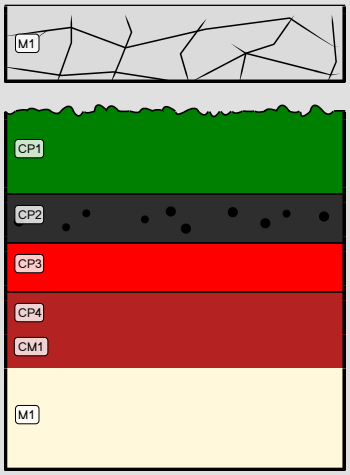
Fig. 4: Stratigraphic representation of the object in cross-section using the MiCorr application. This representation can be compared to Fig. 8.
