BUST OF AN APPLIQUE 2005.054.F00265.1 – QUARTERNARY BRONZE ALLOY – ROMAN TIMES – SWITZERLAND

Artefact name	Bust of an applique 2005.054.F00265.1
Authors	Christian. Degrigny (HE-Arc CR, Neuchâtel, Neuchâtel, Switzerland) & Marie. Arnautou (HE-Arc CR, Neuchâtel, Neuchâtel, Switzerland) & Valentin. Boissonnas (HE-Arc CR, Neuchâtel, Neuchâtel, Switzerland)
Url	/artefacts/337/

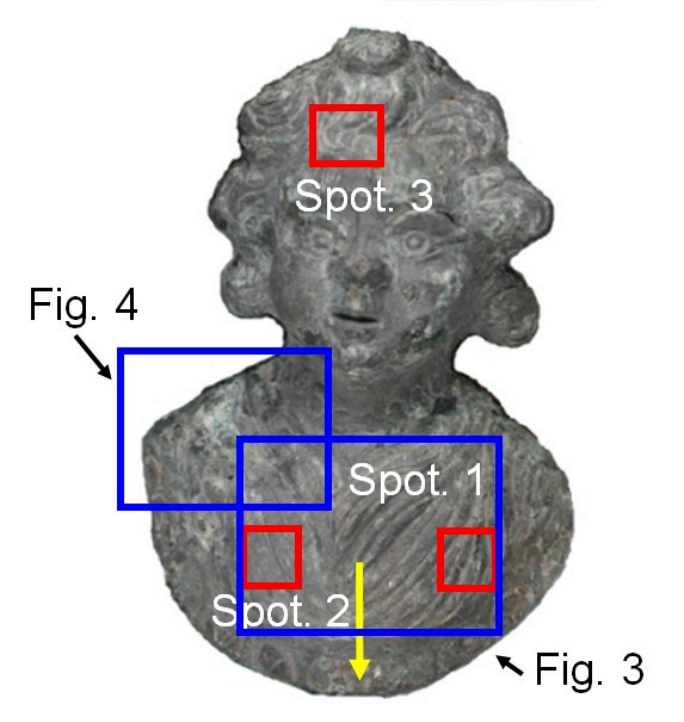
Fig. 1: Bust of an applique as found (left picture) and the bust (right picture),

Description of the artefact	Bust representing a love figure from a bronze applique (Fig. 1), covered by a thin dark-grey patina and scattered green corrosion products. Dimensions: L = 6 cm; W = 3.5 cm; T = 3 cm.
Type of artefact	Applique
Origin	Augst BL, Augusta Raurica, Insula 27, Roman villa, Avenches, Vaud, Switzerland
Recovering date	Excavation 2005
Chronology category	Roman Times
chronology tpq	753 B.C.
chronology taq	476 A.D.
Chronology comment	Roman Times

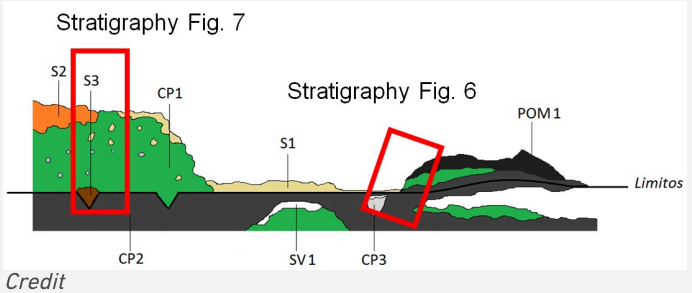
The schematic representation below gives an overview of the corrosion layers encountered on the bust from a first visual macroscopic observation.

Fig. 5: Stratigraphic representation based on visual observation and visualization of the stratigraphies of Figs. 6 and 7.

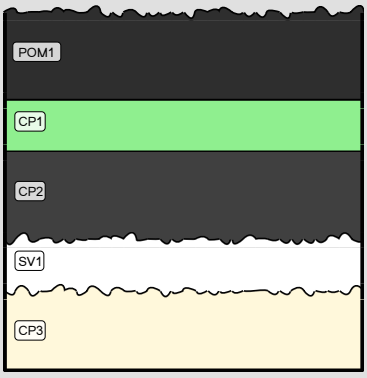
Fig. 6: Stratigraphic representation of the object in cross-section using the MiCorr application. This representation can be compared to Fig. 5.

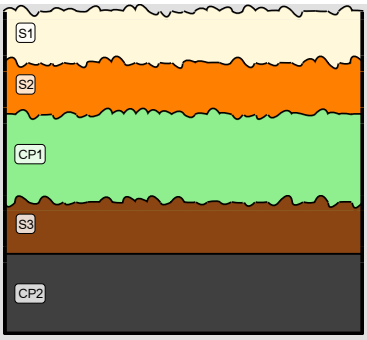
Fig. 7: Stratigraphic representation of the object in cross-section using the MiCorr application. This representation can be compared to Fig. 5.

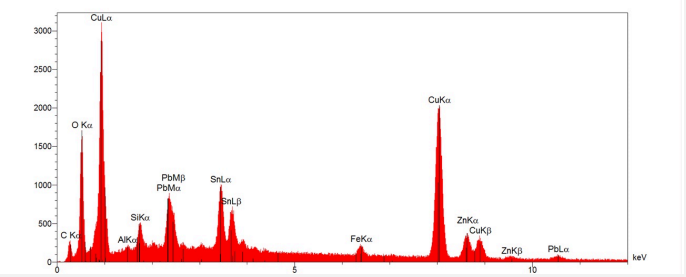
Fig. 6: EDS spectrum of sample 1 located in Fig. 2 (yellow arrow),
