FRAGMENTS OF OENOCHOE GV132-01 US26-OBJ.10 - TIN BRONZE - ROMAN TIMES - SWITZERLAND

Artefact name	Fragments of oenochoe GV132-01 US26-obj.10
Authors	Christian. Degrigny (HE-Arc CR, Neuchâtel, Neuchâtel, Switzerland) & S. Gillioz (HE-Arc CR, Neuchâtel, Neuchâtel, Switzerland) & Valentin. Boissonnas (HE-Arc CR, Neuchâtel, Neuchâtel, Switzerland)
Url	/artefacts/338/

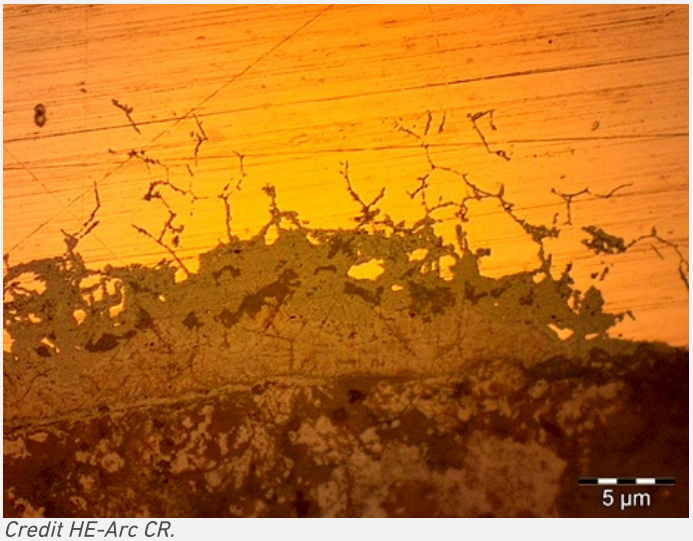
Intergranular corrosion is observed on the edges of the remaining metal (Fig. 9).The sample shows two forms of corrosion: multi-layered pustule corrosion at the left extremity of the sample (Fig. 10, area 1) and a corrosion crust covering the metal (Fig.10, area 2). The multi-layered pustule corrosion has an average thickness of about 1.1 mm (L) and 0.79 mm (W) (Fig.11). It is composed of a sandwich of 7 corrosion products, mainly green, grey, red and blue in dark field. Microscopic observation allows us to highlight new corrosion products that were not detected during the first visual examination (Fig. 11):

Fig. 9: Micrograph of the metal sample from Fig. 4, unetched, bright field, 50x. The grain boundaries are revealed by the intergranular corrosion,

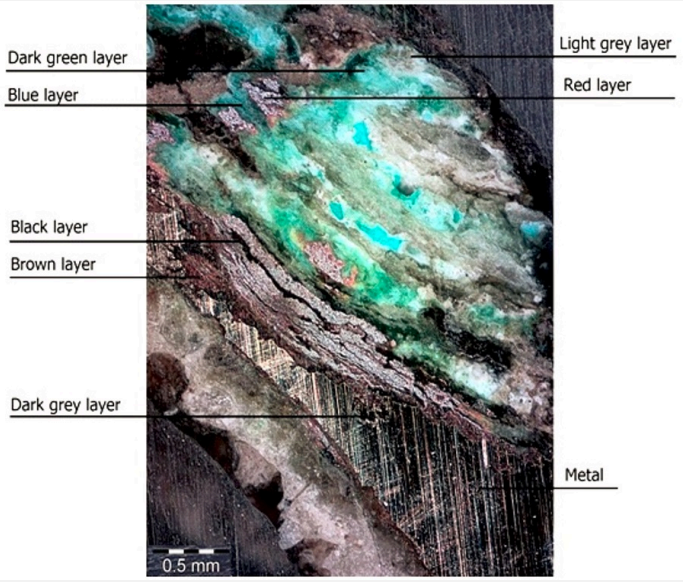
Fig. 11: Micrograph of the metal sample from Fig. 10 (area 1, 60° rotated) and corresponding to the stratigraphy of Fig. 5, unetched, dark field,

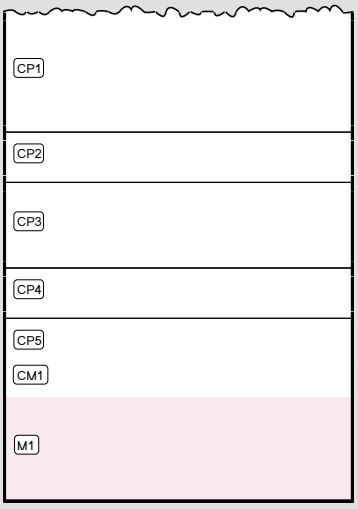
Fig. 5: Stratigraphic representation of the object in cross-section using the MiCorr application. This representation can be compared to Fig. 11.

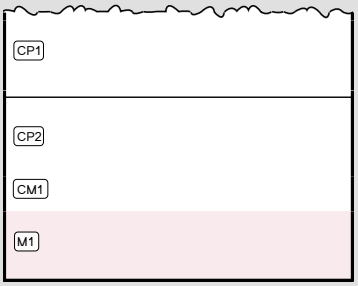
The corrosion crust on the metal has an average thickness of about 70 µm (Fig. 13). It consists of two sub-layers. The inner corrosion layer (CP2) is thin and dark brown in dark field or light grey in bright field. It has penetrated into the metal structure in some areas (Fig. 9). In dark field, the outer corrosion layer (CP1) is constituted of a heterogeneous light grey corrosion crust (Fig.13). The inner brown corrosion layer is enriched in Sn and O but also contains P, while the outer light grey corrosion layer is mainly composed of Pb and O but also contains P and Fe (Fig. 12). The outer light grey layer is probably due to the presence of a soft solder used to assemble the base to the body.

Fig. 6: Stratigraphic representation of the object in cross-section using the MiCorr application. This presentation can be compared to Fig. 13.
